Technical Service Bulletin

94E4 UPDATE - Repairing Headlights (NVLW)

94 12 65 2022790/3 February 14, 2012. Supersedes Technical Service Bulletin Group 94 number 11 – 50 dated July 12, 2011 for reasons listed below.

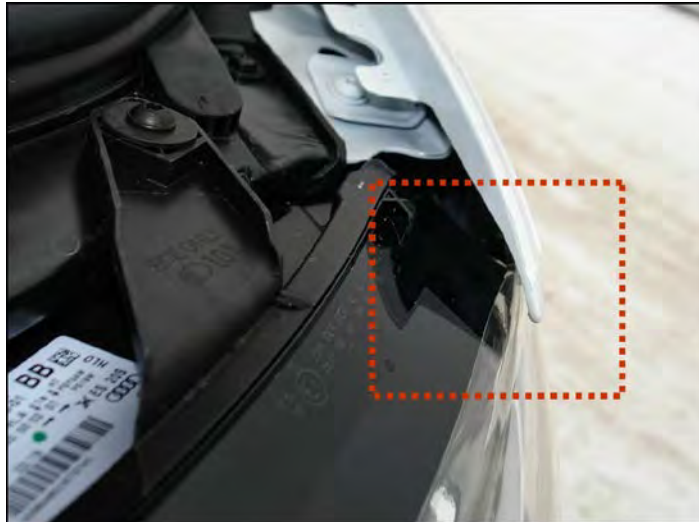
On Audi A3 vehicles manufactured within a specific period it is possible that a clip on the headlight contacts the fender. This can cause paintwork damage.

Figure 1. Area to be modified, viewed with hood open.

1. Open hood.

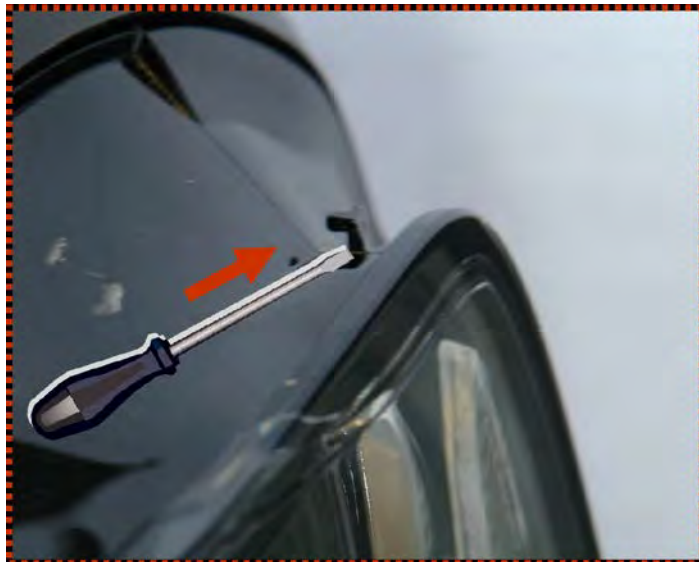
Figure 2. Direction to remove clip.

2. Apply screwdriver and remove clip with a gentle tap (left and right headlight).

3. Spray any abrasion with cavity sealing wax.
