TECHNICAL BULLETIN

LTB00348NAS2

Water Ingress Through High-Mounted Stop Lamp

LR2 (LF)

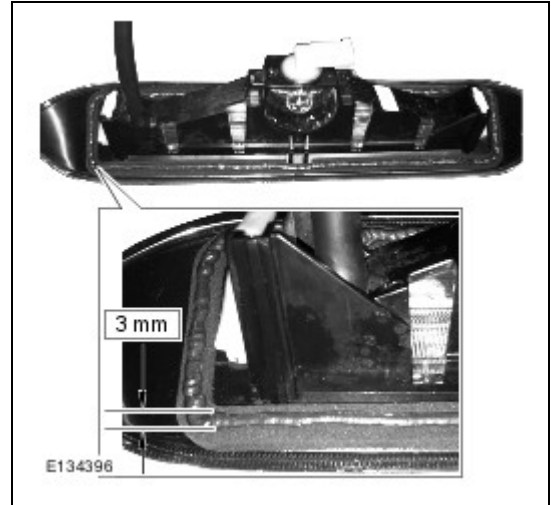
Situation: Water may enter the vehicle through the high-mounted stop lamp area. This may be caused by water passing through the lamp seal.

1. Refer to Workshop Manual, section 417-01: *Exterior Lighting*, and remove the high-mounted stop lamp for access.
2. Clean and dry the sealing faces of the lamp foam seal and vehicle body.
3. Apply a 3mm bead of sealant (STC50550) to the sealing face of the lamp seal.

CAUTION: Allow 24 hours before power washing the vehicle.
