NUMBER: 23-004-12

Exterior Mirror Turn Signal Lamp Water Intrusion

This bulletin involves replacing the turn signal lamps in the exterior mirrors due to possible water intrusion.

2011	(LX)	Chrysler 300
2012	(LX)	Chrysler 300

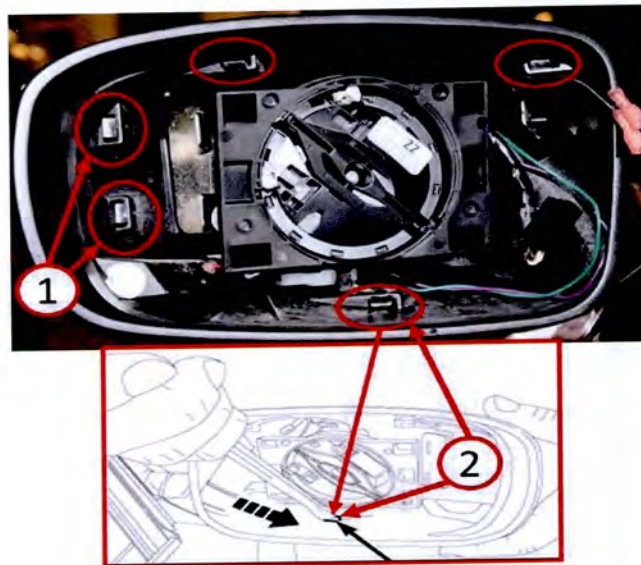
Fig. 3 Mirror Outer Shell Removal

NOTE: Use caution when removing the mirror cap, retainer tabs may break during cap removal.

NOTE: In the event that the mirror cap retainer tabs were broken during a previous disassembly, a piece of double sided adhesive tape would have been added between the mirror cap and shell to improve retention. If the tape is present it will make the amount of force needed to remove the cap higher.

8. Using a flat head screw driver, pliers or equivalent, disengage the mirror shell cap outboard retaining tabs (1) (Fig. 3).
9. Using a flat head screw driver, apply downward pressure to the bottom retaining tab (2) (Fig. 3).
10. Push with the screw driver and pull on the shell cap with your opposite hand creating a gap between the mirror housing and the shell cap.

11. Continue to pull on the shell cap using both hands as necessary until the cap detaches from the mirror assembly and remove the shell cap.

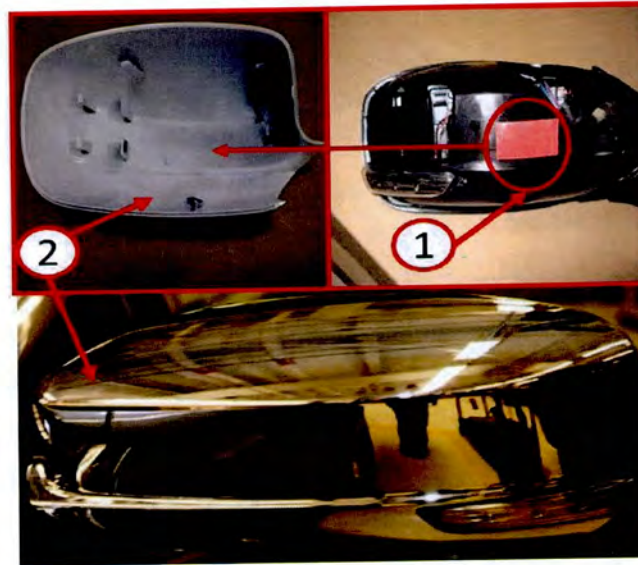
Fig. 7 Mirror Outer Shell Installation

NOTE: Inspect the mirror shell cap (2) (Fig. 7) for any possible handling damage to the exterior of the shell and/or distortion or damage to the inner retaining tabs. If any damage has occurred to the exterior side of the shell it must be replaced.

NOTE: If several inner shell cap retaining tabs are broken off the shell must be replaced.

16. Apply double sided tape (1) to mirror shell as shown if any retaining tabs are broken or distorted (Fig. 7).

17. Reinstall the shell cap onto the mirror housing and make sure it is fully seated.
