SERVICE PROCEDURE

SUBJECT:**NVLD REPLACEMENT (SERVICE CAMPAIGN TG6)**

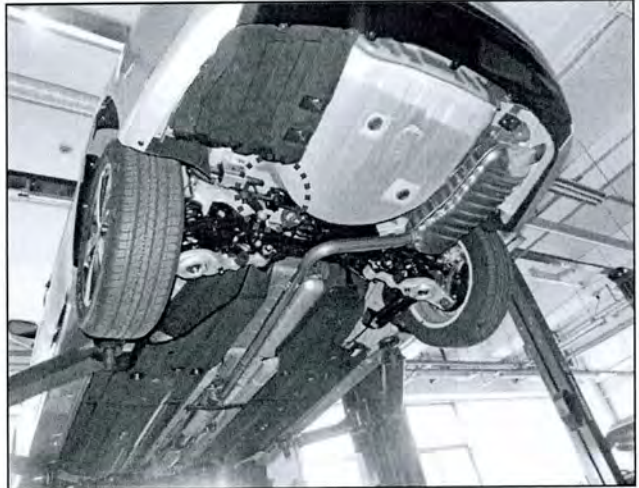
1. Turn off the ignition key and confirm that the "READY" light is not illuminated in the IP cluster.
2. Lift up the vehicle and locate the NVLD on the left side of the fuel tank. (Shown at right)
