Service Bulletin

Bulletin No.: PI0639

Date: January, 2012

Subject: Service StabiliTrak Message Displayed in DIC, StabiliTrak Indicator Light On, DTC C0455 and/or C0710 Set

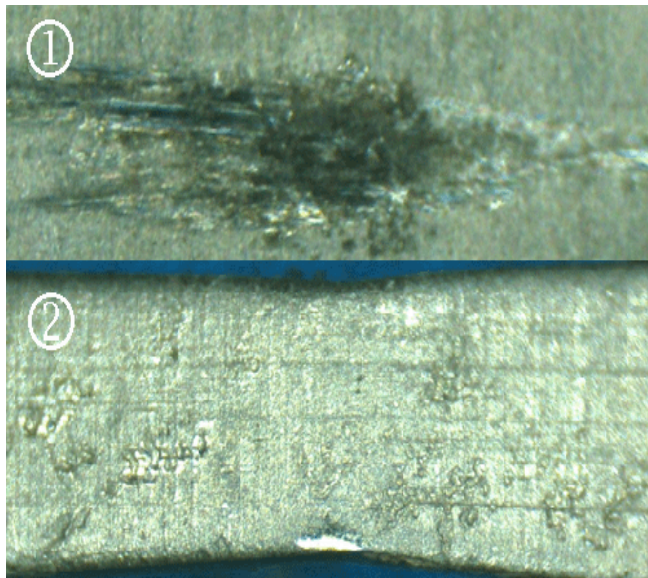
2745017

This condition may be caused by an increase in resistance in the circuits connecting the steering position sensor and the EBCM due to fretting corrosion on the connector terminals.

Note: Fretting corrosion looks like little dark smudges on the electrical terminals and appear where the actual electrical contact is being made. In less severe cases it may be unable to be seen or identified without the use of a magnifying glass.

- (1) Corrosion on female terminal contact point
- (2) Clean female terminal contact point

Important: DO NOT replace the steering position sensor for this condition. The terminal pins on the sensor do not have the same concentration of deposits.

1. Disconnect the steering wheel position sensor connector.

Important: DO NOT apply an excessive amount of dielectric lubricant to the connector, as hydrolock may result when attempting to mate the connector. Use **ONLY** a clean nylon brush that is dedicated to the repair of this specific condition.

2. With a one-inch nylon bristle brush, apply dielectric lubricant to both the sensor side and the harness side of the affected connector.
3. Reconnect the steering wheel position sensor connector and wipe away any excess lubricant that may be present.
4. Confirm end to end circuit resistance is less than 0.5 ohms. If resistance is still high, replace the harness side connector with the service pigtail. Refer to the Steering Angle (Position) Sensor connector end view in SI for correct service connector part number.
