Service Bulletin

Bulletin No.: PIC5644

Subject: Lack Of or No Power Steering Assist (NJ1)

Models: 2012 Buick Regal
Built prior to August 26, 2011

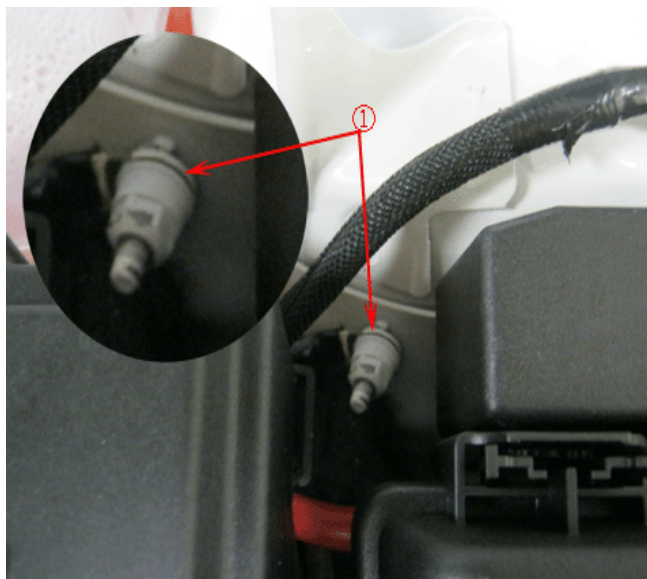
2738655

Poor connection at G111 (1).

On vehicles built prior to August 26, 2011 it has been found that the nut on the ground post could be loose - allowing paint to enter under the nut and negatively impacting the ground connection.

Remove the nut and wire from ground post G111, inspect the base of the ground post and the base of the ground nut.

If paint is found, clean the ground post base and replace the M6 nut (GM P/N 11609767) and torque to 8 N·m (71 lb in).
