**NUMBER:** 21-002-12**GROUP:** Transmission and Transfer Case**DATE:** January 12, 2012

Manual Transmission Pops Out Of 2nd, 4th, And 6th Gear Positions

2011 - 2012 JK Wrangler

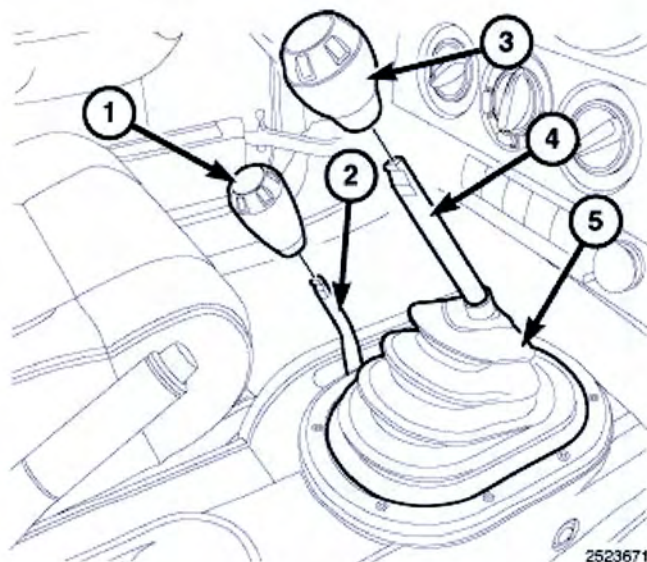
Fig. 1 Shift Lever

1. Verify that the outer shift lever boot has not been trapped under the shift knob or pushed too far down the shift lever. The boot should be allowed to slide freely on the shift lever. In the neutral position, there should be an approximately 50mm (2 inches) of clearance between the shift knob and the upper boot end. If the boot is trapped, remove the knob to release the boot. If the boot is too far down the shift lever, pull the boot up so that there is approximately 50mm (2 inches) of clearance between the shift knob and the upper boot end.
2. Slide the shift lever back towards the seat and pull the shift knob (Fig. 1) in an upward motion with a "quick" snap to remove the shift knob.
