Service Bulletin

Bulletin No.: PIC5646

Subject: Service Engine Soon Light On And Emissions 2 (EMIS 2) Fuse Open

Models: 2012 Impala
Build prior to February 15, 2012

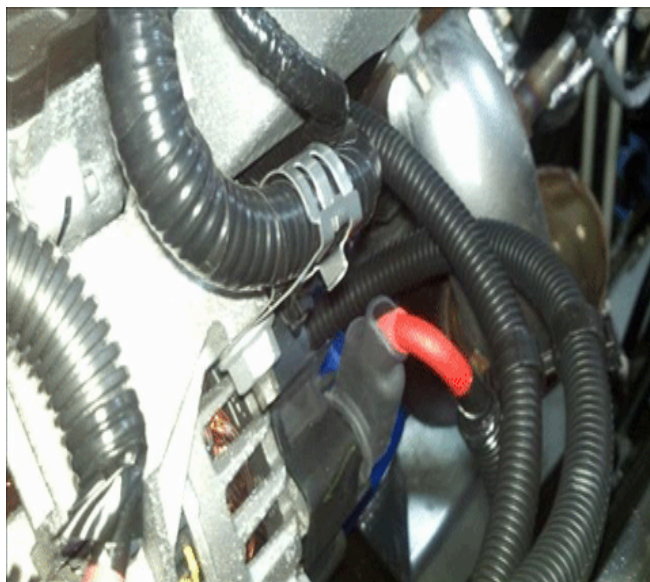
2778412

In rare situations a customer may come to the dealer with a Service Engine Soon light on and an Emissions 2 (EMIS 2) fuse open. The technician will most likely find codes P2199 P11C2 P0693 P0691 P0178 P0161 P0141 P0102 P0097 P0056 P0036 P2228 P1258 P0113.

The technician should check the metal wiring harness clip located just above the alternator (see picture below).

Please repair the wiring and conduit as necessary and modify the clip so it holds the harness in place but will prevent the metal clip from re-piercing the harness.

Some dealers have used a die grinder to remove all traces of the tab that pierces the harness and reformed the retaining clip to prevent future issues with the clip.

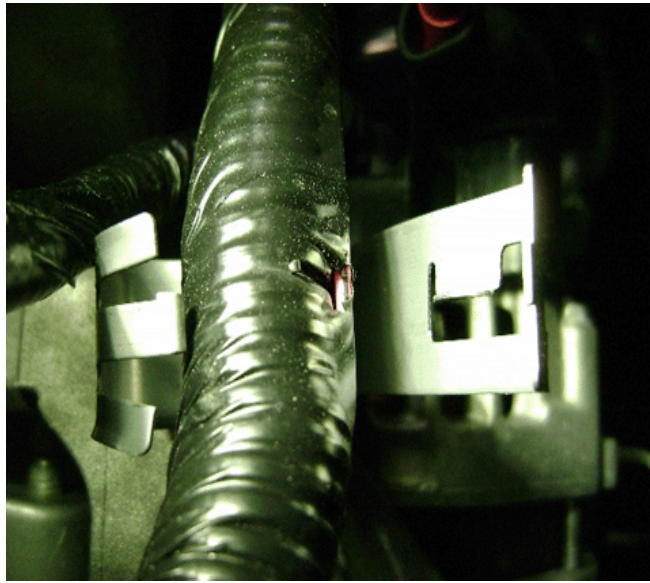
2778419

Once the metal clip is opened you may or may not see damage to the conduit (see picture below). You may need to open the conduit to inspect the circuits.
