# Product Service Bulletin

**MODEL:** HDX

**SUBJECT:** MUD FLAP AND DPF CONTACT, BRACKET INSTALLATION

**BULLETIN:** 40

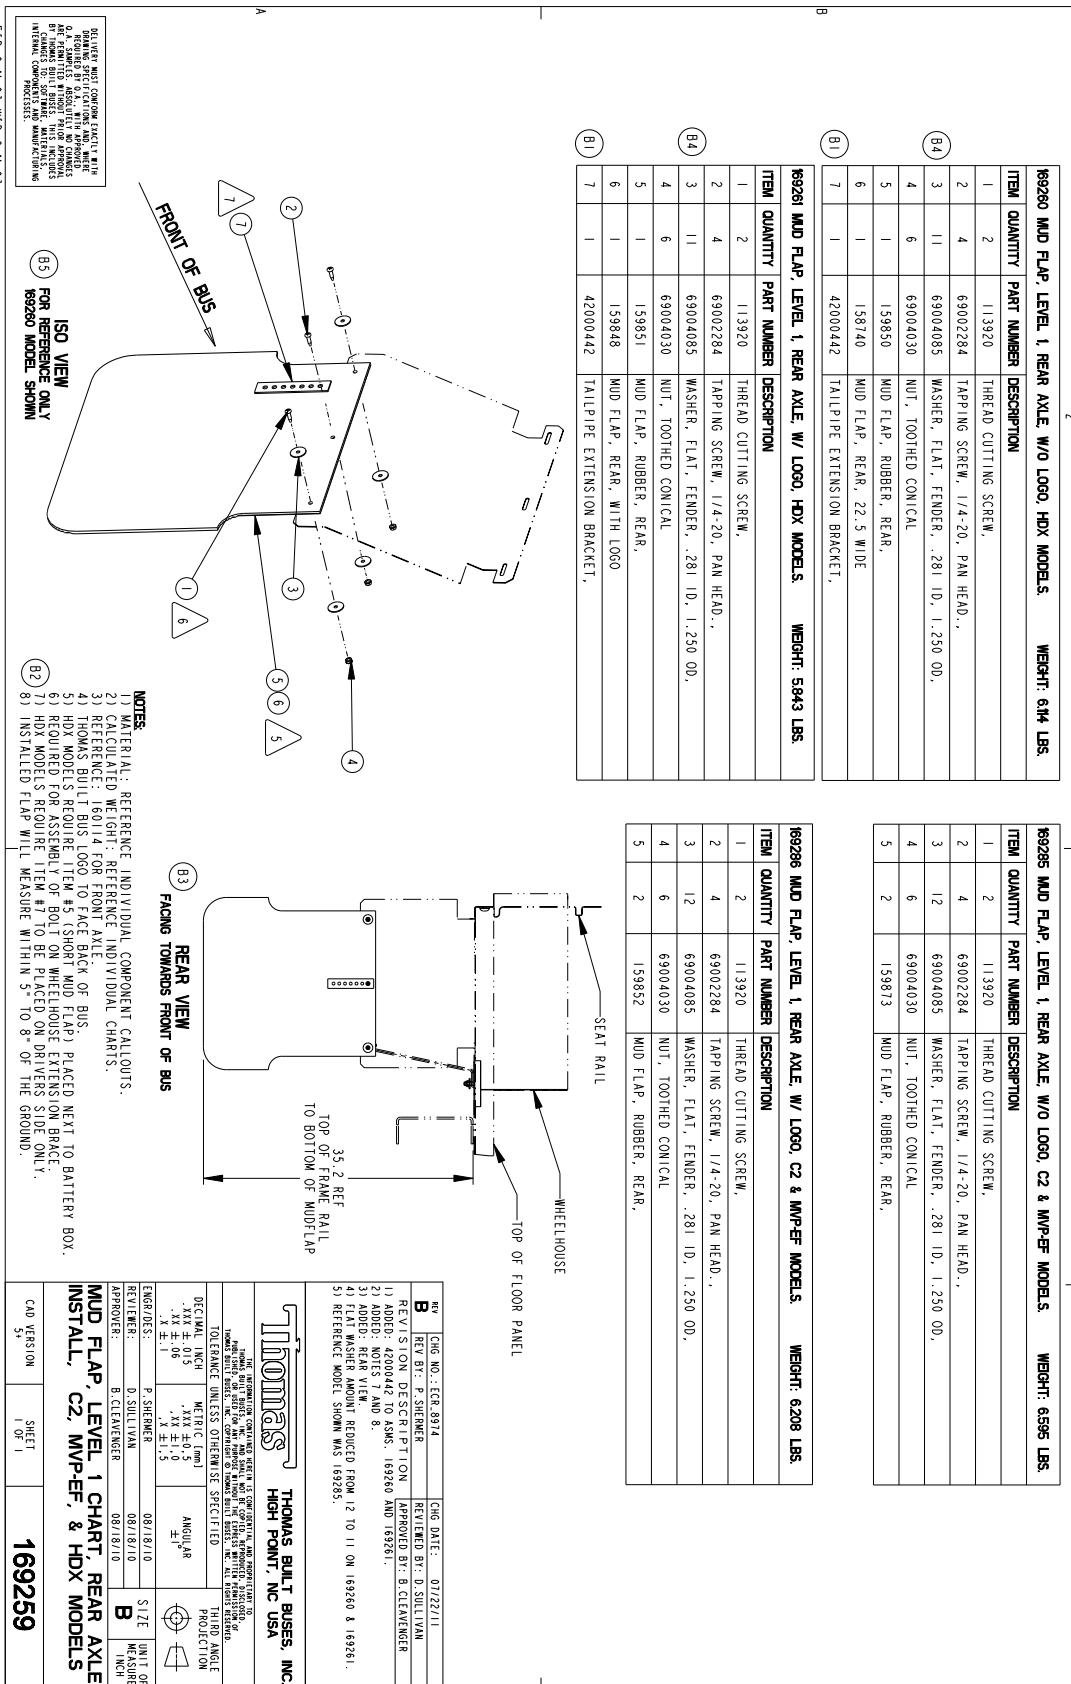
This service bulletin will add a bracket to limit the swing of the driver's side mud flap, preventing possible contact with the DPF while the unit is in transit.

1. Turn the ignition key to the "Off" position and chock tires.
2. Install part number TBB 42000442, Tailpipe Extension Bracket, behind the driver side mud flap use existing hardware. (reference Mud Flap installation drawing 169259)
3. Remove tire chocks.
