# Service Bulletin No. 374

| MODEL<br><b>E / J Series Coaches</b> | TYPE<br><b>Field Change Program</b> | SECTION/GROUP<br><b>6 – Cooling</b> | DATE<br><b>Jan. 13, 2012</b> |
| SUBJECT<br><b>LINNIG FAN CLUTCH COOLING RING</b> | | | |

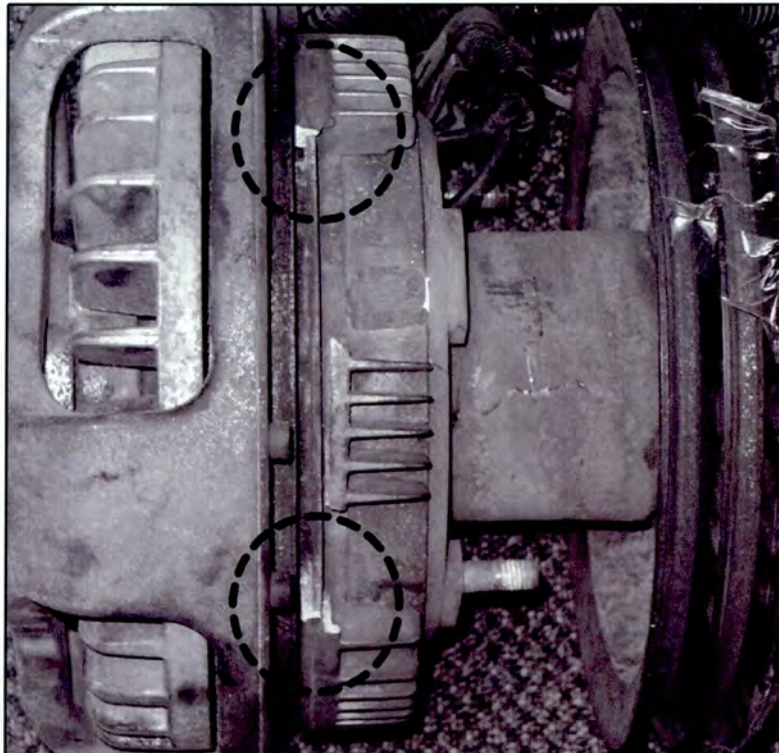
The cause is due to vendor ( Linnig ) manufacturing process.

Figure 2. Reference photo of missing portion of cooling ring fins.

*Upon completion of visual inspection, if the fan clutch cooling ring displays evidence of stress cracks and/or missing portions of the fins, contact the MCI Fleet Support Technical Center at 1-800-241-2947 for fan clutch cooling ring replacement information. Re-install the belt and close the engine compartment door. Return the wheel wrench and handle to the drag link compartment. No further action required. Procedure complete.*

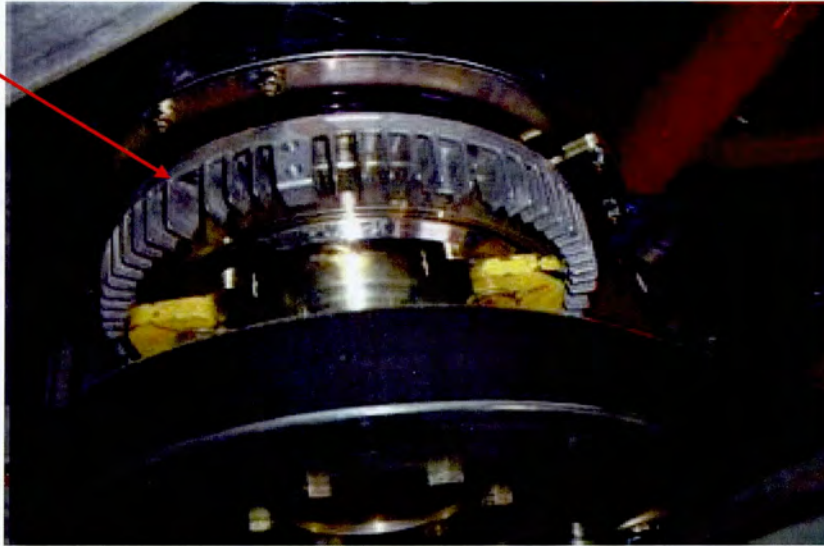
**Figure 1: Exhibits the fan clutch that is affected**

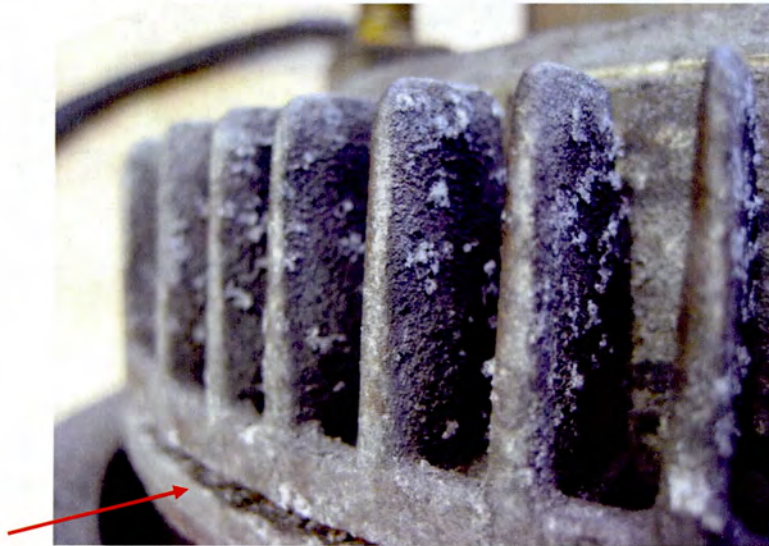
**Figure 2: Exhibits a stress crack on the cooling ring**

- Shut off engine & power supply to the clutch prior to inspection
- Conduct a clutch inspection prior to any scheduled or unscheduled maintenance to the coach with the engine and power shut off
- Locate the cooling ring that is affected on the fan clutch (See figure 1)
- Inspect the cooling ring for defects such as stress cracks or missing portions (See figure 2 & 3)
- A routine clutch inspection should be conducted during every oil change and normal PM intervals
- If any defects are present, replace the fan clutch (06-06-1220) immediately to avoid further damage(s) or injury

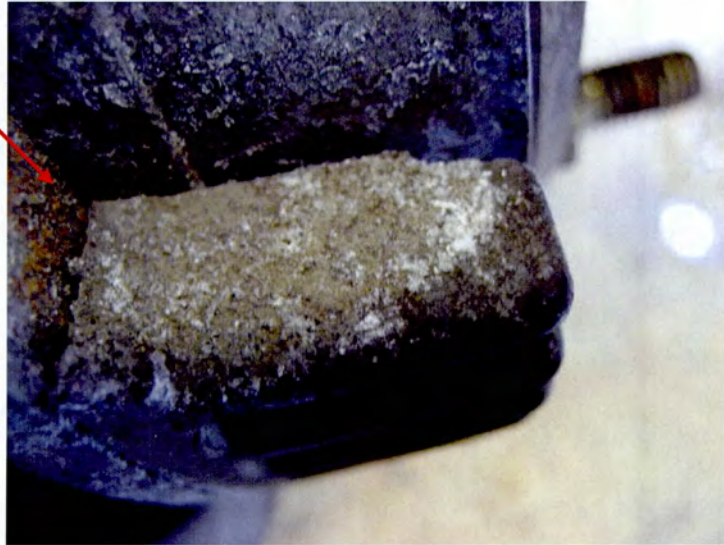
**Figure 3: Exhibits missing portion of the cooling ring**
