SB-10043712-3576

SI B52 01 12
SeatsJanuary 2012
Technical Service

SUBJECT**Service Action: Replace the Bolted Connection on the Front Seat****MODEL**

F12 (6 Series) Convertible

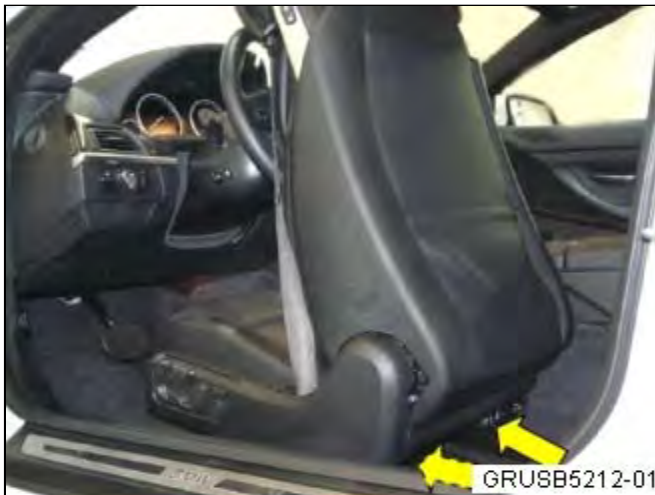
The bolted connection between the seat rail and seat height mechanism may not be properly installed.

1. Move the front seat fully forward to expose both rear nuts securing the seat mechanism to the seat rail.
