SB-10043724-9201

February 2012
Technical Service

Installation of a Heat Shield for the Bonnet Intake Air Grill

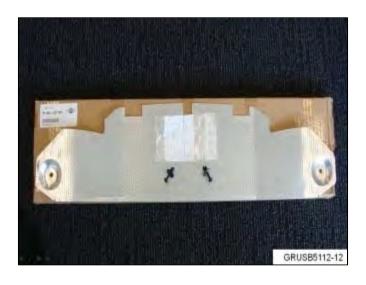
The bonnet air grill can deform due to the high heat from the engine turbocharger.

1. The thermal insulation for the air inlet grill (51 48 2 183 986) comes complete with two pushtype pins for easy installation.
