**SUBJECT: 2009 Mazda6 Advanced Keyless Entry Door Handle Request Switch
Special Service Program (SSP) 89**

Mazda Motor Corporation has decided to conduct a Special Service Program (SSP) on certain 2009 Mazda6 vehicles equipped with Advanced Keyless Entry and produced from February 4, 2008 through February 27, 2009.

2009 Mazda6 Advanced Keyless Entry Door Handle Request Switch SSP89

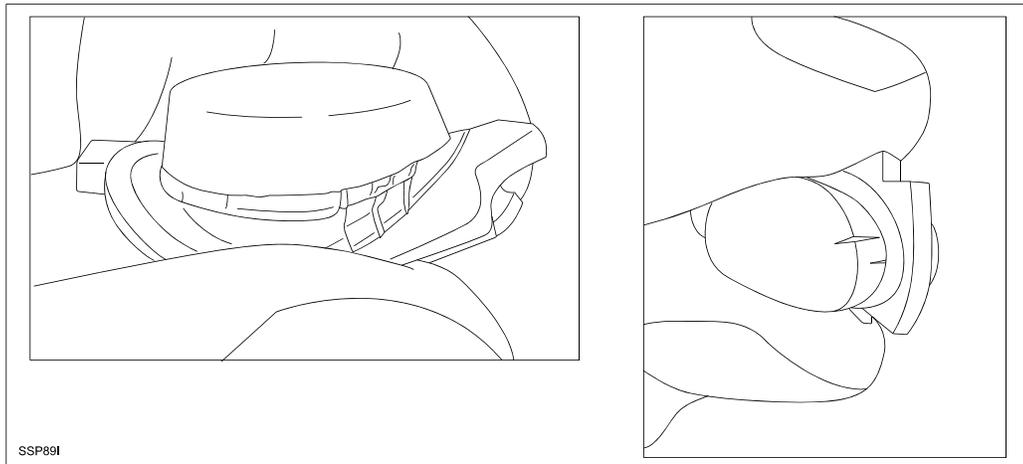
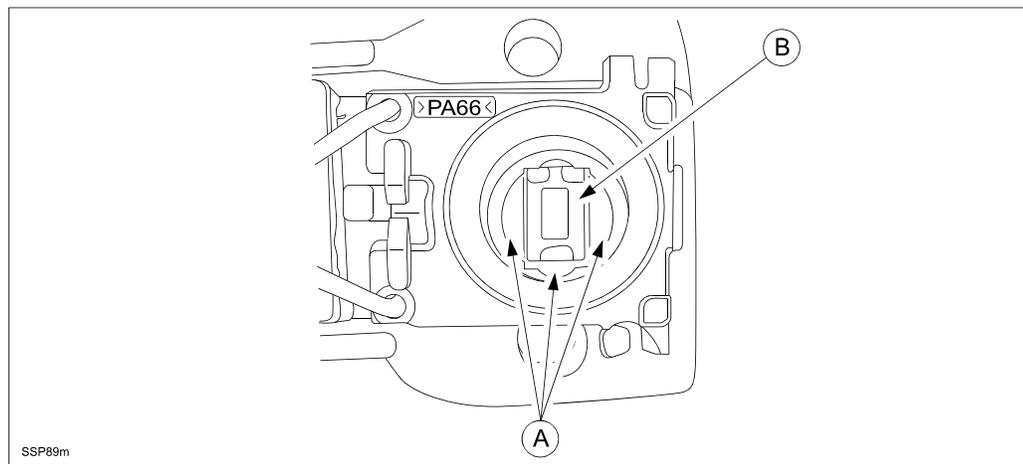
13. Remove the rubber button and closely inspect for cracks. If cracks are found, closely inspect the switch (B) and switch cavity (A) for signs of corrosion or moisture.

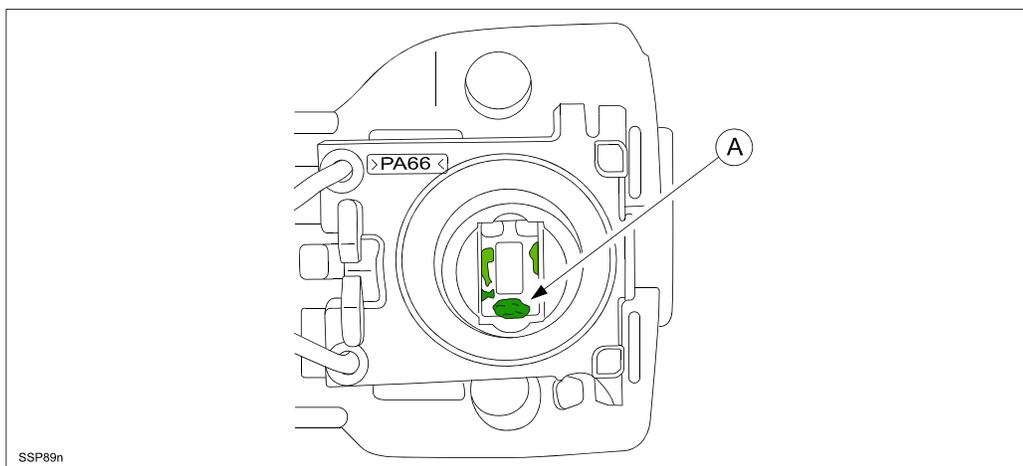
Example of corrosion include: Greenish residue (A) on the switch and/or on the bottom of the switch cavity.

- Was Corrosion found on the switch or switch cavity?
- No, proceed to D. RUBBER BUTTON REPLACEMENT AND HANDLE REASSEMBLY.
- Yes, proceed to E. REQUEST SWITCH REPLACEMENT PROCEDURE.
