**SB-10043781-9719**

**Title:** TerraStar Headlamp Wiring Harness Rerouting

**Applies To:** All TerraStar variants

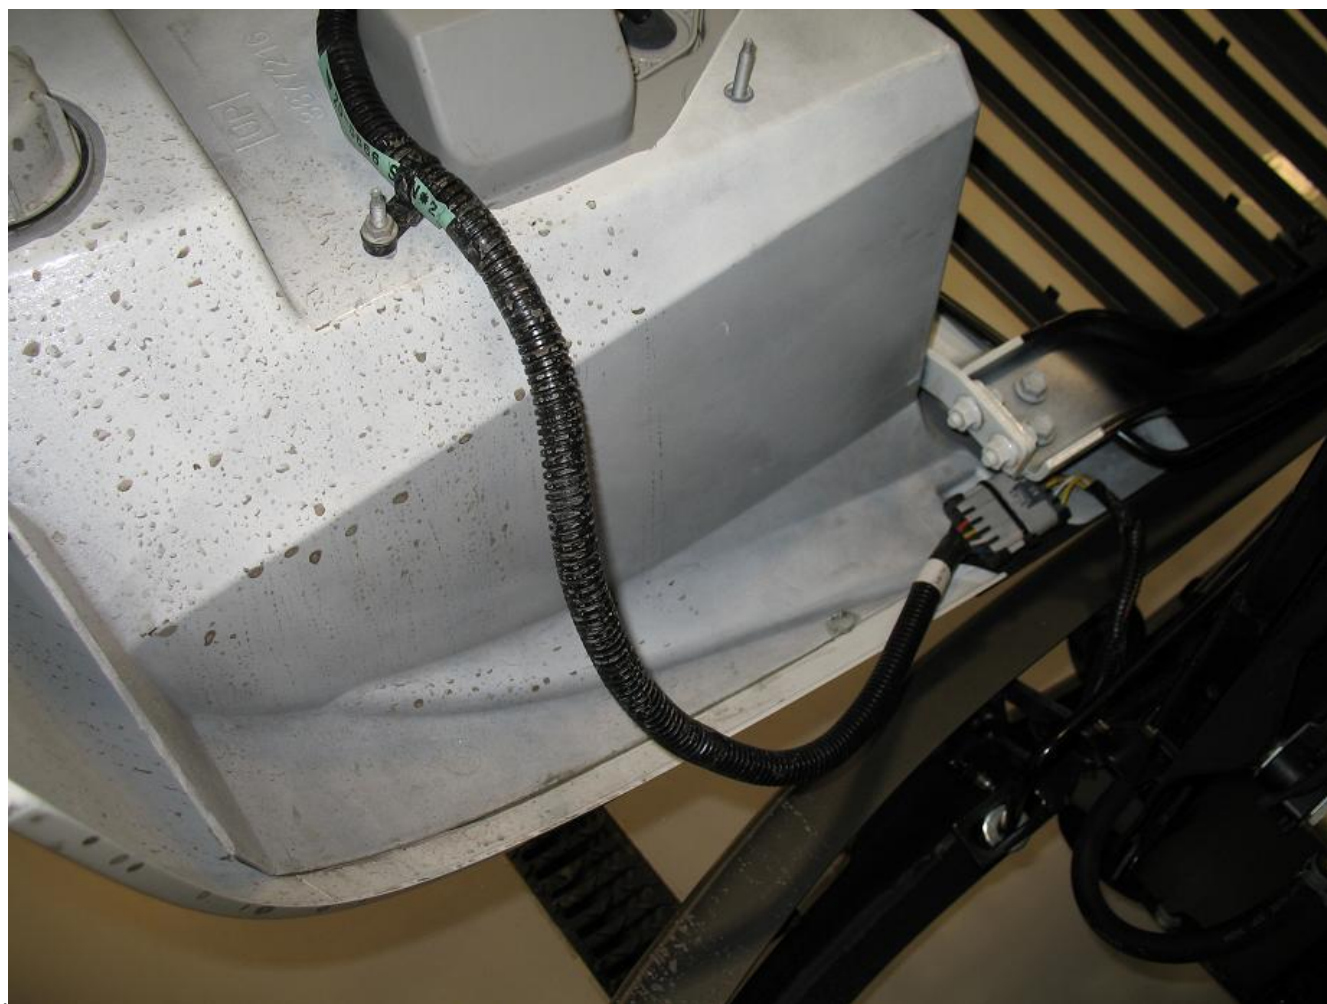
The harness will appear as in Figure 1, below. The harness will extend from the chassis to a flat connector and from the connector, to the lamp cavities in the hood. Note that in some instances, the flat connector itself will not be secured to the hood, as it is in Figure 1, during assembly.

Figure 1 - Headlamp Harness in As-Built Configuration (note that connector may not be secured during assembly)

1) As mentioned above, it is possible that the harness flat connector may not be secured in any way. If this condition is observed, using one (1) Navistar P/N 291207C1 wire tie, secure the connector to the slot along the bottom edge of the hood, which will be immediately adjacent to the connector. Cut off and dispose of excess wire tie material. Study Figures 1 and 2 to determine how a properly secured connector should appear.

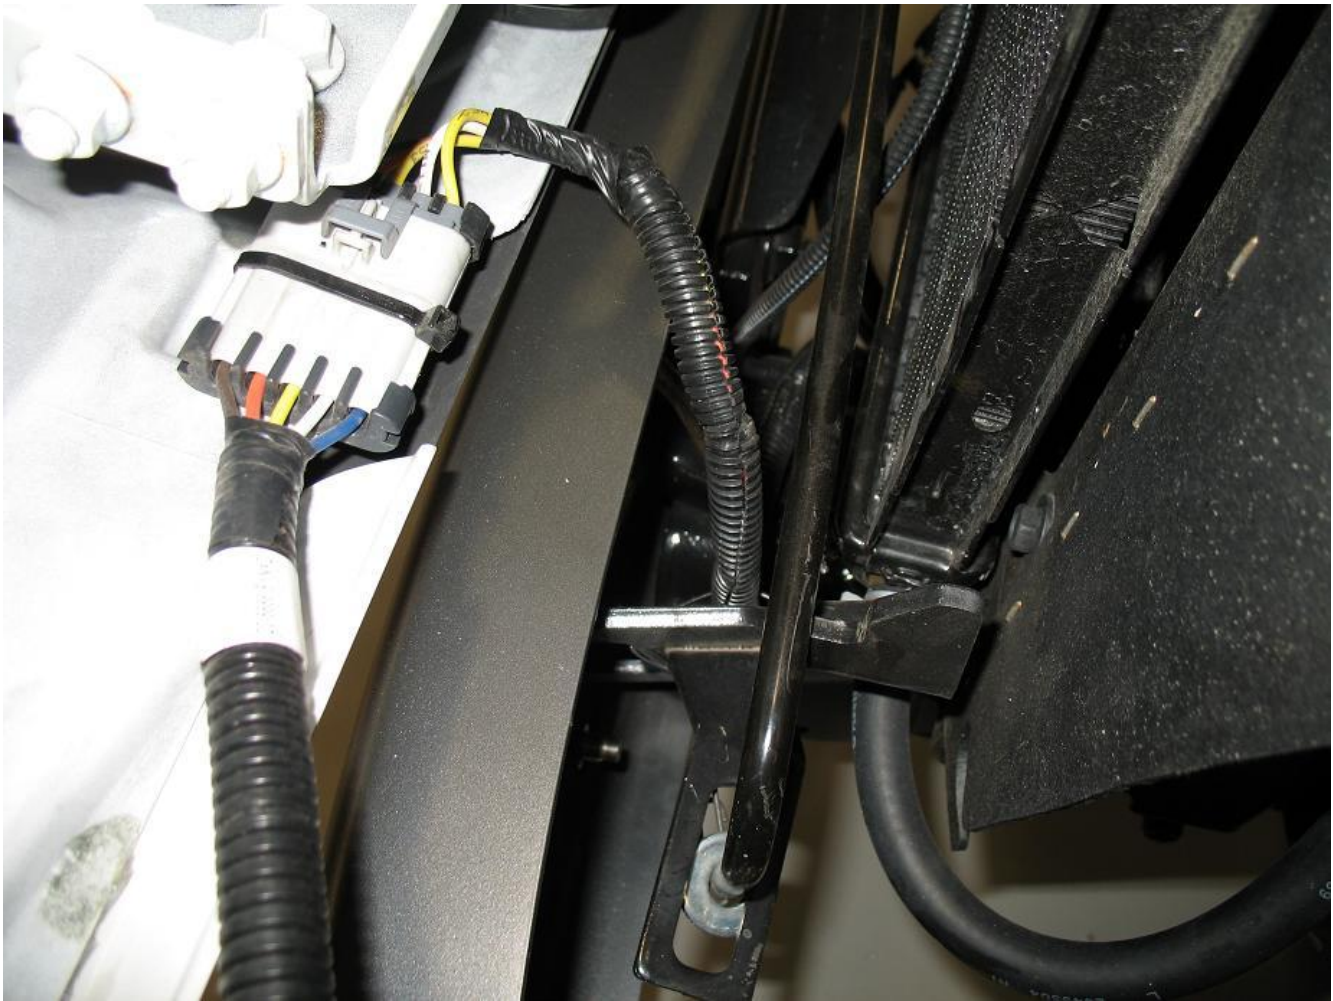
2) The harness on the chassis side of the connector must be rerouted. Study Figure 2 to determine how the harness will have been positioned in production. In this Figure, note the pinched area on the harness convolute tubing, where the harness has been

trapped between the bottom edge of the hood and the hood counterbalance torsion rods.

Figure 2 - Headlamp wiring harness (chassis side) in "as-built" location - note pinch point on harness

Reroute the chassis side harness to the opposite side of the vertical plate which anchors the counterbalance torsion rod. Study Figure 3 (and compare to Figure 2) to determine how the rerouted harness should appear. Secure the rerouted harness to the existing hole at the bottom of the bumper bracket, using one (1) Navistar P/N 289862C1 wire tie. Cut off and dispose of excess wire tie material. In Figure 3, a wire tie has been positioned in the hole, for illustration purposes.

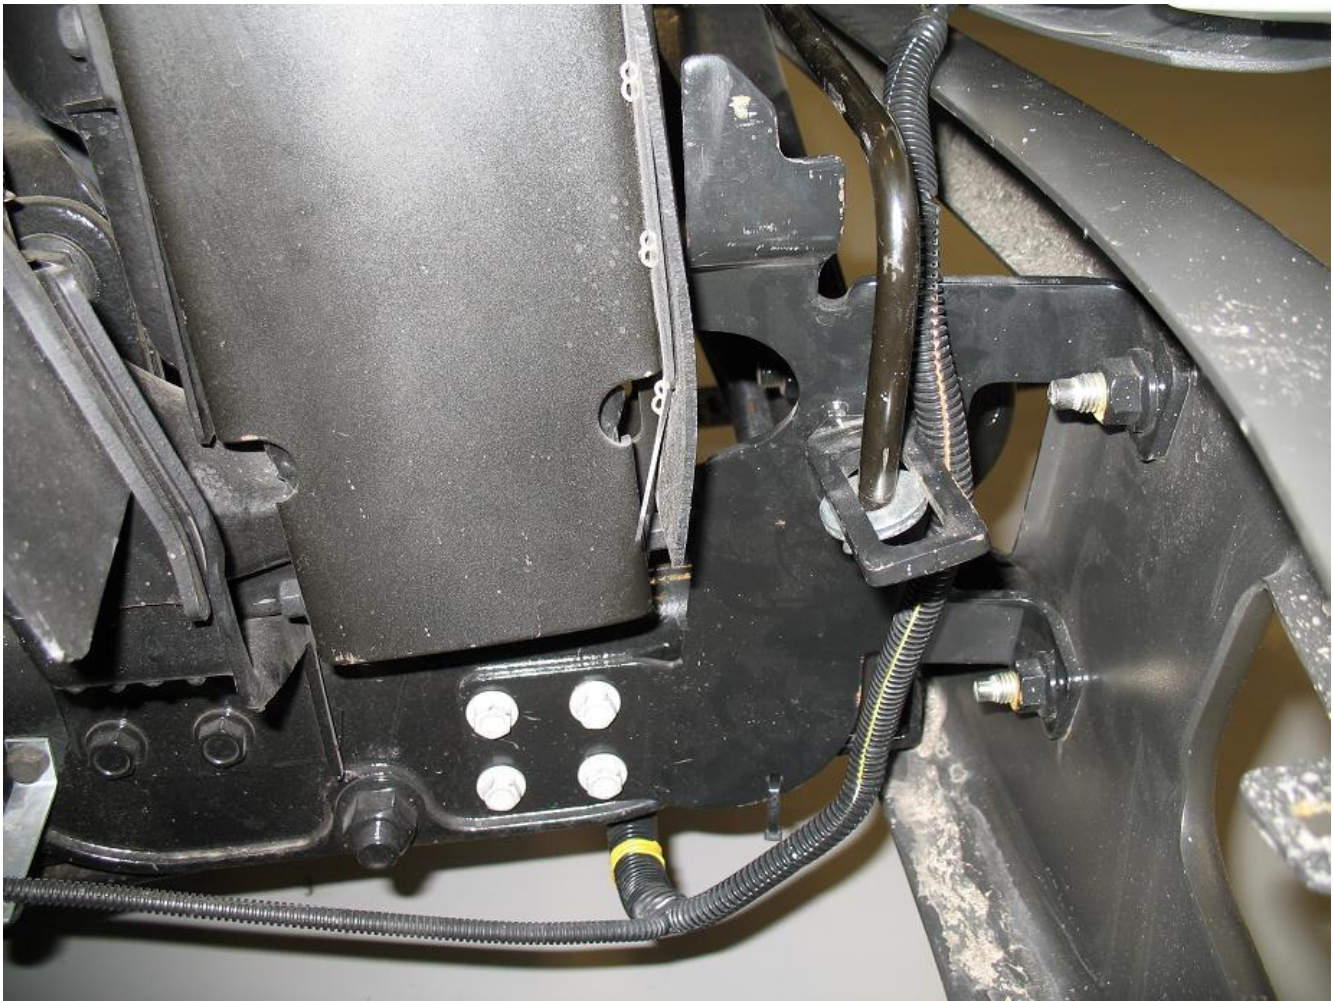
Figure 3 - Headlamp wiring harness (chassis side) in "after relocation" position - note hole/wire tie for securing

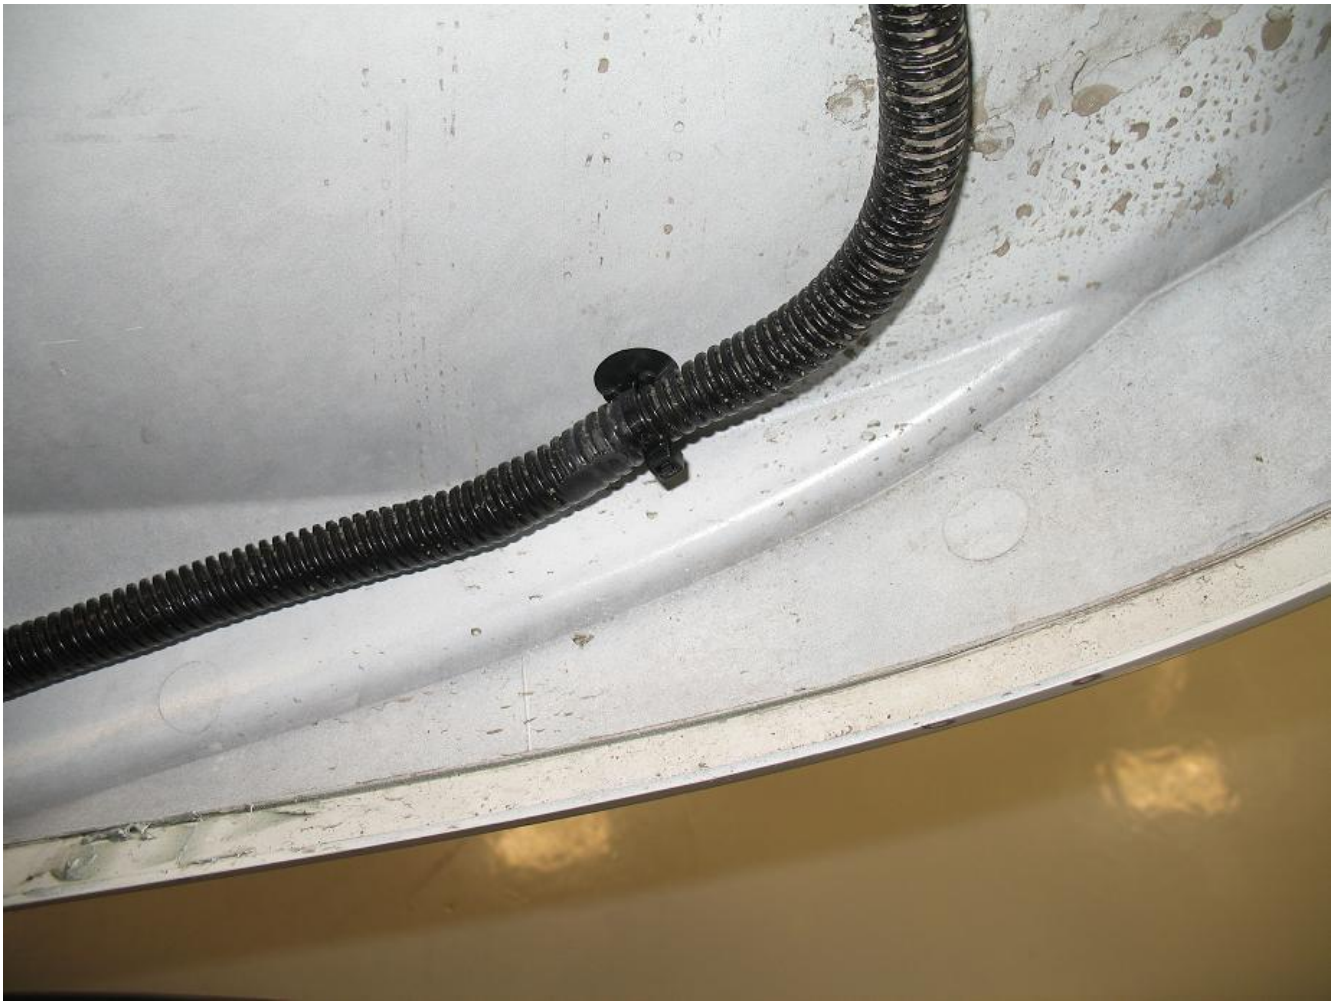
Figure 4 - Headlamp wiring harness (hood side) secured with P/N 3613346C91, combination retainer and wire tie

3) The harness on the hood side of the connector must be secured. Study Figure 3 (and compare to Figure 1) to determine how the harness should be positioned when properly secured. In the approximate position shown in Figure 3, on each side of the hood assembly, carefully drill a .125 inch diameter hole. To ensure a professional-quality repair, take care to measure the location of the first hole and position the second hole in exactly the same location, on the opposite side of the hood. Press the push-pin side of one (1) Navistar P/N 3613346C91 retainer (w/wire integral tie) into the drilled hole. When the push-pin side of the retainer is fully inserted into the hole, secure the harness to the wire tie side of the retainer and cut off and dispose of the excess wire tie material.
