# Service Bulletin

## 2012 GL1800/A Navigation System Software PRODUCT UPDATE CAMPAIGN

**Campaign End Date:**  
**Last Day of March, 2017**

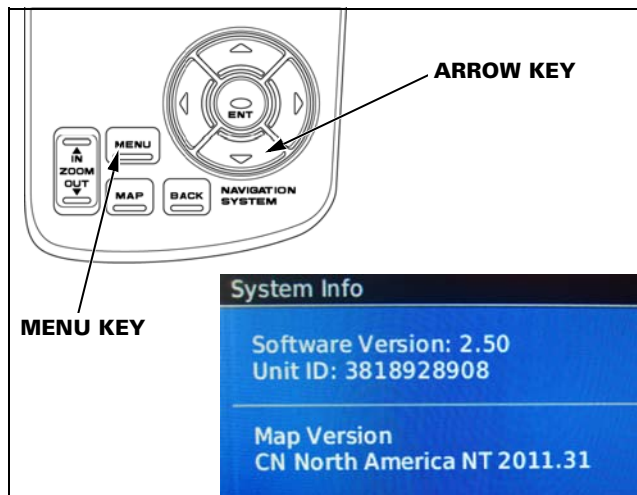
1. Turn the ignition switch to ACC and let the Navigation System boot up.
2. Press the *Menu* key on the navigation switch panel.
3. Use the arrow key and select *Setup/Info*.
4. Use the arrow key and select *System Info*.
  - An updated unit will have *Software Version 2.50*

- If the *Software Version* is less than 2.50, proceed with the UPDATE PROCEDURE.
