Program Bulletin

CUSTOMER SATISFACTION PROGRAM

SUBJECT: Enhancements for Side Impact Pole Performance

MODELS: 2011-2012 Chevrolet Volt

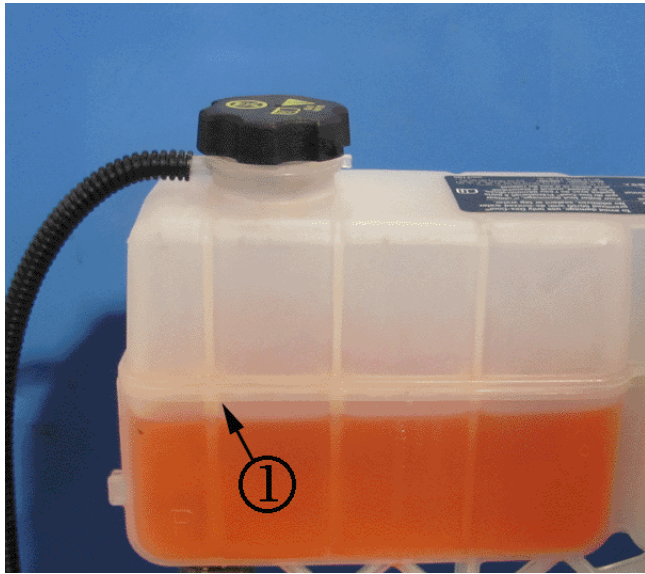
2770857

Perform a visual inspection of the drive motor battery cooling system reservoir fluid level **BEFORE** completing the service repairs in this bulletin.

- If the coolant level of the drive motor cooling system reservoir is **below the seam of the reservoir (1)**, perform leak inspection diagnostics **BEFORE** proceeding to the service repair in this bulletin. Refer to SI for the appropriate leak inspection diagnostic information. Submit a warranty claim for leak inspection diagnostics and service repairs. After completing the inspection and repairs, proceed to the service repairs in this bulletin.
- If the drive motor cooling system reservoir is **NOT below the seam of the reservoir (1)**, proceed to the service repairs in this bulletin.
