Program Bulletin

CUSTOMER SATISFACTION PROGRAM

SUBJECT: Enhancements for Side Impact Pole Performance

MODELS: 2011-2012 Chevrolet Volt

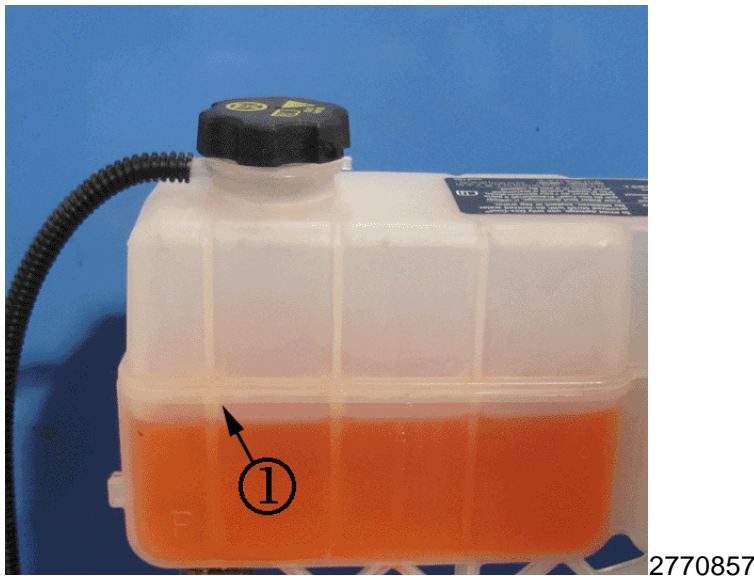
- If the coolant level of the drive motor cooling system reservoir is **below the seam of the reservoir (1)**, perform leak inspection diagnostics **BEFORE** proceeding to the service repair in this bulletin. Refer to SI for the appropriate leak inspection diagnostic information. Submit a warranty claim for leak inspection diagnostics and service repairs. After completing the inspection and repairs, proceed to the service repairs in this bulletin.
- If the drive motor cooling system reservoir is **NOT below the seam of the reservoir (1)**, proceed to the service repairs in this bulletin.
