Program Bulletin

CUSTOMER SATISFACTION PROGRAM

SUBJECT: Enhancements for Side Impact Pole Performance

MODELS: 2011-2012 Chevrolet Volt

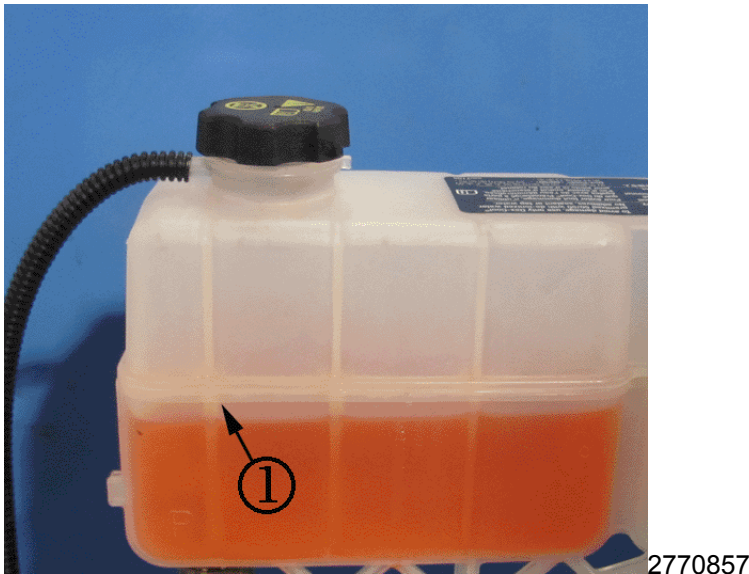
Perform a visual inspection of the drive motor battery cooling system reservoir fluid level **BEFORE** completing the service repairs in this bulletin.

- If the coolant level of the drive motor cooling system reservoir is **below the seam of the reservoir (1)**, perform leak inspection diagnostics **BEFORE** proceeding to the service repair in this bulletin. Refer to SI for the appropriate leak inspection diagnostic information. Submit a warranty claim for leak inspection diagnostics and service repairs. After completing the inspection and repairs, proceed to the service repairs in this bulletin.
- If the drive motor cooling system reservoir is **NOT below the seam of the reservoir (1)**, proceed to the service repairs in this bulletin.
