Service Action: Left-Hand Rear Lamp LED Failure

XF (X250)

**VIN: R00001 - R61290
Model Year: 2009 - 2010**

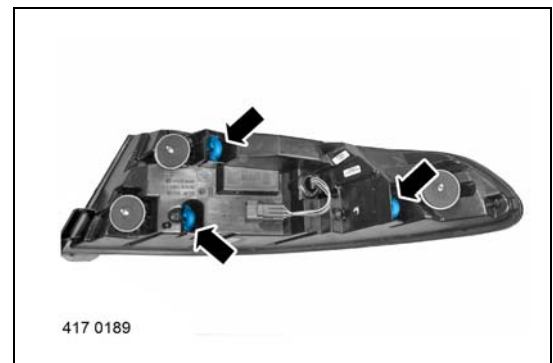
Situation: On a limited number of 2009 – 2010 model year Jaguar XF vehicles within the VIN range above, the light emitting diode (LED) within the left-hand (LH) rear lamp assembly may fail due to corrosion of the silver lead frame.

1. Turn the exterior lights 'ON'.
 - If the left-hand (LH) lamp assembly LEDs are functioning correctly, perform steps 2-4 below only.
 - If the LH rear lamp assembly LEDs are not functioning correctly, perform step 5 below only.
2. Refer to Workshop Manual, section 417-01: *Exterior Lighting*, and remove the LH rear lamp assembly.
3. Replace the vent tubes:
 - Release and remove the three (3) vent tubes from the lamp assembly.
 - Install three (3) new vent tubes to the lamp assembly.
4. Refer to Workshop Manual, section 417-01: *Exterior Lighting*, and install the LH rear lamp assembly.
