SECTION: 417

Service Action: Left-Hand and Right-Hand Rear Lamps LED Failure

XF (X250)

VIN: R00001 - R61290
Model Year: 2009 - 2010

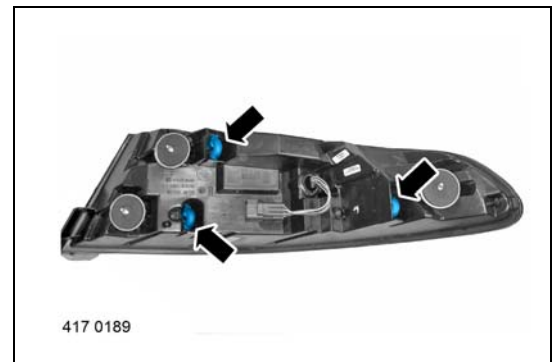
Situation: On a limited number of 2009 – 2010 model year Jaguar XF vehicles within the VIN range above, the light emitting diode (LED) within the left-hand (LH) and right-hand (RH) rear lamp assemblies may fail due to corrosion of the silver lead frame.

1. Turn the exterior lights 'ON'.
 - If the left-hand (LH) lamp assembly LEDs are functioning correctly, perform steps 2-4 and 6 below only.
 - If the LH rear lamp assembly LEDs are not functioning correctly, perform steps 5-6 below only.
2. Refer to Workshop Manual, section 417-01: *Exterior Lighting*, and remove the LH rear lamp assembly.
3. Replace the vent tubes:
 - Release and remove the three (3) vent tubes from the lamp assembly.
 - Install three (3) new vent tubes to the lamp assembly.
