Technical Service Bulletin

01 MIL on (P1297, P2187, P2279), oil leaks

01 12 44 2015505/10 March 16, 2012. Supersedes Technical Service Bulletin Group 01 number 11 – 37 dated November 23, 2011 for reasons listed below.

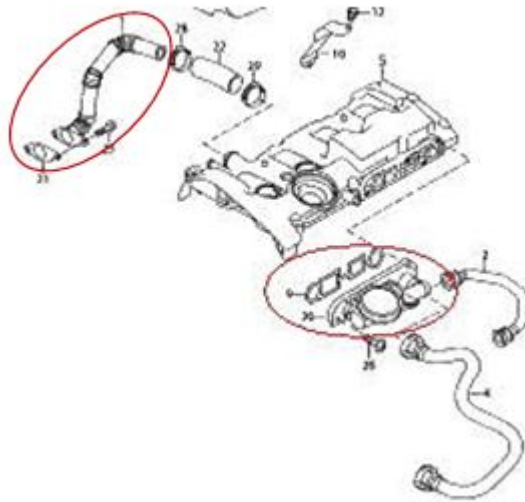
The conditions described may be caused by a malfunction of the crankcase ventilation pressure regulating valve or turbo intake pipe (Figure 1), resulting in excessive vacuum or excessive pressure being applied to the engine crankcase.

Figure 1. The crankcase ventilation pressure regulating valve and turbo intake pipe is circled here.

Improved crankcase pressure regulating valve and turbo intake pipe.

Install improved pressure regulating valve and/or turbo pipe according to table below.

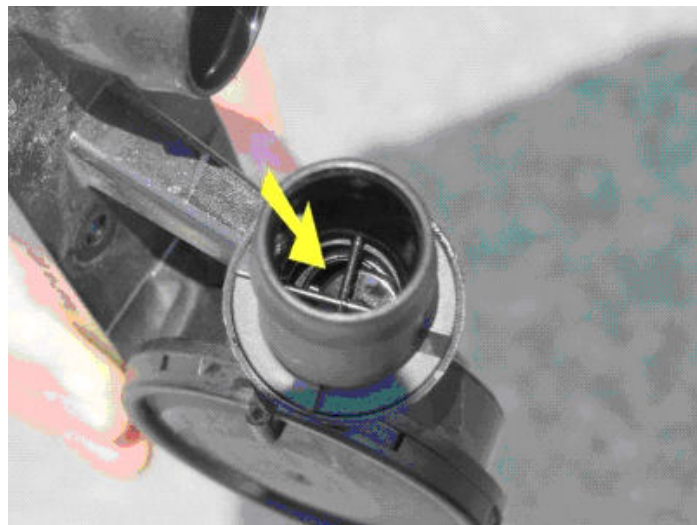
The guide pin of the check valve in the intake manifold side of the valve (Figure 2) may break, preventing the check valve from correctly sealing when boost pressure is present in the intake manifold. Intake boost pressure may thus be applied to the engine crankcase, resulting in possible oil leaks.

Figure 2. The guide pin of the check valve in the intake manifold side of the valve. (Depending on part number, the check valve may be installed horizontally inside the housing.)
