Service Bulletin

PRELIMINARY INFORMATION

Subject: Diagnosis and Repair HVAC Blower Function

Models: 2008-2013 Cadillac Escalade Models
2007-2013 Chevrolet Silverado
2008-2013 Chevrolet Suburban, Tahoe
2007-2013 GMC Sierra
2008-2013 GMC Yukon Models
All Built Prior to November 1, 2012

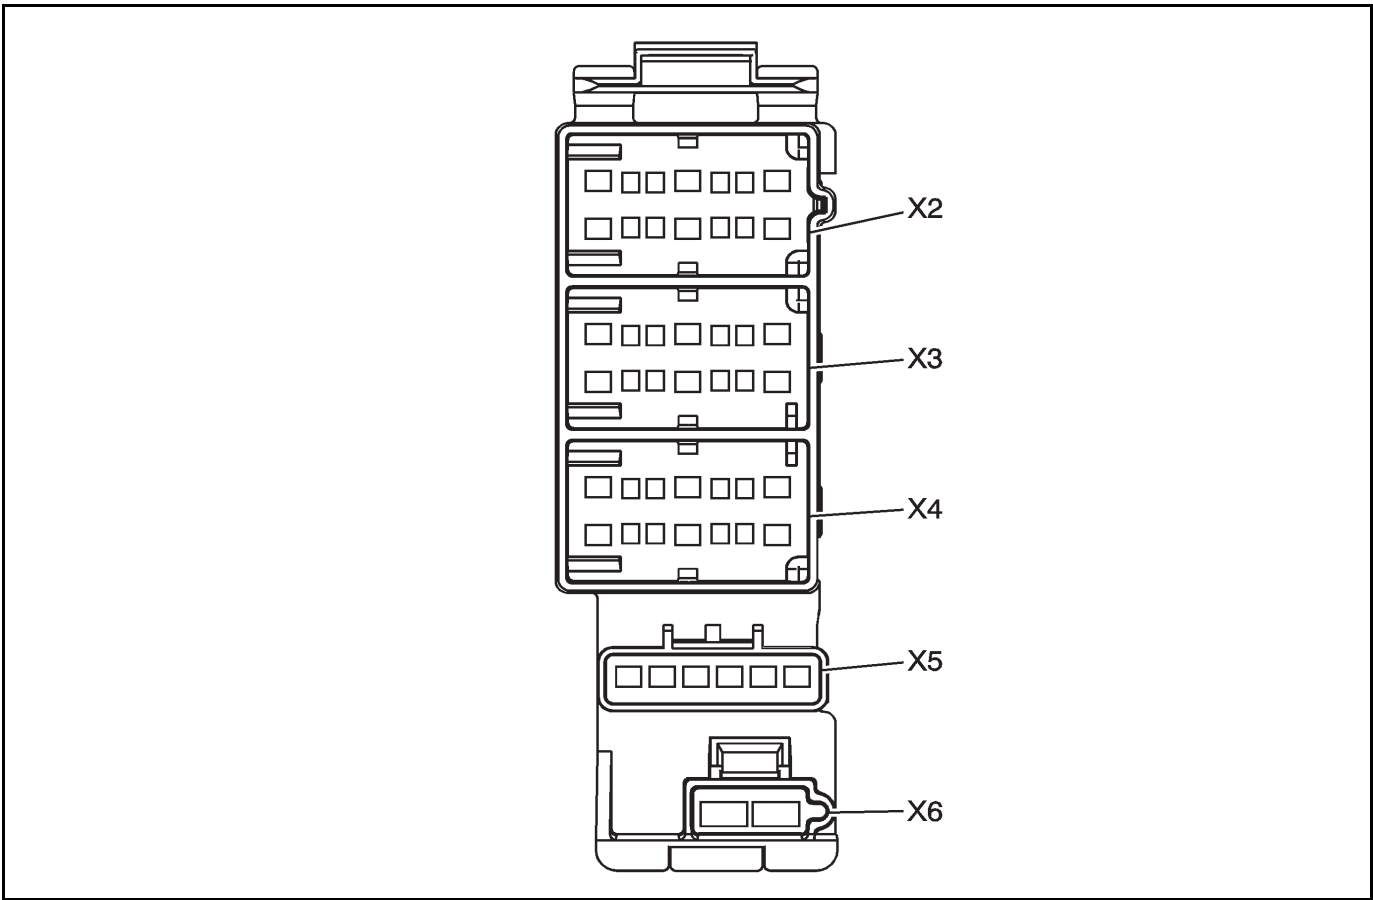
1991088

One possible cause of this condition may be the contacts in the HVAC junction block(s) located at the right side of the instrument panel.

2. Identify Junction Block X4 and X6.
3. With the ignition key in the on position, turn on the HVAC blower and apply light hand pressure to the connectors. Determine if this movement affects the blower operation (intermittent operation).
4. Determine which junction block is affecting the blower operation.
