**SB-10043900-3421**

Reference SSM56077

Models X250 / XF

Title Front Pilot Lamp (Side Light) replacement

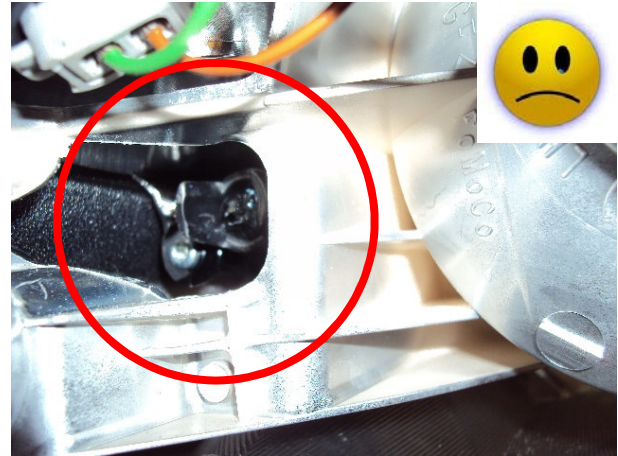
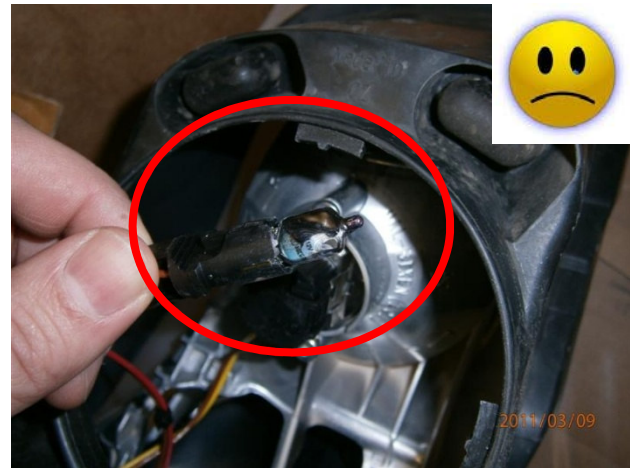
Front headlamp reflector and or bulb holder "Melted".

Miss fitting of the bulb holder after bulb replacement.

Content When replacing the pilot lamp (side lamp) bulb special care must be taken to make sure that the bulb holder is inserted into the reflector housing correctly. The bulb holder should be inserted / push into place securely until a firm click can be felt & heard. If the bulb holder is not fully inserted it becomes loose, the bulb then comes into contact with the reflector housing melting both the bulb holder and reflector. This results in the need for a replacement lamp. Please see attachment for illustrations of a correctly fitted bulb holder and a melted lamp and bulb holder as a consequence of misfitting the bulb holder.
