Service Bulletin

Bulletin No.: 07-08-50-022B

Subject: Seat Rattle and/or Hard to Latch and Unlatch, Power Release Fold and Tumble Not Fully Functioning (Perform Repair as Outlined)

Models: 2007-2012 Cadillac Escalade, Escalade ESV
2007-2012 Chevrolet Suburban, Tahoe
2007-2012 GMC Yukon, Yukon XL, Yukon Denali, Yukon Denali XL

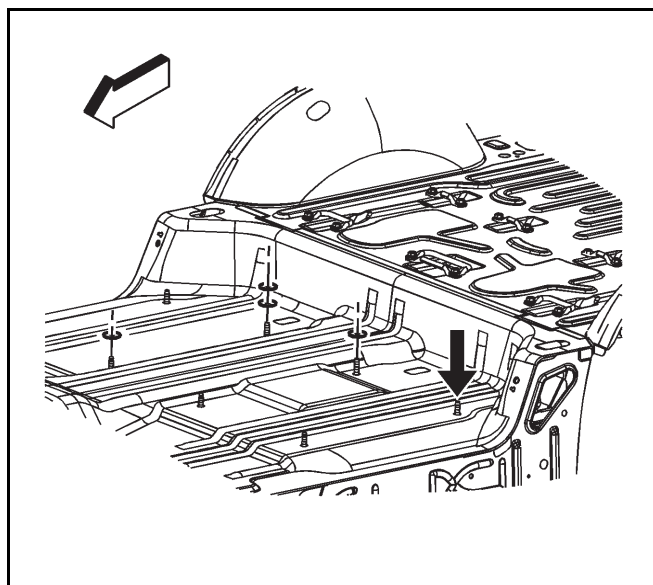
2040919

The condition may be caused by the floor being slightly lower in one corner of the second row seat mounting area, possibly affecting the alignment of the seat latches and the seat base plate.

1. Place the affected seat into the tumbled, or raised, position.
2. Verify that the seat latches on the bottom of the seat are fully opened.
3. Slowly lower the seat to rest the latches on the strikers; **Do Not** allow the seat to latch. Observe the seat latches to mating strikers for even contact or gap.

4. If there is even contact and no gap between the latches and strikers, observe the carpet for signs of not being fully seated, or being improperly installed. Mispositioned carpet may possibly hinder full motion of the latches down onto the strikers.
5. Correct any conditions that may be caused by the carpet, then retest seat latch function.
6. If a gap is present between one of the latches and the mating striker, measure the vertical gap.

Inspect the second row seat for proper operation/latching, and adjust carpet fit and/or adjust leveling of the seat spacer plate to correct striker to latch fit, as necessary.
