# Program Bulletin

## CUSTOMER SATISFACTION PROGRAM

**SUBJECT:** Driver Airbag Inspection

**MODELS:** 2012 Buick Verano  
2012 Chevrolet Camaro, Sonic, Volt

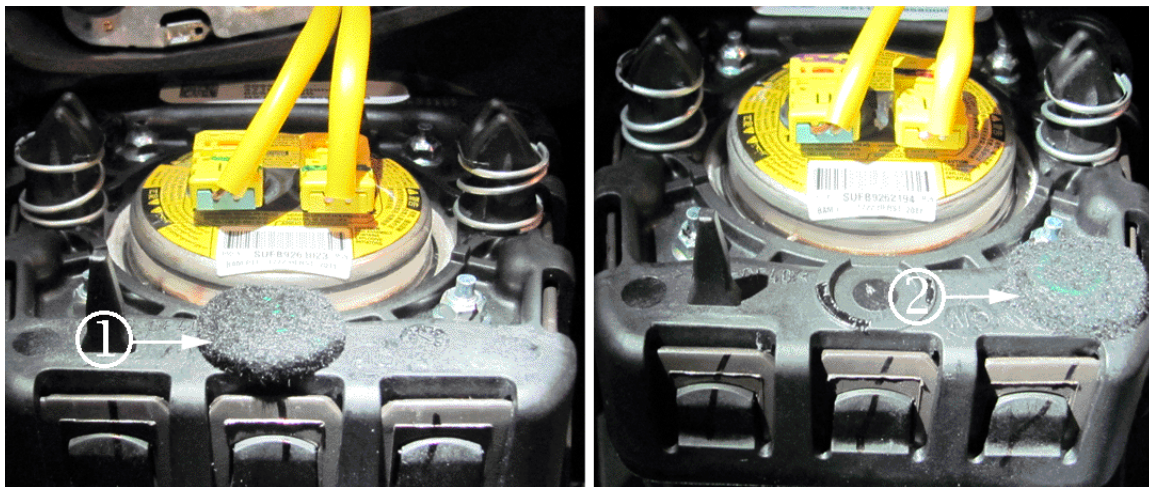
**Certain** 2012 model year Buick Verano; Chevrolet Camaro, Sonic, and Volt vehicles may have a condition in which the driver airbag module retainers may not be fully engaged in the steering wheel due to an interference condition with a felt insulator patch. This condition does not affect the function or operation of the airbag. The airbag will deploy as designed.

1. Disable the supplemental inflatable restraint (SIR) system. Refer to *SIR Disabling and Enabling* in SI.
2. Turn steering wheel 180 degrees to access the module release points on top of the column.
3. Insert suitable tools to the openings on both sides of the steering wheel.
4. Release the springs in direction of the arrows.

5. Remove the felt patch from the 6 o'clock position (1) and re-install it in the 5 o'clock position (2) as shown in illustration. The felt patch edge should be in line with the edge of the airbag module. The felt patch should not hang over the airbag module edge.
6. Align the steering wheel module fasteners to the steering column fastener holes.
