17 12 01 March 09, 2012 2028830
UPDATE – 17D2 Positive Crankcase Ventilation Valve

Required DMS Wording/Programming Text (SAGA claim comments): UPDATE 17D2 Positive Crankcase Ventilation

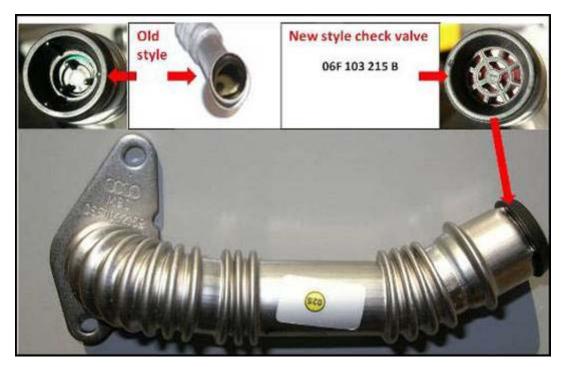
Figure 1: Pressure Control Valve (1). Gasket (2), Pipe gasket (3),

The guide pin of the check valve in the intake manifold side of the valve may break, preventing the check valve from correctly sealing when boost pressure is present in the intake manifold. Intake boost pressure may thus be applied to the engine crankcase, resulting in possible oil leaks.

Remove Pressure Control Valve (Figure 1, 1) and check part number.

If the part number of the pressure control valve is **06F 129 101 P** no further steps are required.

If the part number of the Pressure Control Valve is any other suffix prior to "P", replace Pressure Control Valve

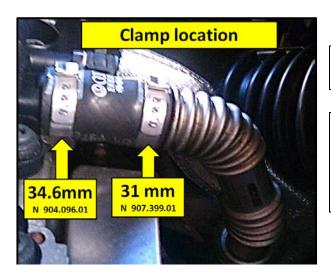
Tip: Picture <left> shows correct location of clamps.

Install improved pressure regulating valve and turbo pipe.

Tip: To install 31mm clamp, first insert clamp onto turbo pipe, then insert turbo pipe into rubber hose, then slide clamp over rubber hose.
