SB-10043911-6194

SI B34 01 12
Brakes

Service Action: Replace Integrated Chassis Control Module (ICM)

6 Series (F13)

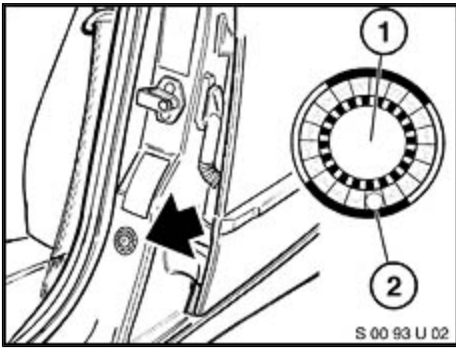
LABEL INSTRUCTIONS

This Service Action has been assigned code number **607**. After the vehicle has been checked and/or corrected, obtain a label (SD92-403) and:

- A. Emboss your BMW center warranty number in the middle of the label (1);
- B. Punch out code number **607** (2), printed on the label; and
- C. Affix the label to the **B**-pillar as shown.

If the vehicle already has a label from a previous Service Action/Recall Campaign, affix the new label next to the old one. Do not affix one label on top of another one because a number from an underlying label could appear in the punched-out hole of the new label.
