SI B34 01 12
Brakes

March 2012
Technical Service

Service Action: Replace Integrated Chassis Control Module (ICM)

6 Series (F13)

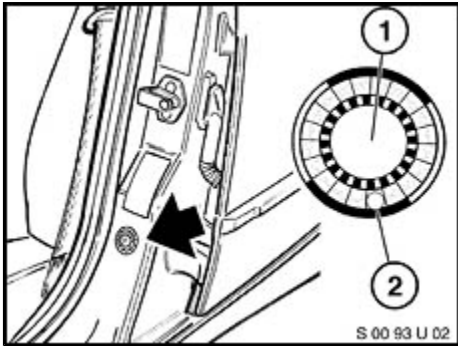
LABEL INSTRUCTIONS

This Service Action has been assigned code number **607**. After the vehicle has been checked and/or corrected, obtain a label (SD92-403) and:

- A. Emboss your BMW center warranty number in the middle of the label (1);
- B. Punch out code number **607** (2), printed on the label; and
- C. Affix the label to the **B**-pillar as shown.

If the vehicle already has a label from a previous Service Action/Recall Campaign, affix the new label next to the old one. Do not affix one label on top of another one because a number from an underlying label could appear in the punched-out hole of the new label.
