Service Bulletin

Bulletin No.: PIC5574A

Subject: Intermittent No Crank No Start Multiple Communication Codes

Models: 2012 Chevrolet Sonic

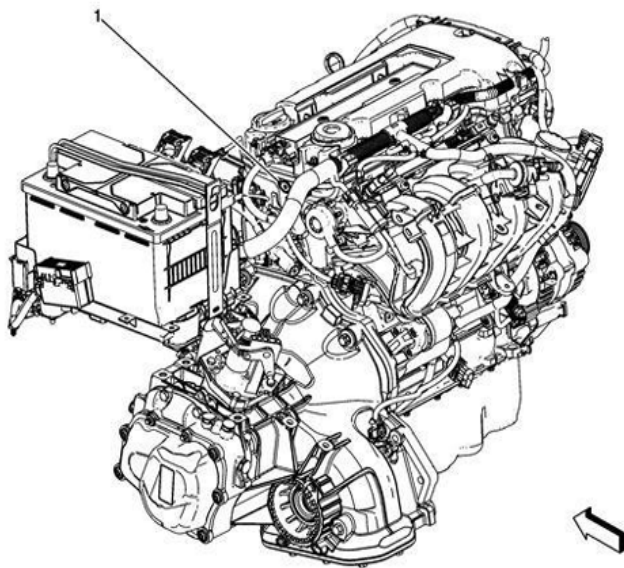
2784117

1. Inspect for loose ground connection at G104 and improperly crimped wires.

Note: G104 Location is wrong in SI for US Sonic but is correct in SI Global Sonic. A correction is being made at this time.

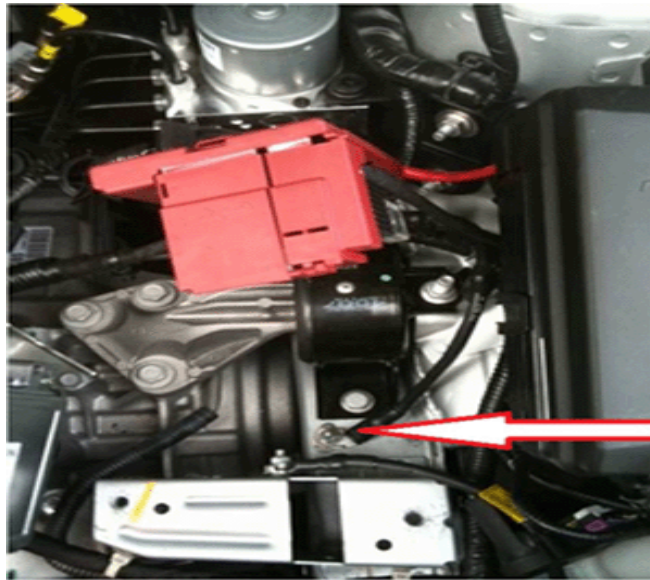
2734623

2. G105 under the battery tray for weld slag or paint on the grounding surface of the stud or nut. Remove the battery tray to inspect the grounds. G105 is directly under the battery tray, left of the UBEC on the frame rail.
