Technical Service Bulletin

69 Airbag warning light on, upper limit for front or rear side airbag exceeded

69 12 24 2011667/7 March 12, 2012. Supersedes Technical Service Bulletin Group 69 number 10 – 08 dated August 10, 2010 for reasons listed below.

Model(s)	Year	VIN Range	Vehicle-Specific Equipment
A8	2003 – 2007	All	All

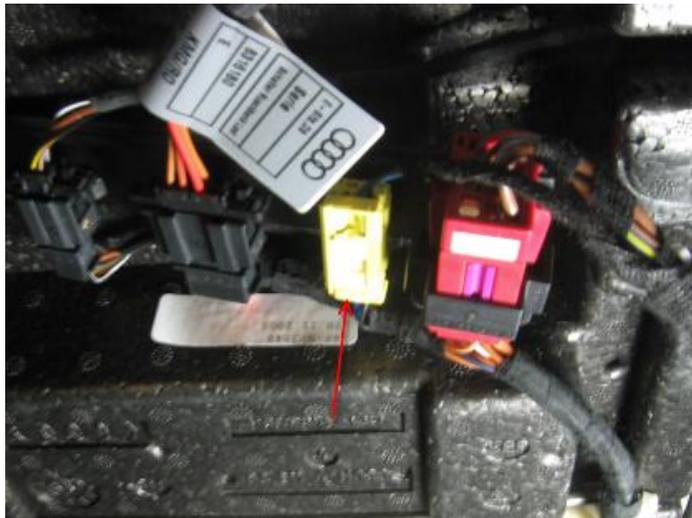
May be caused by resistance in the connector between the airbag and seat harness sporadically becoming too high.

Figure 1. The yellow airbag connector located below the rear seats.

4. Remove approximately 50 mm of protective tape on both ends of the wiring harness. Cut off the wires leading to the yellow connector on both the vehicle wiring harness and the airbag wiring harness in the seat.
5. Install repair cable (**000 979 015 D**) in the new yellow connector housing (**4E0 972 576**). Cut the wire to a length of approximately 50 mm.
6. Install repair cable (**000 979 010 D**) in the new yellow connector housing (**4E0 972 586**). Cut the wire to a length of approximately 50 mm.
7. Connect the new wires to the existing wiring harness using a yellow butt connector (**000 979 940**). Crimp the yellow connector - (Part number **000 979 940**) with VAS pliers **1978/1A** from the repair kit VAS **1978/A**, and heat-shrink the butt connectors using the hot air blower. Begin heating from the center of the butt connector outward.

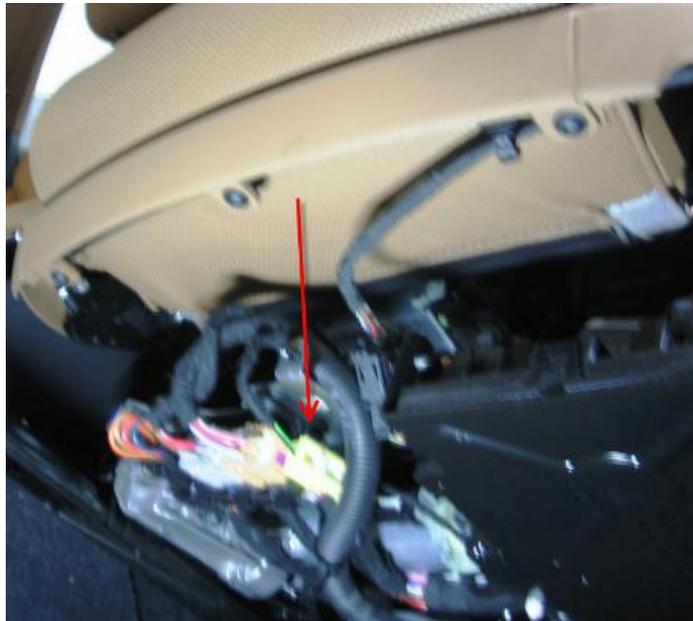
Figure 2. The yellow airbag connector located beneath the front seats.

1. Read the fault memory in the airbag control module (address-word 15). If a DTC entry "igniter for side airbag upper limit exceeded" is present, proceed as follows:
2. Partially remove seat. (Loosen seat mounting bolts and tilt seat backwards.)
3. Replace both airbag connectors (male and female sides) for the front seat side airbags with the part numbers listed above and according to the repair instructions described above. (Figure 2)

1. Read the fault memory in the airbag control module (address-word 15). If a DTC entry "igniter for side airbag upper limit exceeded" is present, proceed as follows:
2. Remove the seat right front seatback cover, and inspect the wiring to N200 for damage due to burrs, a tie wrap cinched too tight, or tension on the harness.
3. If any damage is found in step 2, repair the wire harness, and proceed to step 4.
4. Partially remove seat. (Loosen seat mounting bolts and tilt seat backwards.)
5. Replace both airbag connectors (male and female sides) for the front seat side airbags with the part numbers listed above and according to the repair instructions described above (Figure 2).
