SB-10043927-2032

SI M65 08 03
Audio, Navigation, Monitors, Alarms, SRS

Airbag Warning Light Is ON: MRS FC 02, 03, 05, 06

NEW R50 (Cooper)

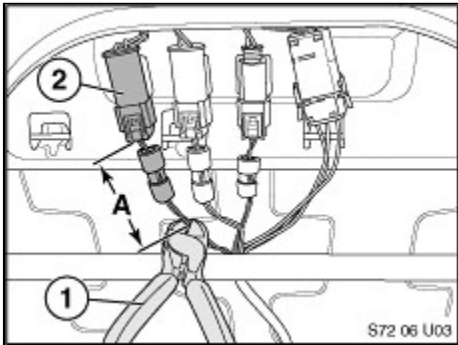
5. Locate the yellow side airbag connector (DO NOT DISCONNECT).

Cut the wire as shown, **100mm from the connector (A)**.

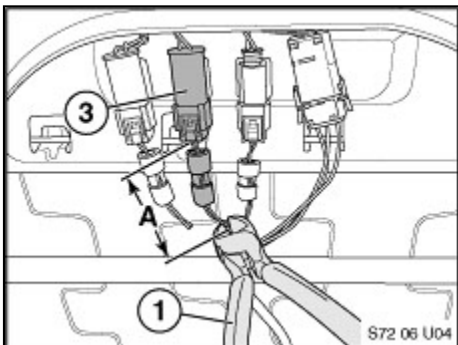
6. Locate the blue seat tensioner (DO NOT DISCONNECT).

Cut the wire as shown, **100mm from the connector (A)**.

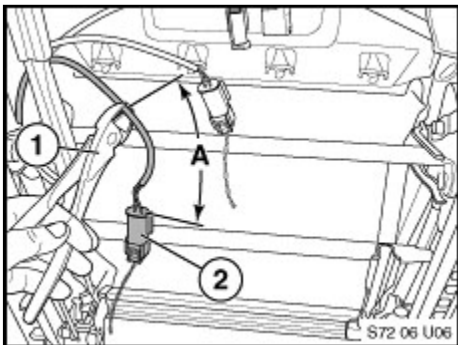
11. Locate the yellow side airbag connector (2). Cut the wire as shown, **100mm from the connector (A)**.

Tag the removed part with the VIN. Do not scrap the removed part; it may be necessary to ship the part to BMW for analysis (DO NOT DISCONNECT THE CONNECTOR).

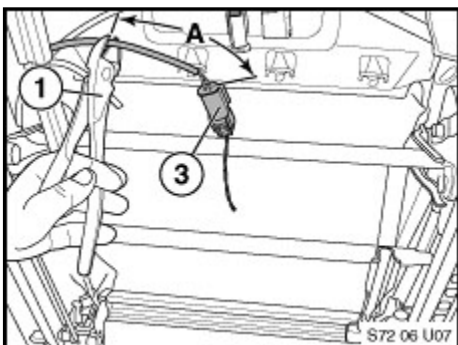
12. Locate the blue seat tensioner connector (3). Cut the wire as shown, **100mm from the connector (A)**.

Tag the removed part with the VIN. Do not scrap the removed part; it may be necessary to ship the part to BMW for analysis (DO NOT DISCONNECT THE CONNECTOR).
