Service Bulletin

Bulletin No.: PIC5651

Subject: Intermittent Service Power Steering Message With DTC U0131

Models: 2011 - 2012 Buick Lacrosse
2012 Buick Regal
2013 Chevrolet Malibu
With NJ1

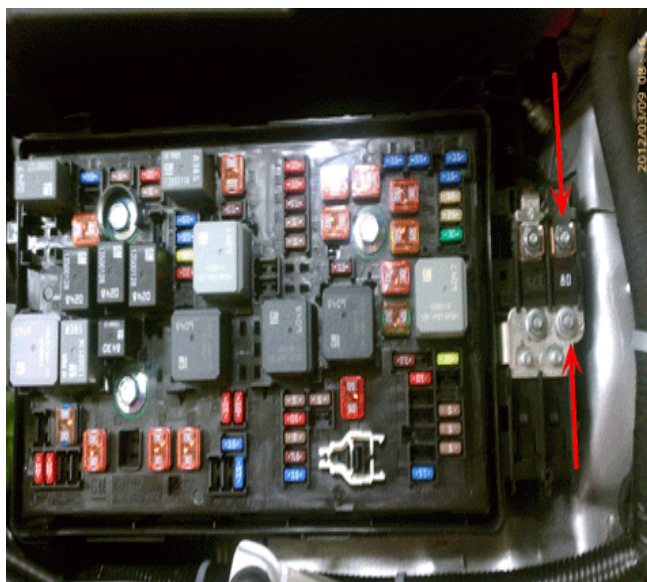
2790193

Cause: Loose B+ feed at the X50A Underhood Fuse Block or the 80A fuse retaining bolts in the UHFB. Battery feed is X6 on LaCrosse and Malibu and X8 on Regal, loose G111. Please refer to SI for your vehicle.

(2013 Chevrolet Malibu shown)

Correction: Secure B+ feed or fuse nuts as needed. Check G111.
