EL12-016

April 27, 2012

## IGNITION SWITCH (PUSH BUTTON) WILL NOT RESPOND

**APPLIED VEHICLES:** 2010 – 2012 G37 Coupe (CV36)

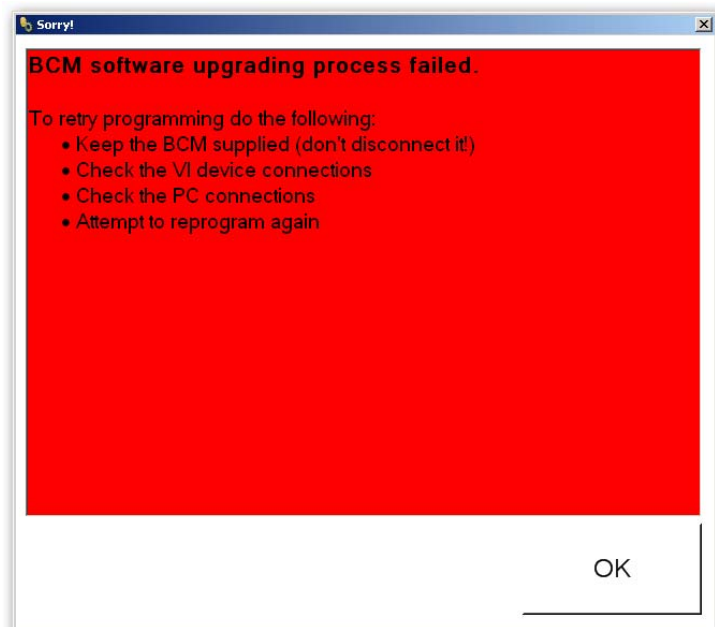
Error – BCM reprogramming failed (reprogramming did not complete correctly)

- The reprogramming process will stop and the message in Figure 4 will display.

1<sup>st</sup> time you get this error message:

- a. Check all connections: USB cable, power supply, VI connection, etc.
- b. Select OK, to return to the main screen.
- c. Restart the reprogramming process.

If you get this error a 2<sup>nd</sup> time:

- a. Select OK, to return to the main screen.
- b. Exit BCM reprogramming.

- c. Record the radio station presets.
- d. If equipped with Automatic Temperature Control, record the customer settings. Refer to the appropriate Service Manual for customer setting information.
- e. Disconnect the negative battery cable, wait 3 minutes and then reconnect.
- f. Go to page 5 and restart from the beginning of the BCM reprogramming process.
