RECALL CAMPAIGN BULLETIN

NTB12-040c

VOLUNTARY EMISSIONS RECALL CAMPAIGN 2010 ALTIMA SEDAN AND COUPE ECM REPROGRAM AND MANIFOLD CATALYST

CAMPAIGN ID #: PC129

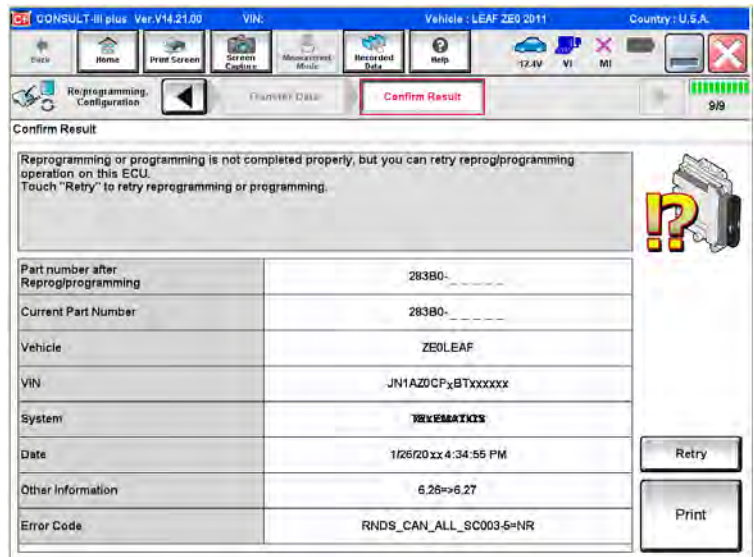
Figure 5

If reprogramming does not complete and the “!?” symbol displays as shown in Figure 5:

- Check battery voltage (12.0 – 15.5V).
- Ignition is ON, Ready Mode is OFF.
- External Bluetooth® devices are OFF.
- All electrical loads are OFF.
- **Select Retry and follow the on screen instructions.**

NOTE: Retry may not go through on first attempt and can be selected more than once.

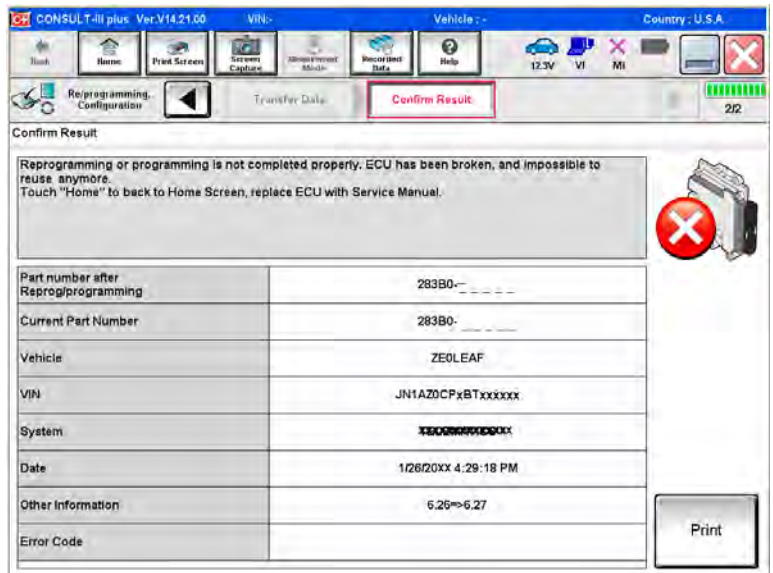
Figure 6

If reprogramming does not complete and the “X” symbol displays as shown in Figure 6:

- Check battery voltage (12.0 – 15.5V).
- CONSULT A/C adapter is plugged in.
- Ignition is ON, Ready Mode is OFF.
- Transmission in Park.
- All C-III plus / plus VI cables are securely connected.
- All C-III plus updates are installed.
- **Select Home, and then restart the reprogram procedure from the beginning.**
