RECALL CAMPAIGN BULLETIN

NTB12-040b

VOLUNTARY EMISSIONS RECALL CAMPAIGN 2010 ALTIMA SEDAN AND COUPE ECM REPROGRAM AND MANIFOLD CATALYST

CAMPAIGN ID #: PC129

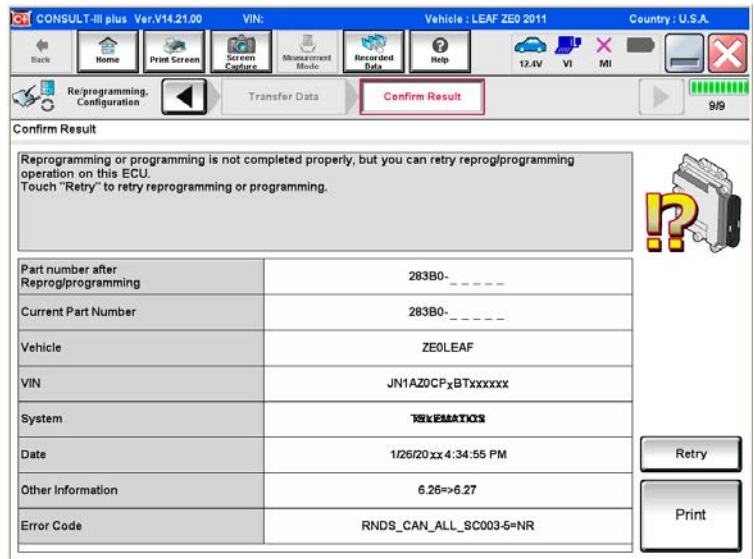
Figure 5

If reprogramming does not complete and the “!?” symbol displays as shown in Figure 5:

- Check battery voltage (12.0 – 15.5V).
- Ignition is ON, Ready Mode is OFF.
- External Bluetooth® devices are OFF.
- All electrical loads are OFF.
- **Select Retry and follow the on screen instructions.**

NOTE: Retry may not go through on first attempt and can be selected more than once.

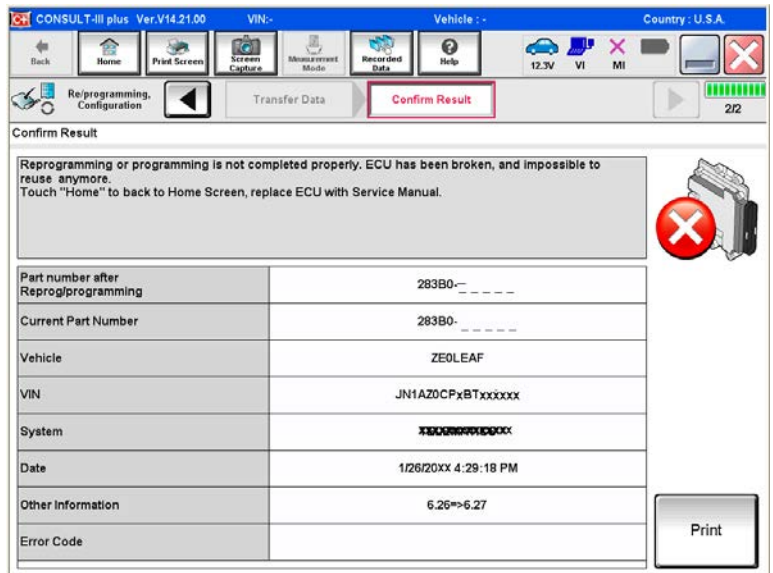
Figure 6

If reprogramming does not complete and the “X” symbol displays as shown in Figure 6:

- Check battery voltage (12.0 – 15.5V).
- CONSULT A/C adapter is plugged in.
- Ignition is ON, Ready Mode is OFF.
- Transmission in Park.
- All C-III plus / plus VI cables are securely connected.
- All C-III plus updates are installed.
- **Select Home, and then restart the reprogram procedure from the beginning.**
