RECALL CAMPAIGN BULLETIN

NTB12-040a

VOLUNTARY EMISSIONS RECALL CAMPAIGN 2010 ALTIMA SEDAN AND COUPE ECM REPROGRAM AND MANIFOLD CATALYST

CAMPAIGN ID #: PC129

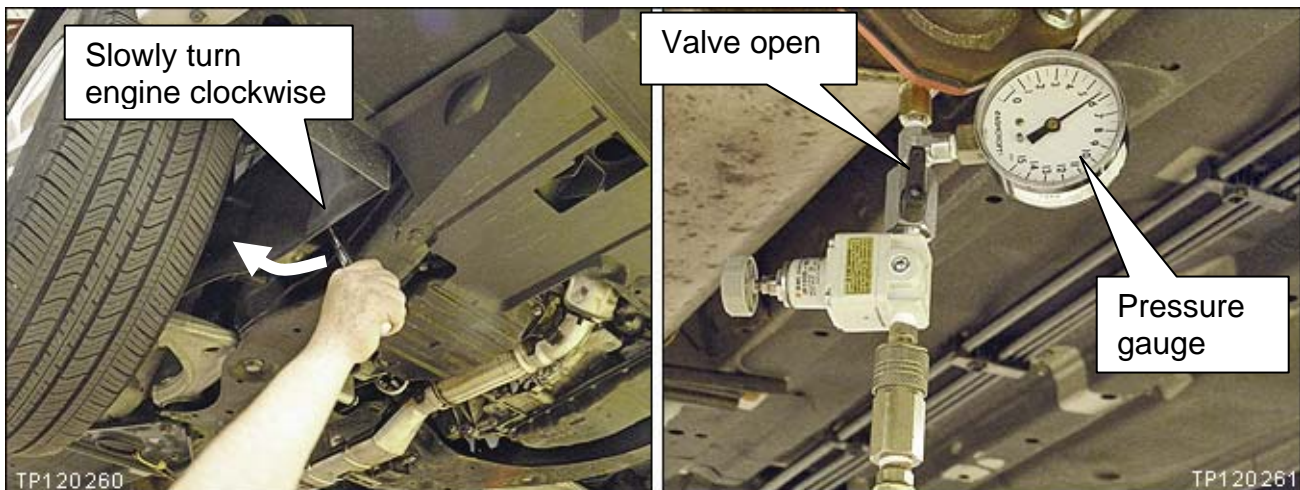
Figure P9a

a. Watch the pressure gauge while slowly turning the engine (see Figures P9a and P9b).

b. When the pressure gauge is reading at the highest point (most PSI) stop turning the engine.

- a. Turn the valve to the closed position.
- b. The pressure will start to drop.
- c. When pressure drops to 5 PSI, begin a 20 second count.
- d. At the end of the 20 second count, read the pressure.

OK: Pressure is 2 psi or above:

NG: Pressure is below 2 psi:

- Front tube or manifold has a leak.
- By feel and sound, locate the leak.
- Replace the leaking part (front exhaust tube and/or exhaust manifold).

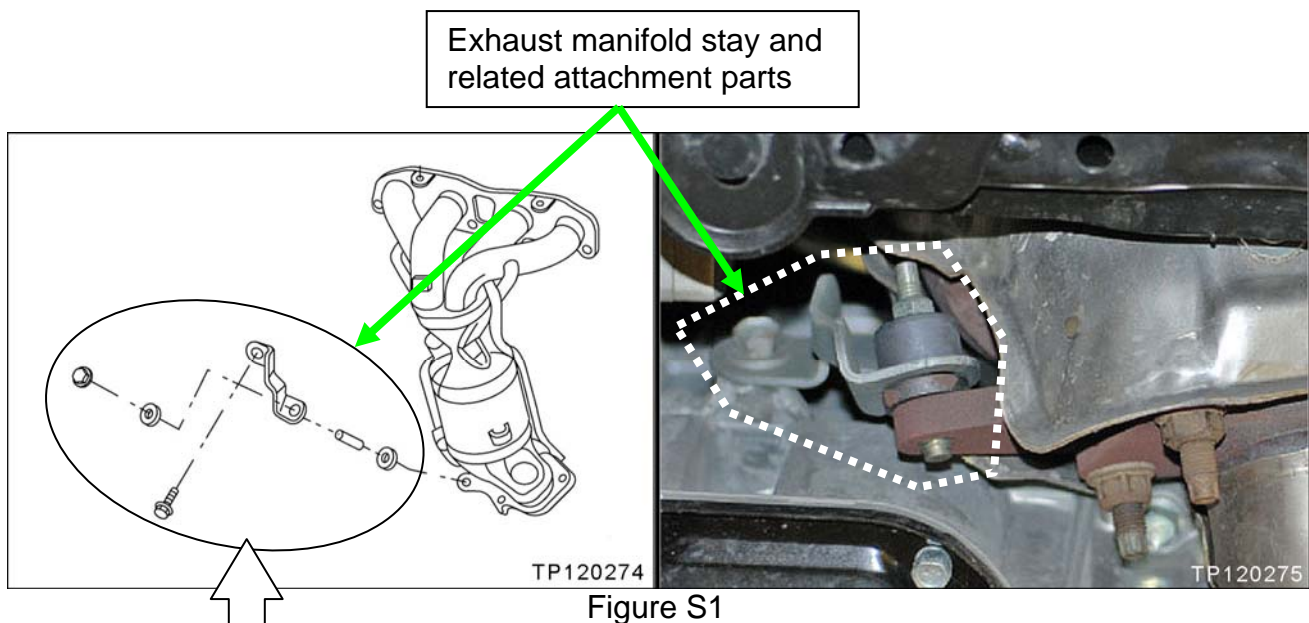
Figure S1

Remove these parts

Do not reinstall

1. Remove the exhaust manifold stay and the related attachment parts (see Figures S1 and S2).
 - These parts will not be reused; do not reinstall.
