# **RECALL CAMPAIGN BULLETIN**

NTB12-040

## **VOLUNTARY EMISSIONS RECALL CAMPAIGN 2010 ALTIMA SEDAN AND COUPE ECM REPROGRAM AND MANIFOLD CATALYST**

**CAMPAIGN ID #:** PC129

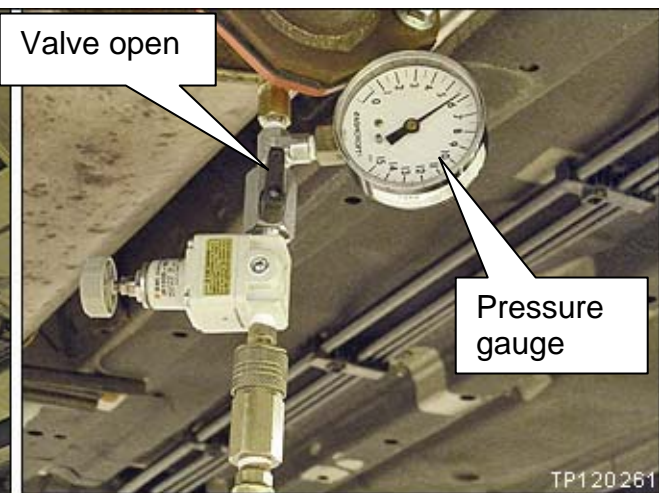
Figure P9b

16. Check for leaks as follows:

- a. Turn the valve to the closed position.
- b. Pressure will start to drop.
- c. When pressure drops to 5 PSI, begin a 20 second count.
- d. At the end of the 20 second count, read the pressure.

**OK: Pressure is above 2 psi.**

**NG: Pressure is below 2 psi.**

- Front tube or manifold has a leak.
- By feel and sound, locate the leak.
- Replace the leaking part (front exhaust tube and/or exhaust manifold).

- Vehicle has **more than** 50,000 miles, go to Exhaust Manifold Replacement on page 13.
- Vehicle has **less than** 50,000 miles:
  - Remove the exhaust manifold stay – see page 10.
  - Reinstall the front exhaust tube.

- For all vehicles with **more than** 50,000 miles, replace the exhaust manifold even if it does not have a leak.
- Replacement of the exhaust manifold includes removal of the exhaust manifold stay.
- Refer to page 11 for Front Exhaust Tube Replacement and/or page 13 for Exhaust Manifold Replacement.

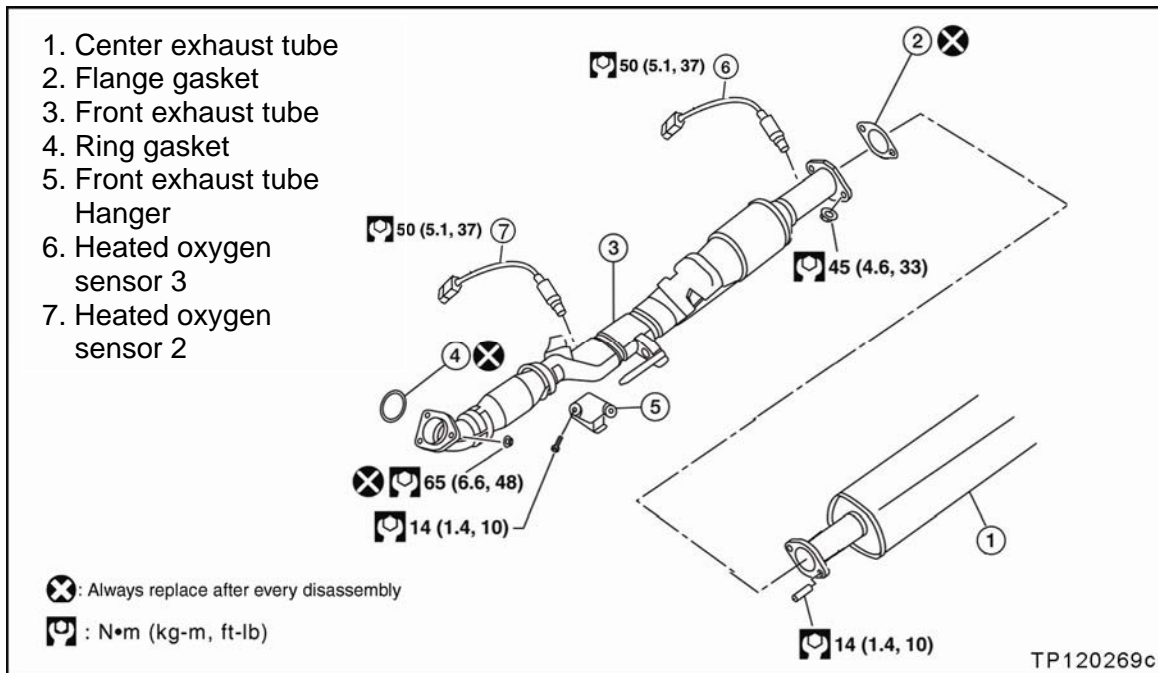
**NOTE:** Replace the front exhaust tube only if a leak is found in the tube during the leak check on page 9.

4. Remove the front exhaust tube as follows (refer to Figure T3):

- a. Disconnect both heated oxygen sensors.
  - b. Unbolt the front exhaust tube hanger.
    - Hanger is held on with 2 bolts.
  - c. Unbolt the front exhaust tube from the center exhaust tube.

- Tube flange is held together with 2 studs and 2 nuts.
  - d. Unbolt the front exhaust tube from the exhaust manifold.
    - Tube to manifold held together with 3 studs and 3 nuts.

- e. Remove the front tube from the vehicle.
5. Swap the heated oxygen sensors (2 and 3) from the old tube to the new tube.
- If the sensors are seized in the exhaust tube, refer to NTB10-099 for sensor removal.

- Refer to Figure T3 for torque specifications.
6. Install front exhaust tube in reverse order.
- Use a new ring gasket.
  - Use a new flange gasket.
  - Use new nuts for tube to manifold connection.

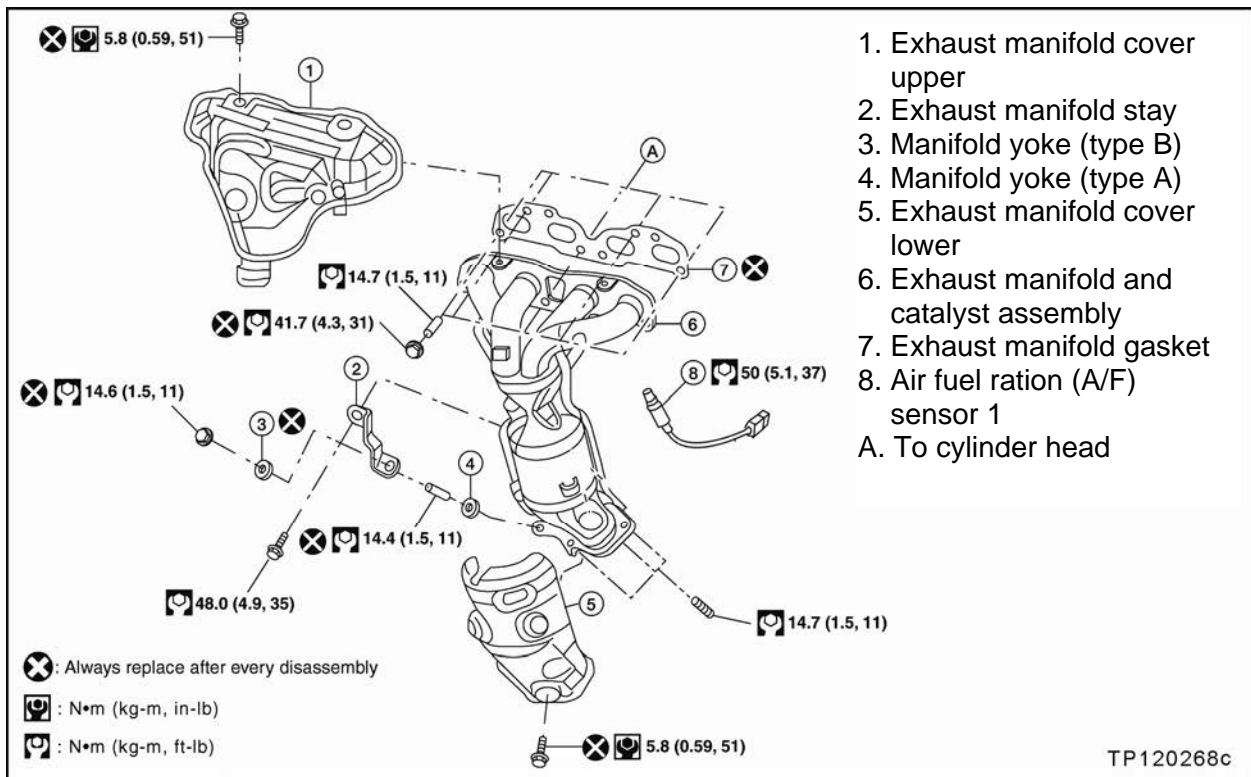
Figure M8

- For all vehicles with **more than** 50,000 miles, replace the exhaust manifold (replacement of the exhaust manifold includes removal of the exhaust manifold stay).
- For vehicle with **less than** 50,000 miles, only replace the exhaust manifold if a leak in the exhaust manifold is found during the leak check on page 9.

12. Remove the exhaust manifold as follows (refer to Figure M8).

a. Disconnect the Air Fuel (A/F) sensor harness and remove the A/F sensor from the exhaust manifold.

d. Remove the exhaust manifold stay **and discard**.

- Manifold stay is held on with a bolt to the engine and nut to the manifold.
- The stay will not be reinstalled – **discard the exhaust manifold stay**.

e. Remove the exhaust manifold nuts in the order shown.
