SB-10044024-6359

SI B61 17 12
General Electrical Systems

SUBJECT**Wipers, Lights and Front Power Windows Are Inoperative****MODEL**

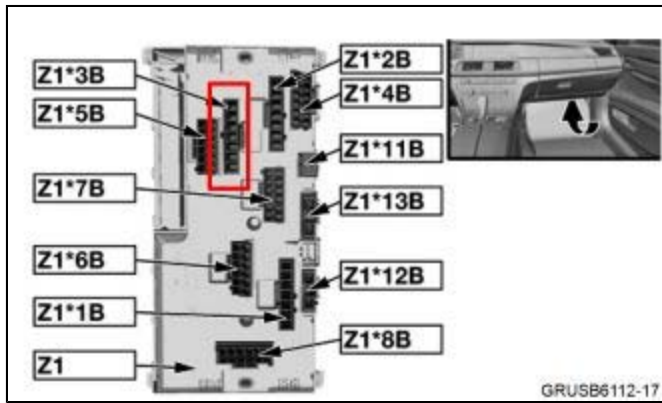
Connector Z1*3B at the (Z1) front power distribution box in the passenger compartment is loose (the 7-pin connector is not fully seated into the power distribution box).

incorrect based on the test plan nominal values, check the back of the front power distribution box 7-pin connector Z1*3B to make sure it is properly seated in place, by pushing it in until it locks.

4. PuMA feedback has indicated that the connector is not fully seated into the power distribution box.
5. Clear the faults and retest the system.

Refer to ISTA Repair Instructions “6113050 Removing and installing/replacing power distribution box in passenger compartment.”
