SI B63 02 12
LightsApril 2012
Technical Service**SUBJECT****Heavy Condensation in Xenon Headlights****MODEL**

F25 (X3)

Vehicles produced from August 31, 2010 to May 26, 2011

Only vehicles with option 522 (Xenon light) and 524 (Adaptive head lights)

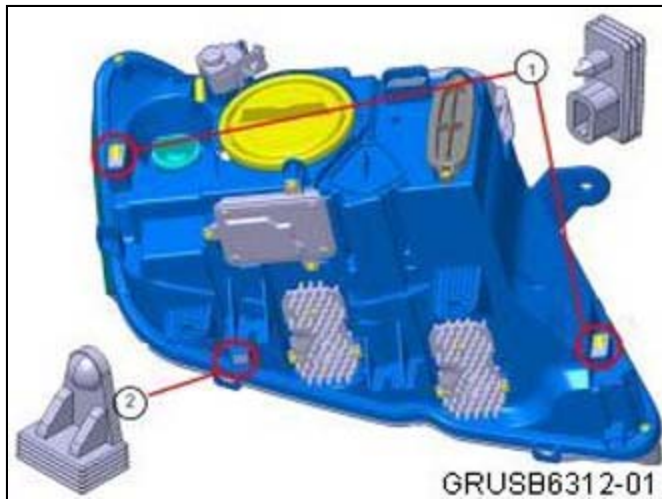
In heavy rain conditions or high humidity, condensation may build up inside one or both headlight (s). The condensation is still present even after a few dry days.

Ventilation openings in the headlight assembly allow humidity inside the headlight(s). Condensation forms when the temperature changes.

2. Remove the affected headlight(s). Refer to Repair Instructions in ISTA (Integrated Service Technical Application) and REP 63 12 010 "Remove and installing or replacing left headlight (Xenon headlight)" and REP 63 12 012 "Remove and installing or replacing right headlight (Xenon headlight)."
3. Remove the cover on the rear of the headlight and allow the headlight to dry out. You can use dried compressed air or warm air.
 4. The photo shows the three ventilation opening areas.
 5. Install the new plugs (1) in the 2 upper holes with P/N 7 324 544, as shown in the photo.
 6. Install a new plug (2) in the

lower hole with P/N 7 324 545.
