EC12-006

ITB12-025

April 30, 2012

2011-2012 QX56; ENGINE FAN IS NOISY AND VEHICLE HAS POOR ACCELERATION

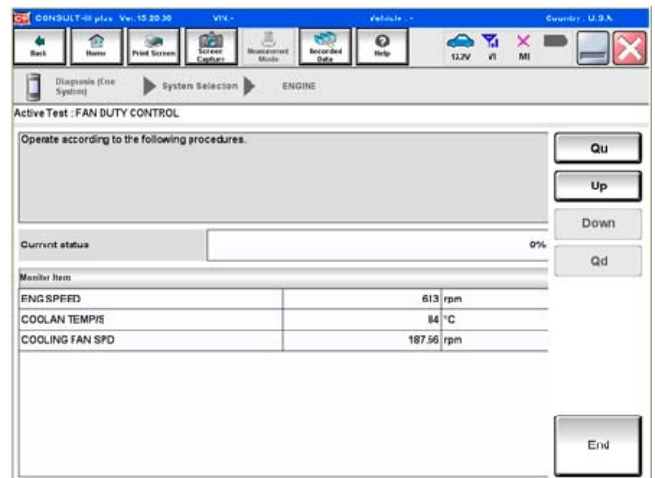
Figure 1

3. Start engine and allow the coolant temperature to reach 80-95°C (176-203°F).
4. With the engine at idle and with the A/C OFF, set the FAN DUTY to 0%.
 - Confirm that the cooling fan speed is below the engine idle speed.

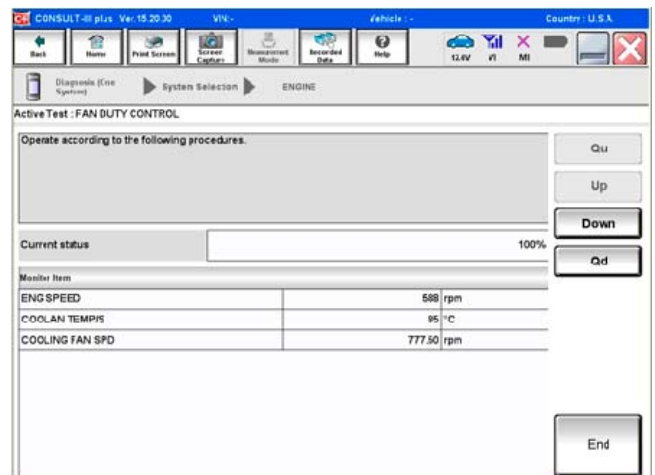
Figure 2

5. Now change the FAN DUTY to 100%.
 - a. Raise the engine speed slowly to 2000 rpm several times and allow it to return to idle, and then confirm that the fan speed increases above engine idle speed (this may take up to 1 minute).
 - b. If the fan speed increases go to step 6.
 - c. If the fan speed **does not** increase go to step 7.

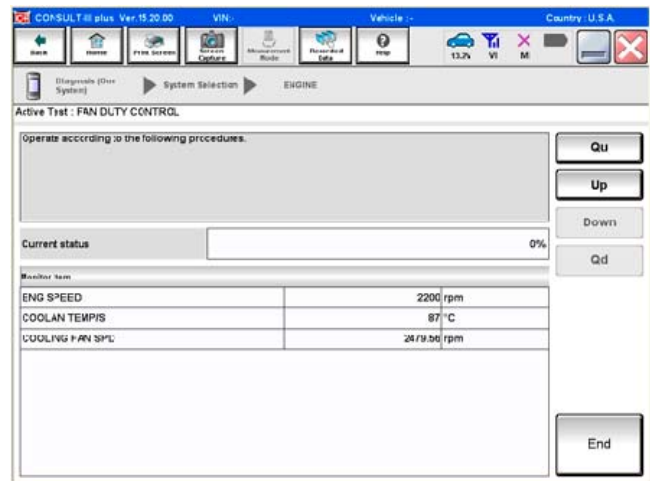
Figure 3

Slowly raise the engine rpm up to 2000 rpm and hold until the fan speed drops below 600 rpm (this may take up to 1 minute).

- a. If the fan speed decreases go to ECM reprogramming on page 4.
- b. **If the fan speed will not decrease**, return engine to idle and allow at least 3 minutes at idle for the fan speed to decrease below engine idle speed.
- c. If the fan speed **does not** decrease go to step 7.
- d. If the fan speed now does decrease go to ECM reprogramming on page 4.

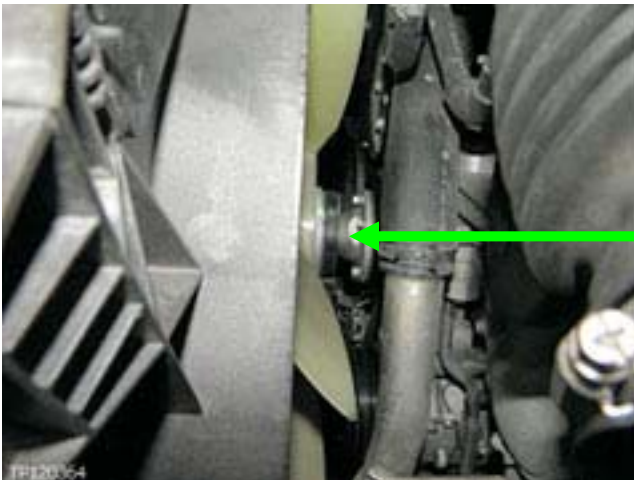
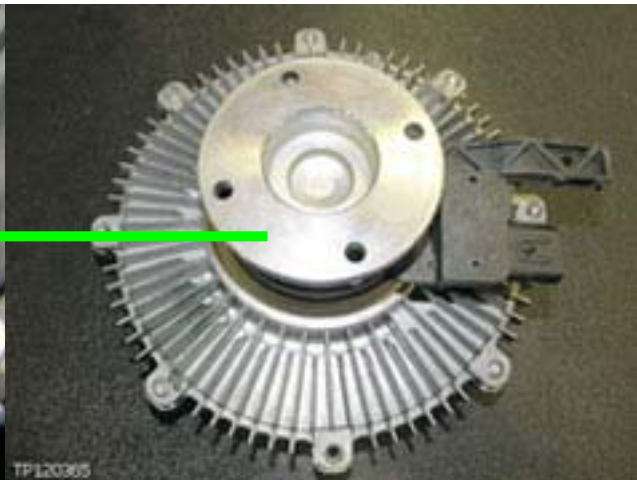
7. If the fan speed will not increase (step 5) or decrease (step 6) using Active Test, replace the fan coupling shown in Figures 4 and 5, then go to step 8 for ECM reprogramming.

NOTE: Refer to ESM Engine Cooling Section for procedure to replace fan coupler.

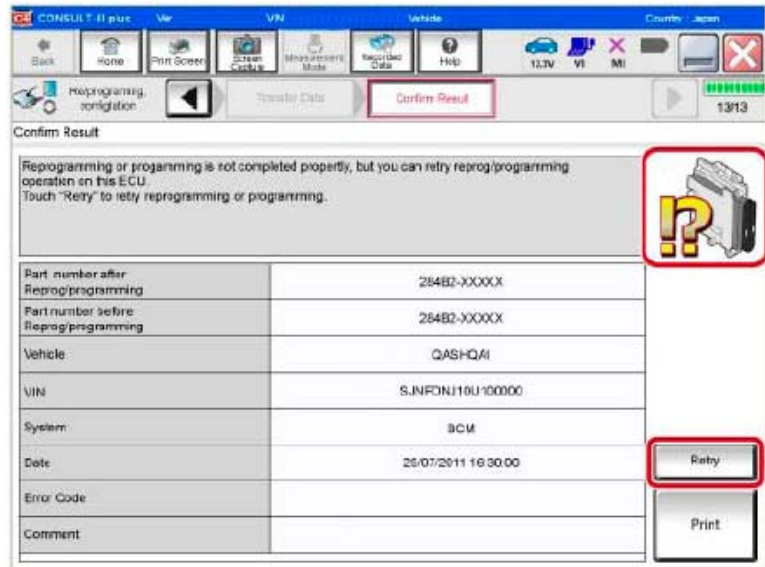
Figure 11

If reprogramming does not complete and the “!?” icon displays as shown in Figure 11:

- Check battery voltage (12.0–15.5 V).
- Ignition is ON, engine OFF.
- External Bluetooth® devices are OFF.
- All electrical loads are OFF.
- Select retry and follow the on screen instructions.
- “Retry” may not go through on first attempt and can be selected more than once.
