SB-10044085-4132

Title Uneven rear tire wear, Correction of excessive negative camber
Ref No US15309.4.1 en-GB
Issuer -
Partner 3 US 7510 Volvo Cars North America
Func Group 6526
Func Desc control arm

TJ No 15309

Uneven rear tire wear, Correction of excessive negative camber

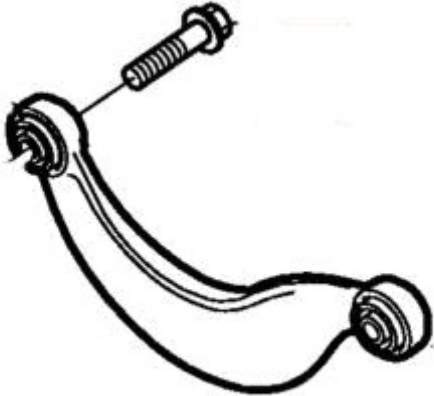
Excessively negative rear camber may cause uneven tire wear and this may be accompanied by abnormal road noise or ride. Refer to the camber angle specifications in RTJ 19674.

A control has been made available as a service part in order to correct excessive rear camber. See Photo 1 in the attachment. The control arm has a bushing offset of 2.5 mm (approx 0.1") which will make the camber angle 0.7 degrees less negative. For example, if the camber angle of one rear wheel was initially -2.6 degrees, it will be -1.9 degrees after the installation of the control arm on that side.
