**NUMBER: 316120002.01****MODEL: Karma****DATE: January 11, 2012****MODEL YEAR: 2012****TITLE: Front Inverter Grounds****PRIORITY:**

All Fisker Karma vehicles produced prior to VIN# YH4K14AA9CA001222 were assembled with incorrect ground locations for the Front Inverter and paint on the mating surface of the bulkhead is causing insufficient ground connections. This Campaign will be used as a reference guide for technicians to perform necessary repairs to properly disconnect these ground wires, swap mounting locations, and remove paint from ground wire mating surfaces on bulkhead.

## TITLE: Front Inverter Grounds

**VIN:** All vehicles produced prior to VIN# YH4K14AA9CA001222

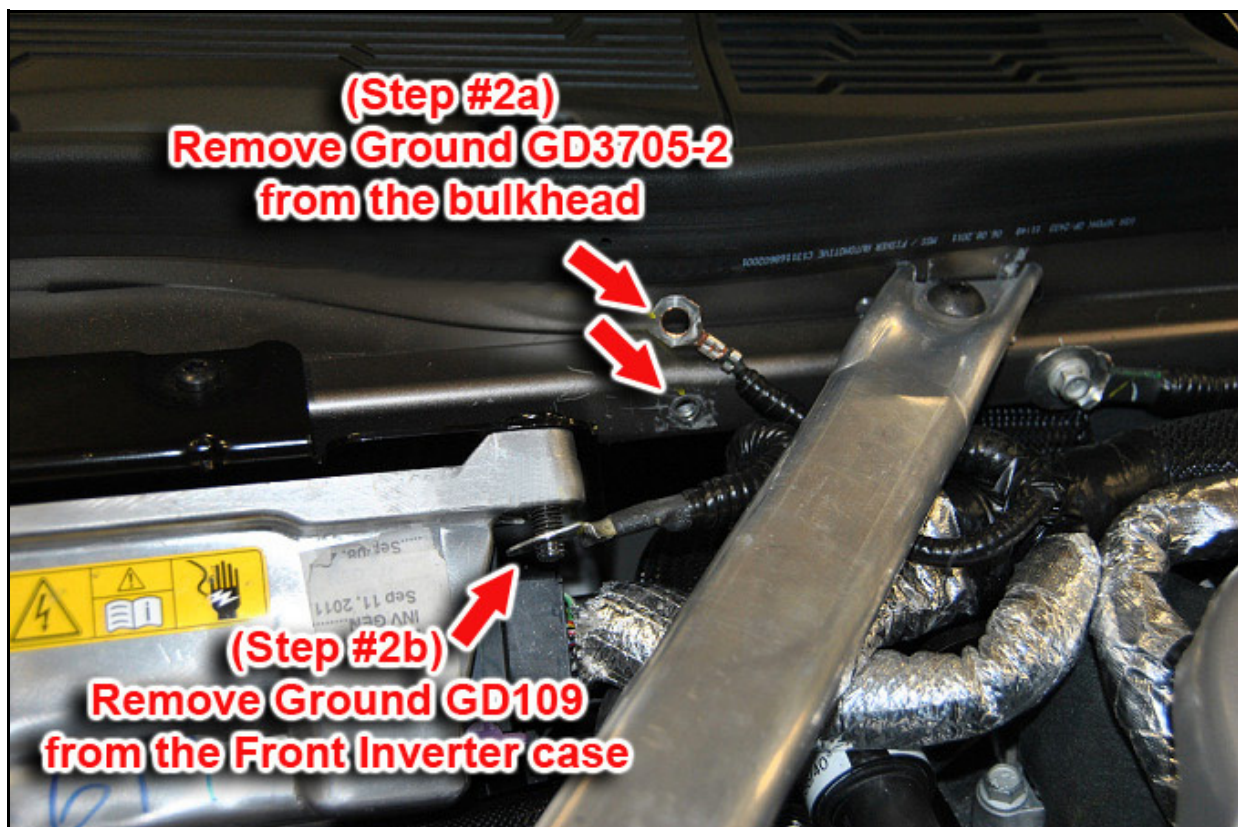
2a. Harness ground wire GD3705-2 is installed in the wrong location. Unbolt harness ground GD3705-2 (Step #2a in photo below) from the bulkhead.

2b. Ground wire GD109 is installed in the wrong location. Remove the nut from the upper right-hand stud of Front Inverter, remove the GD109 ground wire from stud (Step #2b in photo below), and save the nut for reuse.
