TECHNICAL SERVICE BULLETIN

TSB #: 12-001 **Job Code:** 9801138 **Flat Rate:** 0.25 hour

Technical Service Bulletin Notification TSB#12-001

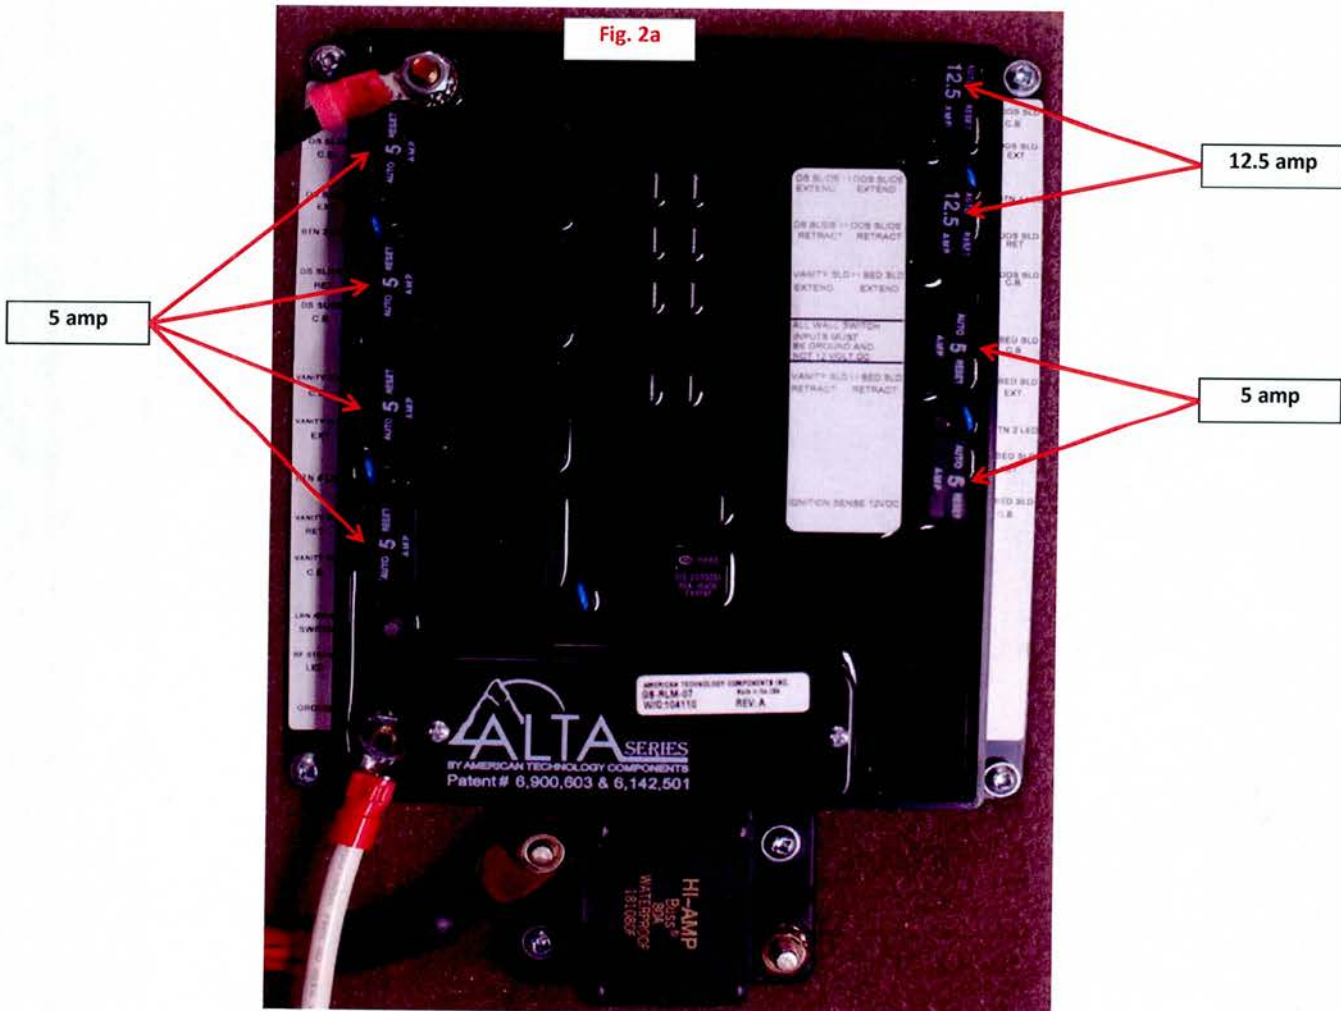
Entegra Coach has determined that on certain model year 2012 & 2013 Entegra Coach Class A Aspire, Anthem, and Cornerstone Motorhomes, extending or retracting the slide out room too far could cause the stop rod bracket underneath the slide room to bend. This situation can be avoided by replacing several fuses according to the attached instructions. **We will send you a parts kit automatically for every unit in your stock.** Once the room is fully extended or retracted, you should release the button and not wait to hear the motor stop running. We will provide two labels in the kit that are intended to be a reminder of this. They are to be installed next to the slide room switch in the bathroom overhead as well as the passenger front overhead.

1. Locate the slide out fuse panel in the front (driver side) exterior compartment (fenderskirt).
2. Using the needle nose pliers, remove the existing fuses and replace them with the new fuses in the order listed in **Figure 2a**.

3. Install (1) label next to each set of slide out switches.
