**NUMBER: 390120010.01****MODEL: Karma****DATE: January 22, 2012****MODEL YEAR: 2012****TITLE: Ground Connection Rework****PRIORITY:**

Proper grounding is essential for the functionality of the Fisker Karma. This Campaign is to address 14 ground points in the 12 Volt System that have high electrical resistance due to the insulation properties of the installed hardware. The 14 ground points are to be inspected, cleaned of any paint residue and new hardware installed. The following instructions will guide the technician through a thorough inspection and repair of the 14 ground points. In addition, a ground strap is to be installed between the RH A-Post and the Instrument Panel (IP) which will improve the ground circuit within the IP. Please see the matrix on the following page that identifies the ground points and related hardware.

**VIN:** All vehicles produced prior to VIN# YH4K14AA4CA000852

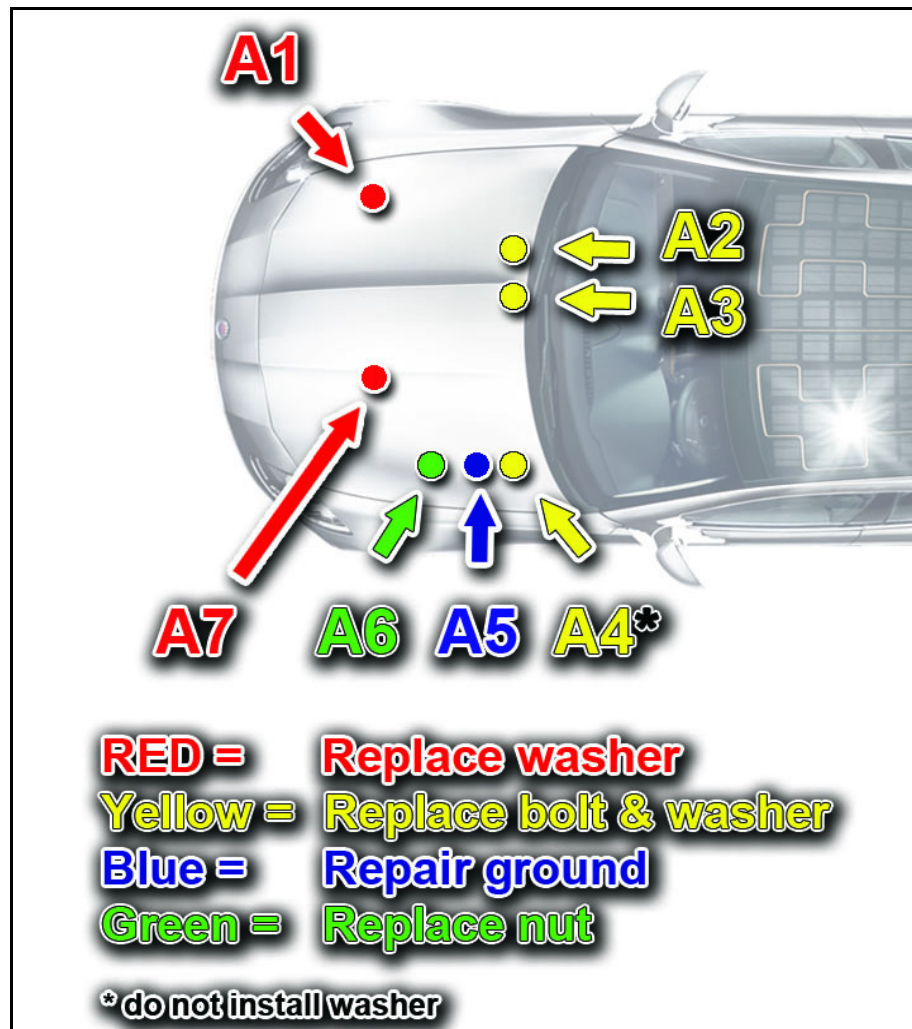
**NOTE:** Image below shows locations of ground wire connections to repair located in the engine compartment. Each ground location is designated with a letter for reference of repair steps included in this document.

- Locations in **RED** will receive a replacement washer under the head of the ground bolt or ground nut.
- Locations in **YELLOW** will receive a replacement ground bolt (except where noted).
- Location in **BLUE** will be checked/repaired if heat shrink tube or its glue is under the head of the bolt.
- Location in **Green** will receive a replacement nut.

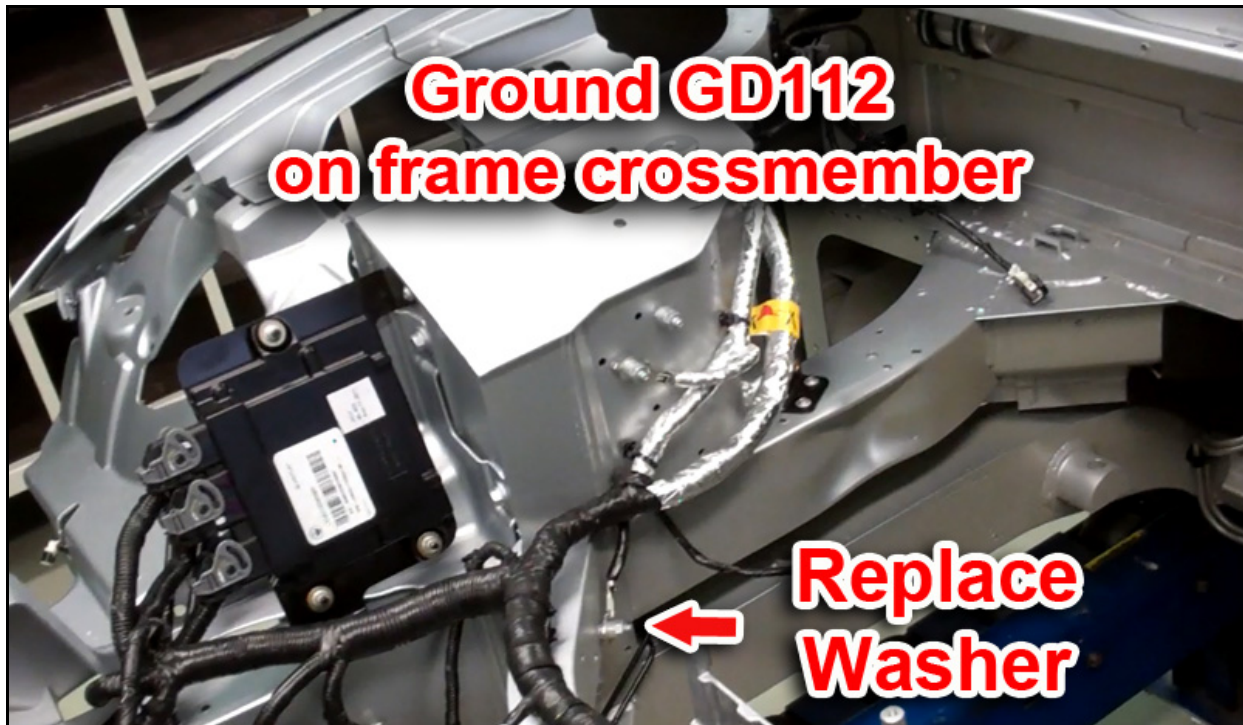
LOCATION A1 – Cylinder Block Ground GD112 – Repair

2a. Locate ground GD112 on frame crossmember.

2c. Remove paint from mating ground surfaces, if present.

2e. Install new replacement Washer (Stainless Steel M8 X 17.0 X 1.6 – PN: C146000907200).

2f. Install ground nut and torque to 10 +/- 5 Nm.

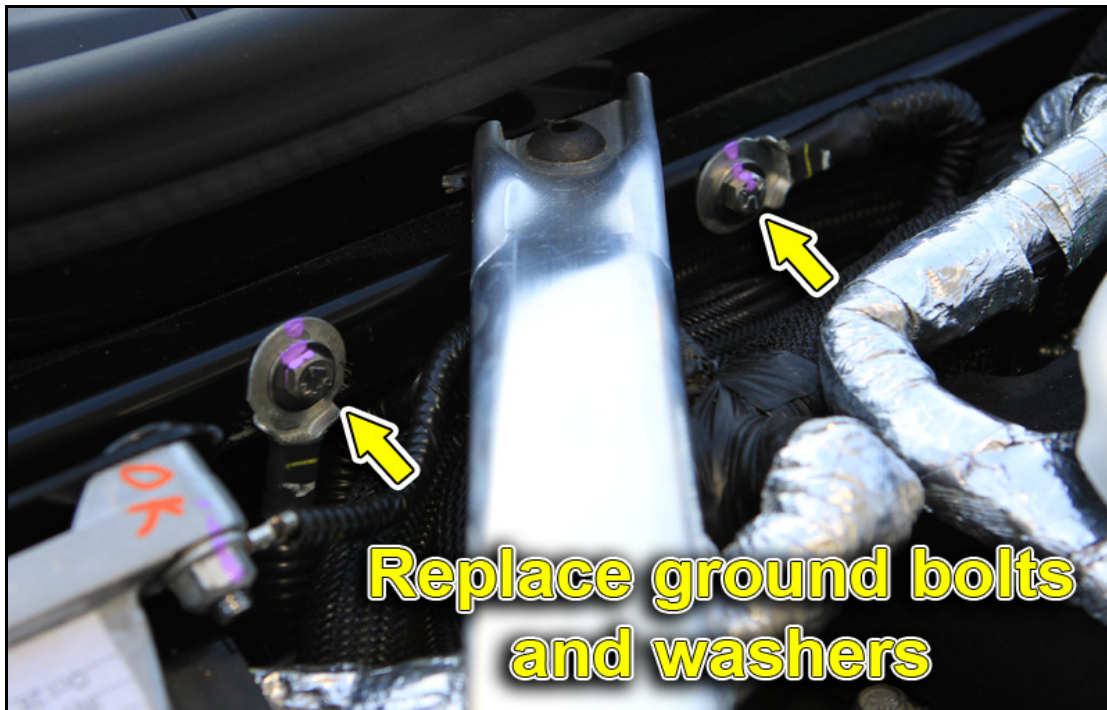
### LOCATION A2 & A3 – Bulkhead Ground GD109 and GD107 – Repair

3a. Locate grounds GD109 and GD107 from the bulkhead (see image below).

3c. Remove paint from mating ground surfaces, if present.

3d. Install ground wires with new replacement Hex-Bolt (SS M6 X 1.0 X 16.0 – PN: C141900200200) and Washer (Steel 6.0 X 20.0 X 1.5 – PN: C146000007200).

3e. Install ground bolt and torque to 8 +/- 2 Nm (do not overtighten, captured nuts are easily damaged).

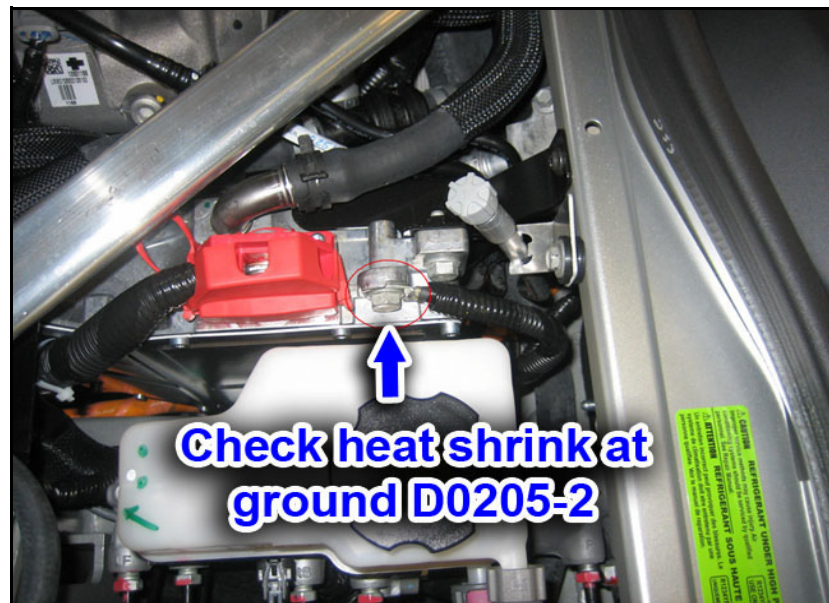
### LOCATION A4 & A5 – APM Ground D0205-2 – Repair

4c. Examine ground for heat shrink tube or its adhesive improperly located under the ground bolt washer.

- If heat shrink tube or its adhesive is under ground washer, go to next step.
- If heat shrink tube or its adhesive is not under ground washer, go to step 4e.

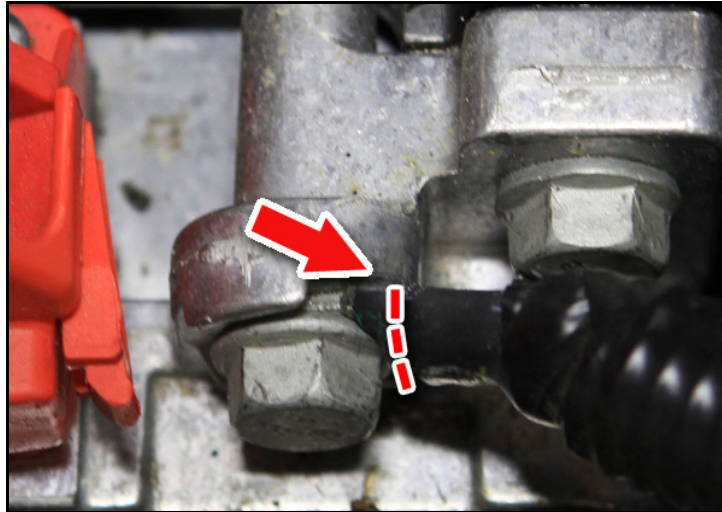
*Example: Improperly installed heat shrink and incorrect ground bolt.*

4d. Trim heat shrink tubing back to red dotted-line (see image below), so that it's not interfering with ground washer and then clean off heat shrink adhesive.

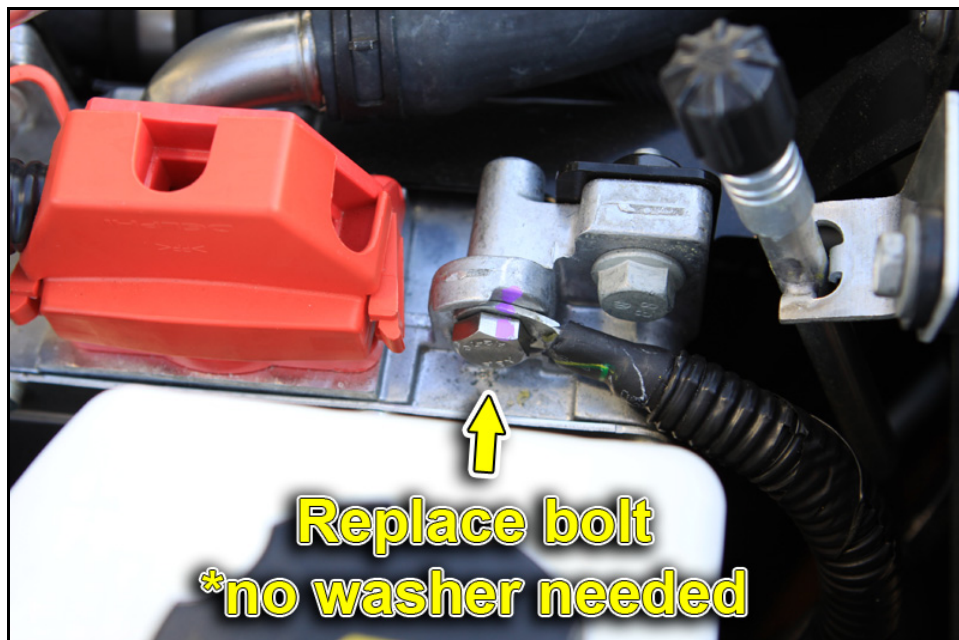
*Example: Corrected heat shrink and proper replacement ground bolt.*

4e. Install ground wire and new replacement Hex-Bolt (Stainless Steel SS M8 X 1.25 X 25.0 – PN: C141900100200) (no washer required), then torque to 18 +/- 5 Nm.

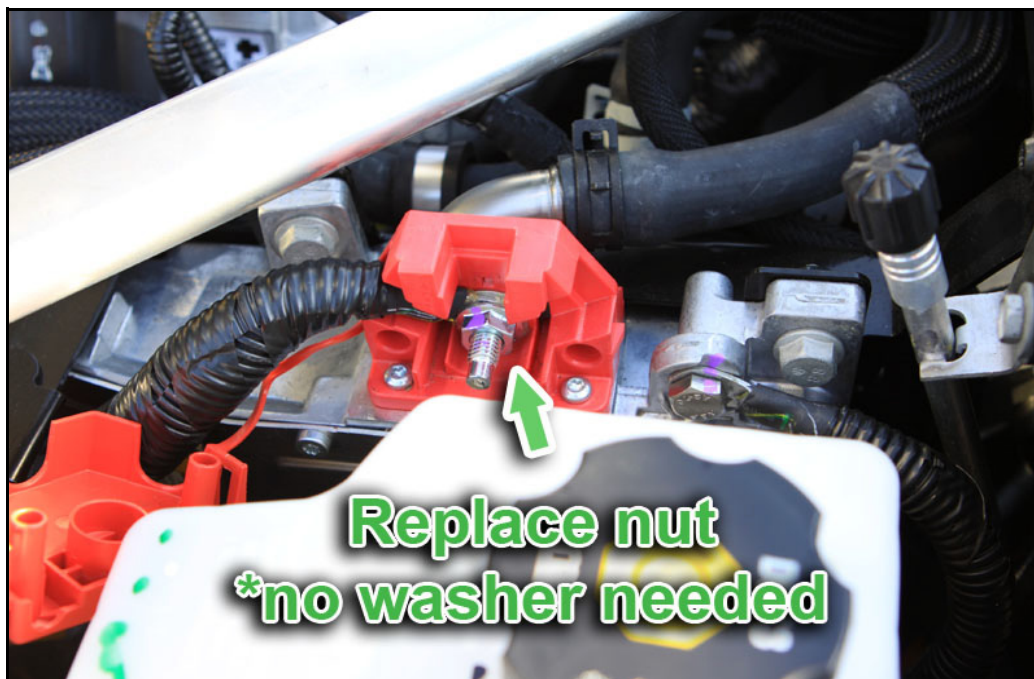
LOCATION A6 – APM Power Wire D0205-3 – Repair

5a. Remove red plastic protective cover from APM power wire junction block (see image below).

5b. Remove nut from APM power wire (see image below).

5c. Install new replacement nut.

5d. Install ground Hex-Nut (FL PTP M8x1.25 PC8 – PN: C144211807200) and torque to 18 +/- 5 Nm.

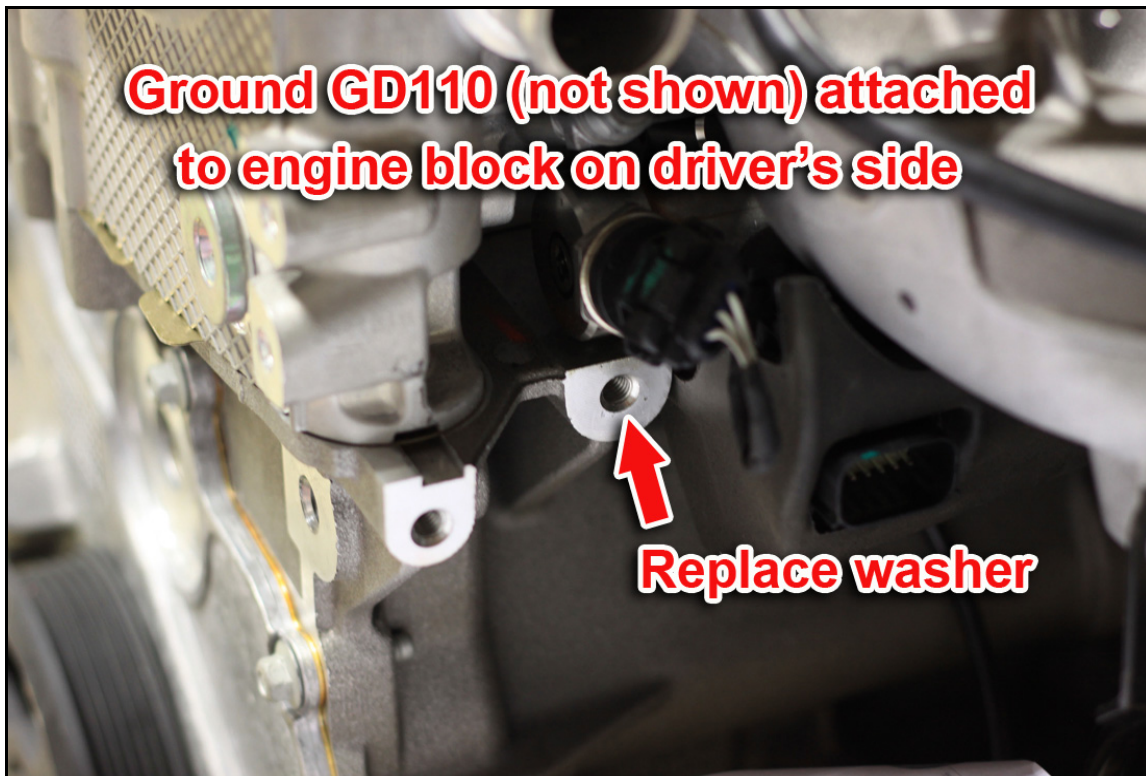
### LOCATION A7 – A/C Compressor Clutch Ground GD110 – Repair

6a. Locate A/C compressor clutch ground GD110 on driver's side of engine behind coolant hose (for specific ground location, see image below).

6d. Install new replacement Washer (Stainless Steel M8 X 17.0 X 1.6 – PN: C146000907200).

6e. Install ground bolt and torque to 25 Nm.

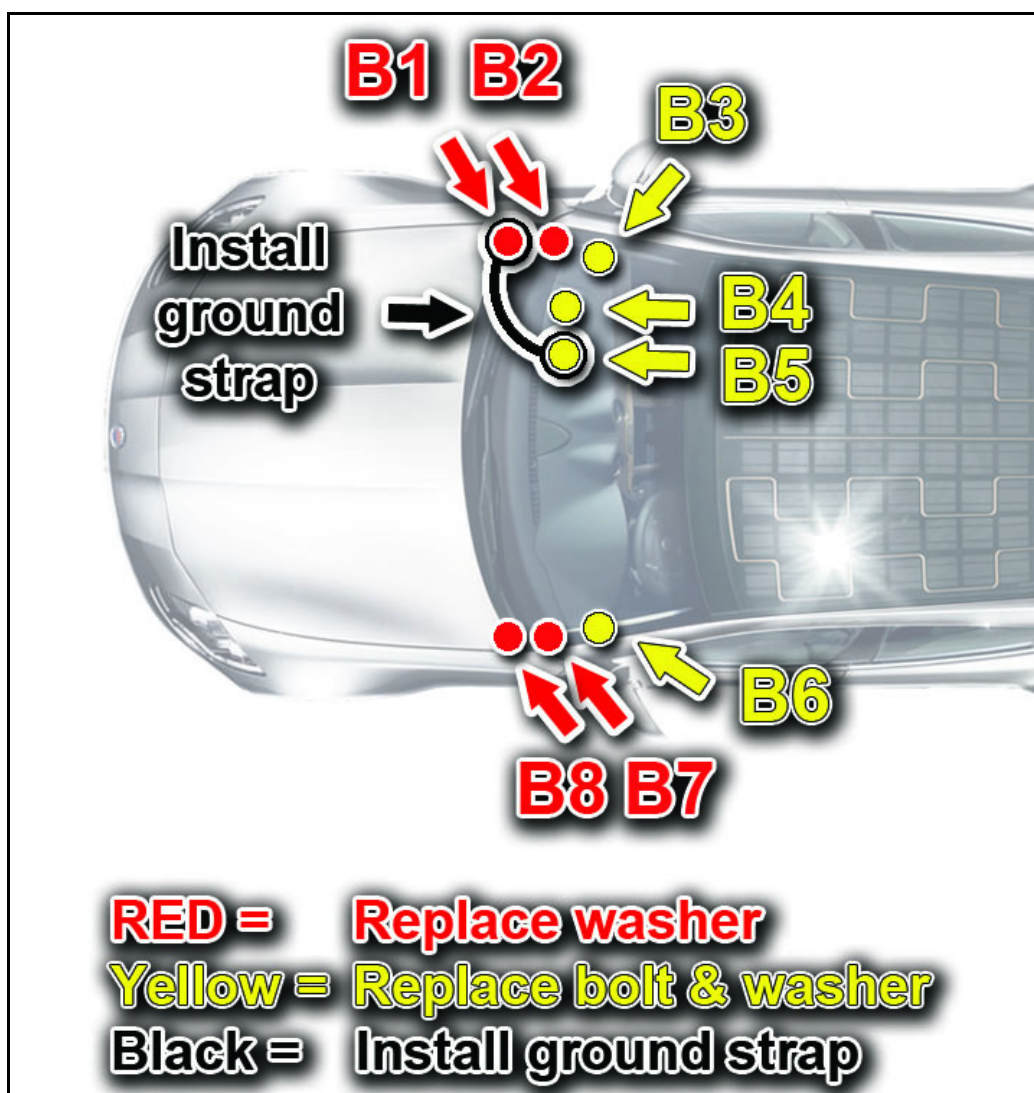
**NOTE:** Image below shows locations of ground wire connections to repair located in the passenger compartment. Each ground location is designated with a letter for reference of repair steps included in this document.

- Locations in **RED** will receive a replacement washer under the head of the ground nut.
- Locations in **YELLOW** will receive a replacement ground bolt to improve ground.
- Location in **BLACK** will receive a ground strap.

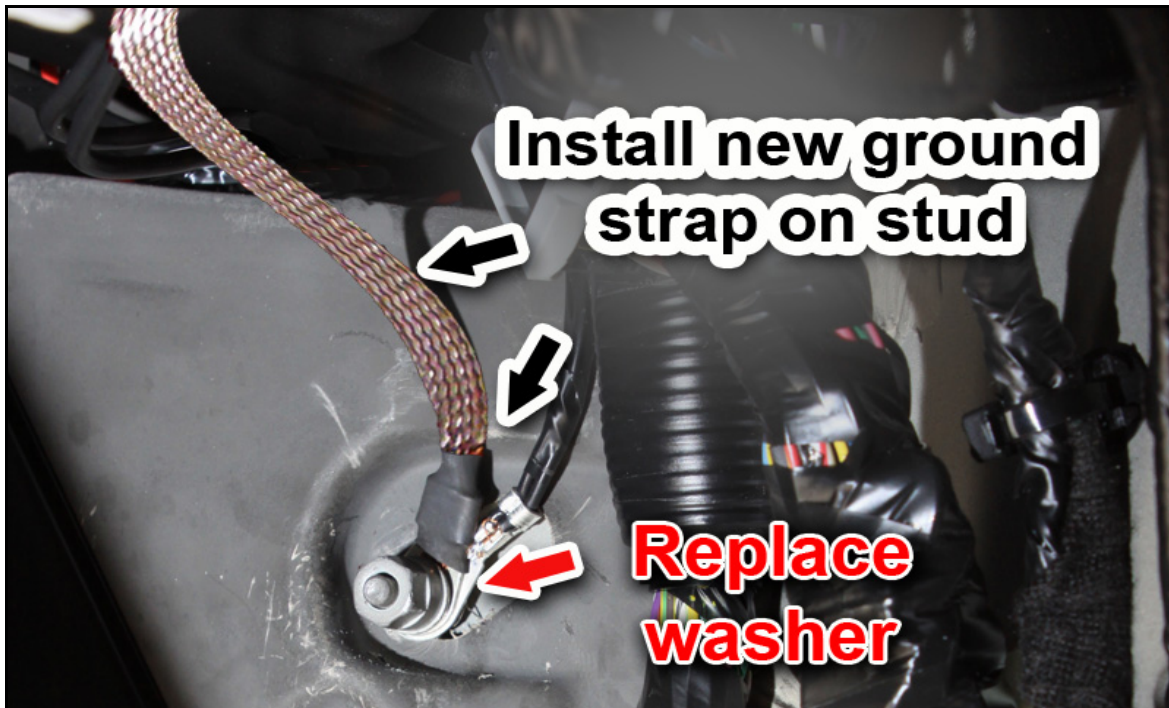
LOCATION B1 – Right-Hand A-Pillar Instrument Panel Ground GD202 C1 – Repair

8a. Locate right-hand A-pillar instrument panel ground GD202 C1 on lower right-hand A-pillar wall.

8c. Remove paint from mating ground surfaces, if present.

8e. Install new replacement Washer (Stainless Steel M8 X 17.0 X 1.6 – PN: C146000907200).

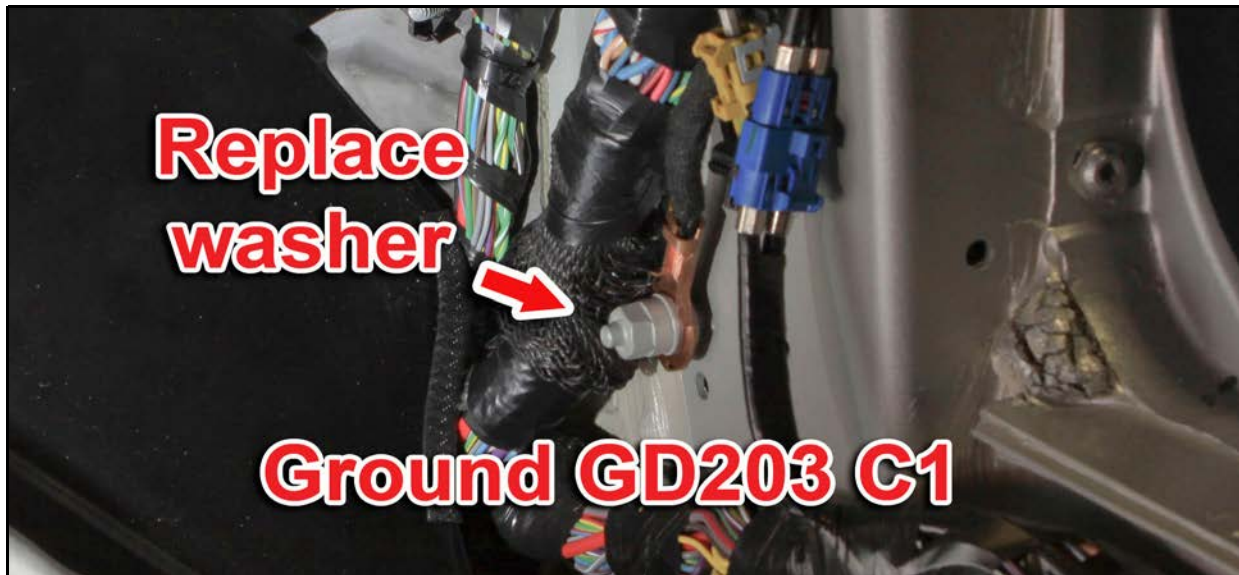
LOCATION B2 – Right-Hand A-Pillar Body Ground GD203 C1 – Repair

9a. Locate right-hand A-pillar body ground GD203 C1 on lower right-hand A-pillar wall.

9c. Remove paint from mating ground surfaces, if present.

9e. Install new replacement Washer (Stainless Steel M8 X 17.0 X 1.6 – PN: C146000907200).

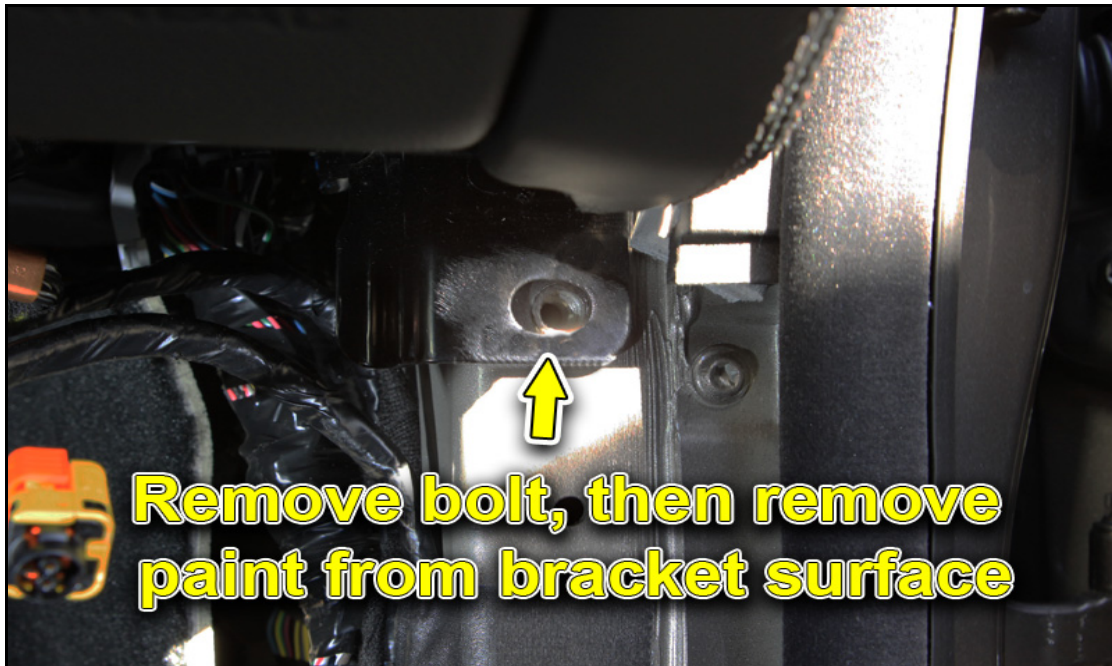
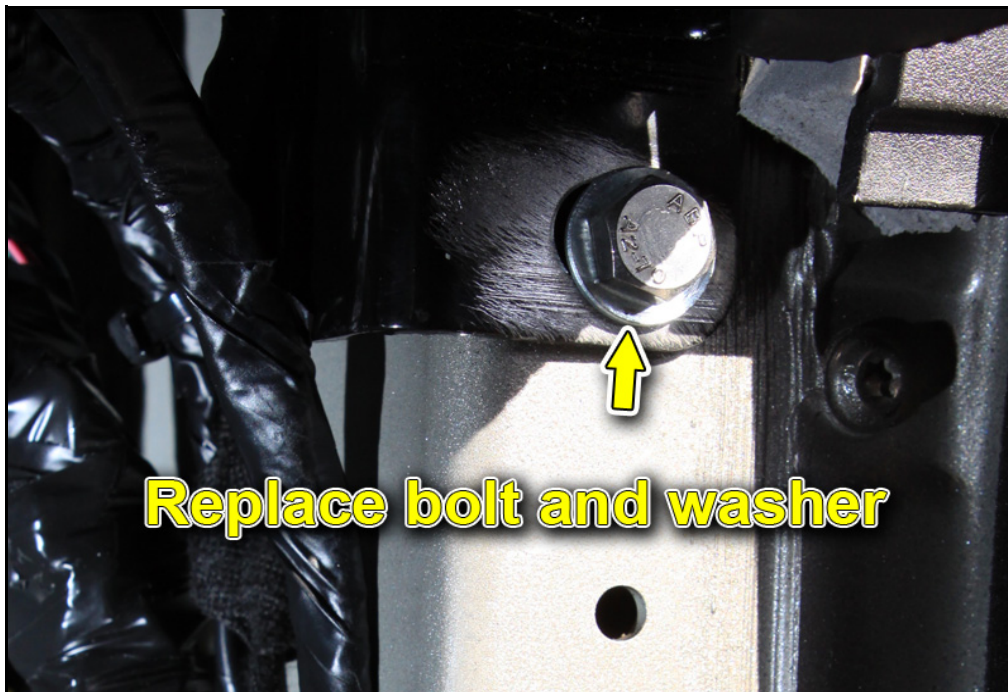
LOCATION B3 – Right-Hand Instrument Panel Cross Member Bracket Ground – Repair

10a. Locate lower Instrument Panel (IP) cross member bracket bolt on right-hand A-pillar.

10c. Remove paint from face of IP cross member bracket at bolt location.

10d. Install new Hex-Bolt (SS M8 X 1.25 X 25.0 – PN: C141900100200) and replacement Washer (Stainless Steel M8 X 17.0 X 1.6 – PN: C146000907200) (torque to 10 +/- 5 Nm).

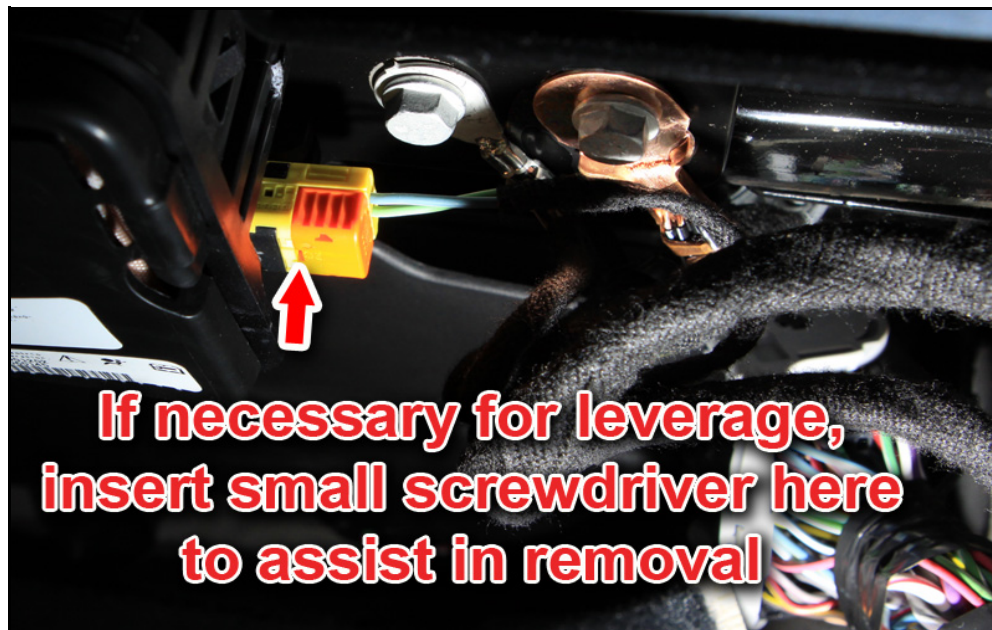
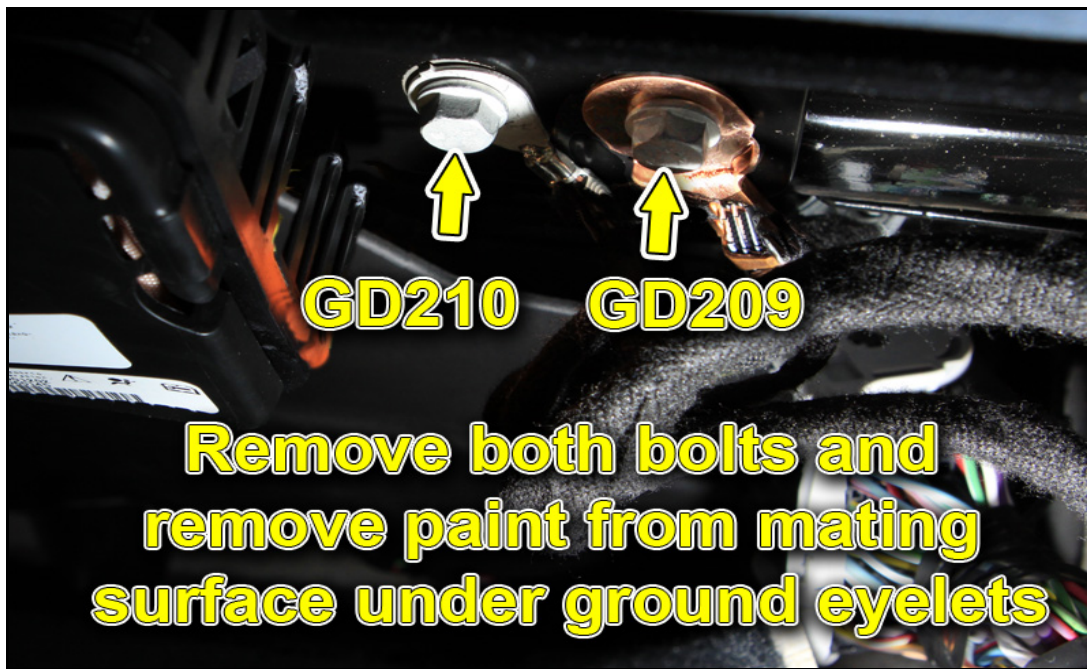
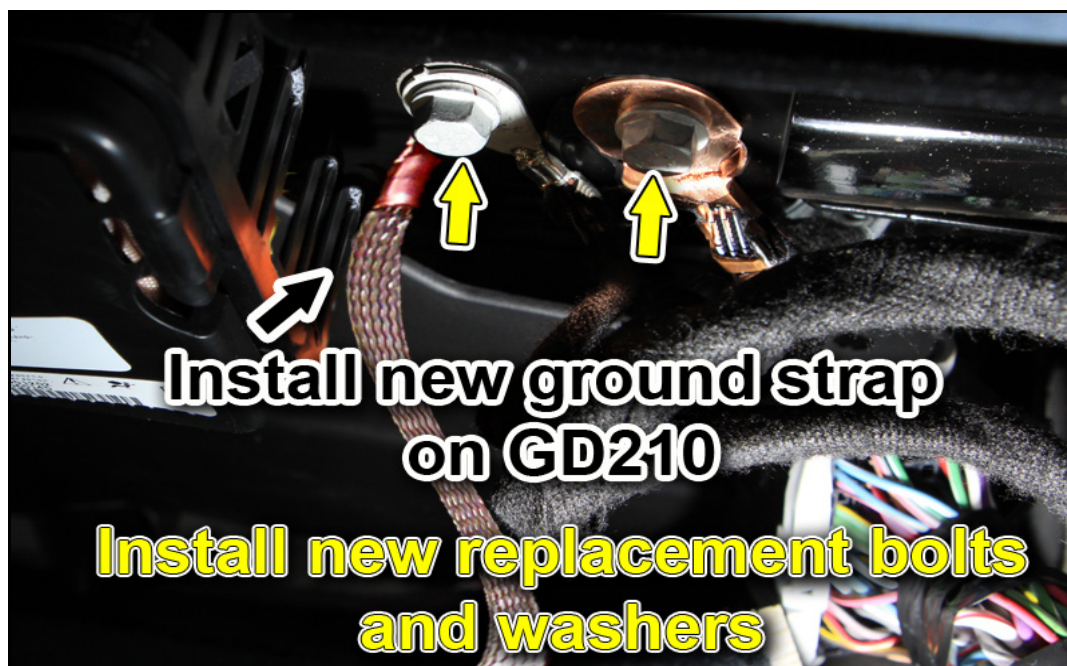
LOCATION B4 & B5 – Grounds GD209 (B4) and GD210 (B5) – Repair

11a. Locate grounds GD209 and GD210 on IP cross member bracket under passenger side of dash (to the right of the passenger knee airbag).

11d. Remove paint from face of IP brace at bolt locations.

11e. Install replacement Hex-Bolt (SS M6 X 1.0 X 16.0 – PN: C141900200200) and Washer (Steel 6.0 X 20.0 X 1.5 – PN: C146000007200) with cowl IP ground GD209 (torque to 8 +/- 2 Nm).

11f. Install replacement Hex-Bolt (SS M6 X 1.0 X 16.0 – PN: C141900200200) and Washer (Steel 6.0 X 20.0 X 1.5 – PN: C146000007200) with IP audio ground GD210 and the unattached end of the Ground Strap (PN: C148700107200) installed in step 8 (page 16) (torque to 8 +/- 2 Nm).

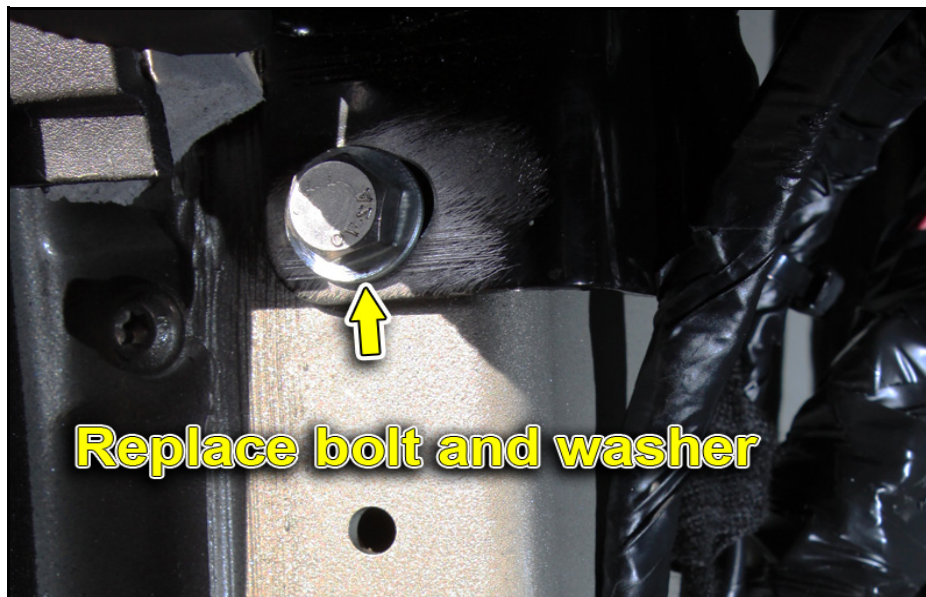
### LOCATION B6 – Left-Hand Instrument Panel Cross Member Bracket Ground – Repair

14a. Locate lower Instrument Panel (IP) cross member bracket bolt on left-hand A-pillar.

14d. Install new Washer (Stainless Steel M8 X 17.0 X 1.6 – PN: C146000907200) and replacement Washer (Stainless Steel M8 X 17.0 X 1.6 – PN: C146000907200) (torque to 10 +/- 5 Nm).

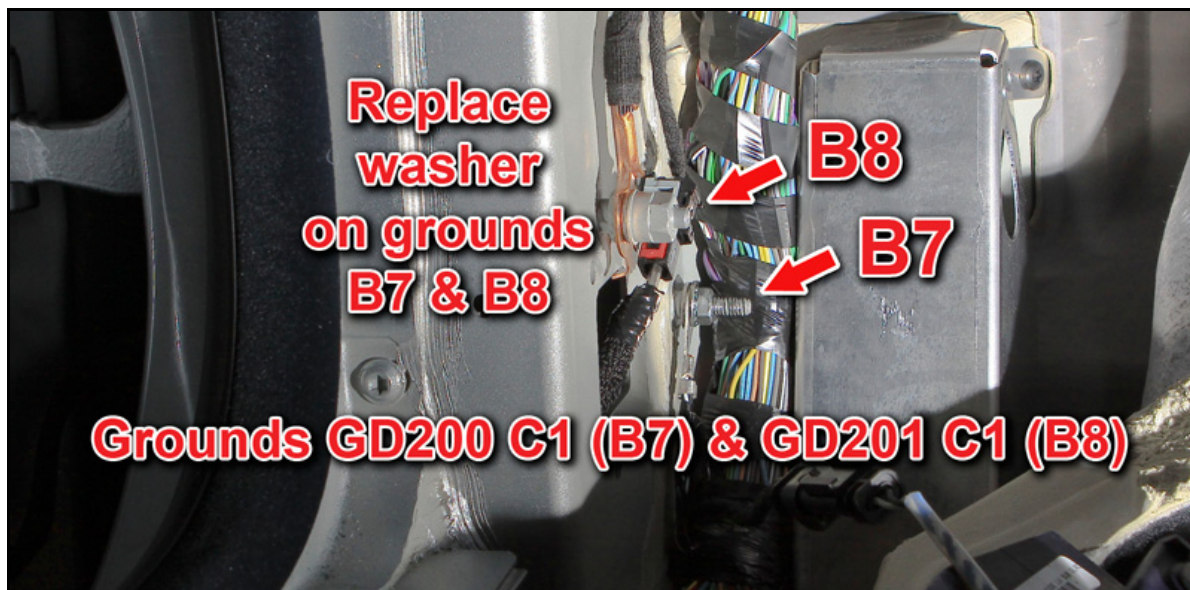
LOCATION B7 and B8 – Left-Hand A-Pillar Body Ground GD200 C1 and Instrument Panel GD201 C1 – Repair

15a. Locate left-hand A-pillar body ground GD200 C1 and instrument panel ground GD201 C1 on lower right-hand A-pillar wall.

15c. Remove paint from mating ground surfaces, if present.

15e. Install one new replacement Washer (Stainless Steel M8 X 17.0 X 1.6 – PN: C146000907200) over each stud.
