**NUMBER: 390120008.01****MODEL: Karma****DATE: January 27, 2012****MODEL YEAR: 2012****TITLE: Baseline 613.5 Release****PRIORITY:**

## CAMPAIGN

**FISKER AUTOMOTIVE, INC.**

Baseline 613.5 ECU Software Identification Number

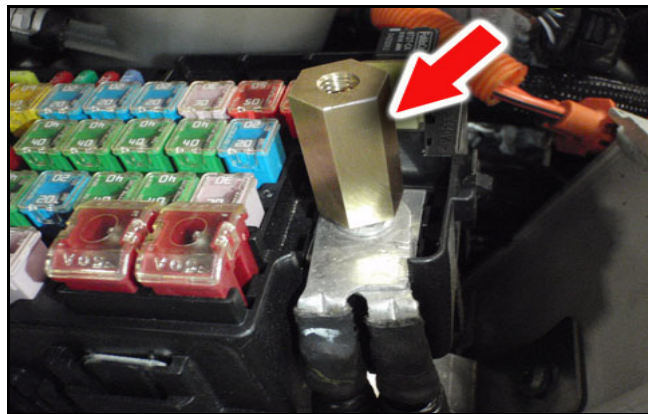
*FST9001 - Battery Charging Terminal Adaptor (red arrow) installed on the B+ post in the PDC.*

– If the low-voltage Battery is not at least 12.2 volts, you must charge battery. Connect the positive lead of the Midtronics MDX series tester (or equivalent) to the B+ positive post at the Power Distribution Center (PDC) with Fisker Special Tool **FST9001 – Battery Charging Terminal Adaptor** (to be used for all electrical system testing and charging). Connect the – Negative lead to the Accessory Power Module (APM) ground terminal.

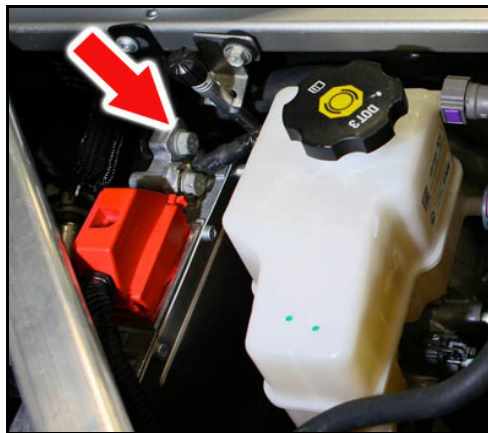
*Negative chassis ground (red arrow) location on Accessory Power Module (APM).*

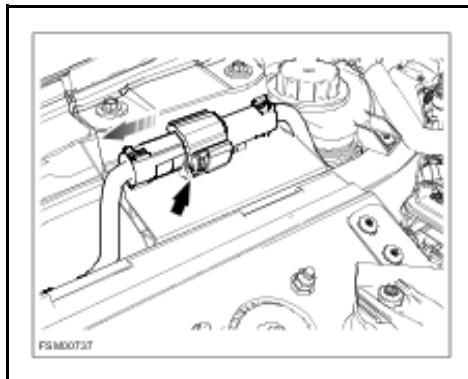
*12 Volt Battery Negative Connector C104*

6b. Power down the vehicle and let it go to sleep. Open the hood and disconnect the 12 volt battery by disconnecting connector C104.
