**NUMBER: 390110015.01****MODEL: Karma****DATE: January 9, 2012****MODEL YEAR: 2012****TITLE: Baseline 611 Overview****PRIORITY:**

Flash reprogramming allows the ECU software to be updated without replacing the ECU. Flash calibration updates for specific vehicle models/ECUs are released as field-fix procedures described in individual service bulletins.

# SERVICE BULLETIN

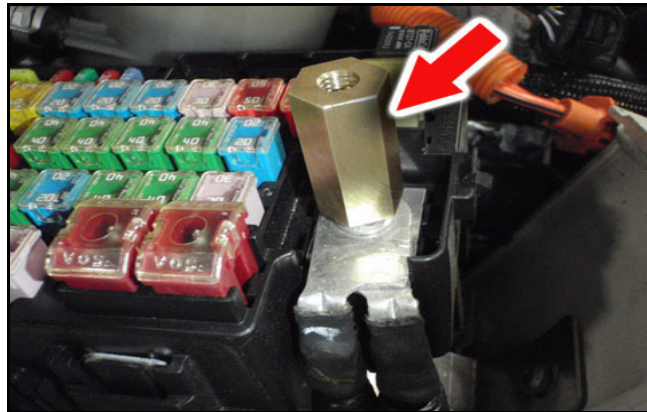
*FST9001 - Battery Charging Terminal Adaptor (red arrow) installed on the B+ post in the PDC.*

3b. If the low-voltage Battery is not at least 12.2 volts, you must charge battery. Connect the positive lead of the Midtronics MDX series tester (or equivalent) to the B+ positive post at the Power Distribution Center (PDC) with Fisker Special Tool **FST9001 – Battery Charging Terminal Adaptor** (to be used for all electrical system testing and charging). Connect the – Negative lead to the Accessory Power Module (APM) ground terminal.

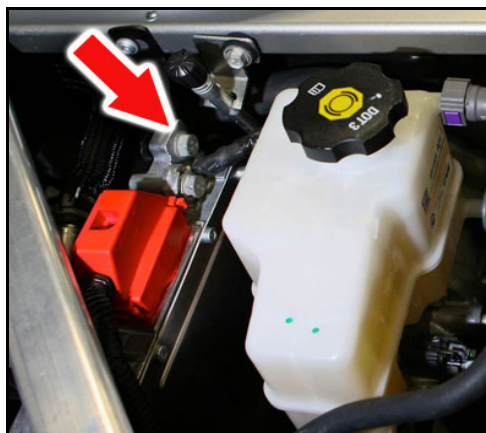
*Negative chassis ground (red arrow) location on Accessory Power Module (APM).*
