SUBJECT: **Revised Parts Information** for Special Service Program (SSP) 73 – 2007 CX-9 Front Door Checker

Mazda Motor Corporation has decided to conduct a Special Service Program (SSP) to replace the front door checkers on certain 2007 CX-9 vehicles produced from October 24, 2006 through January 26, 2007.

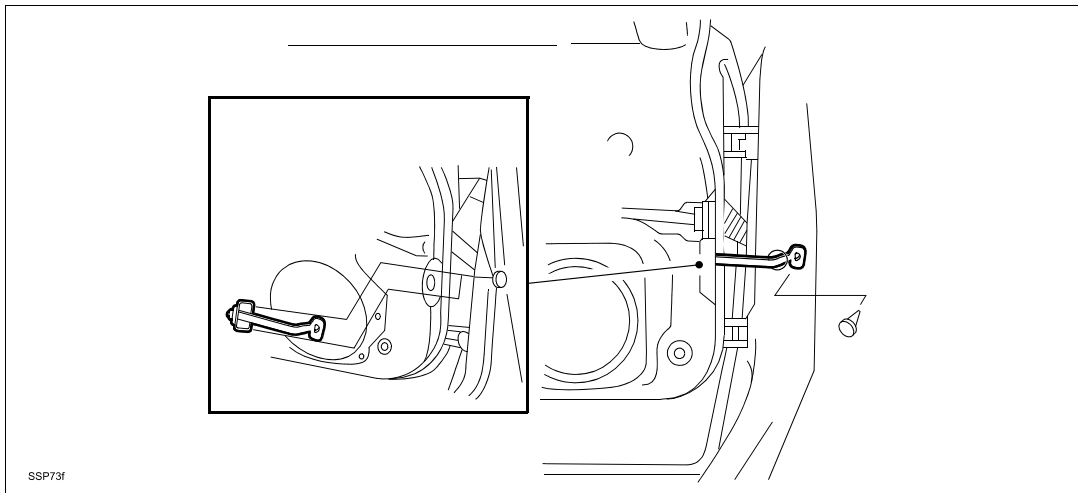
16. Remove the front door checker.

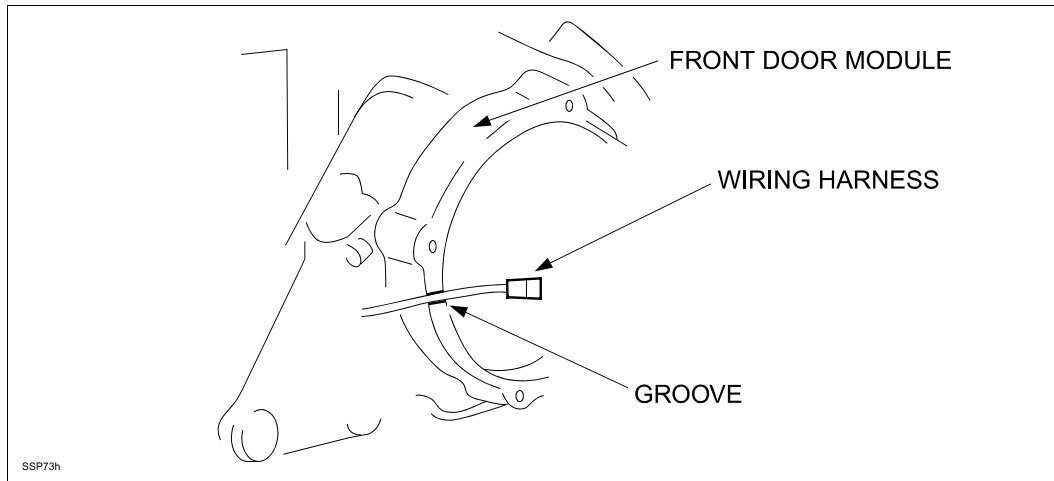
- If the front door speaker is installed with the wiring harness out of the groove, damage to the wiring harness may occur.

18. Install the front door speaker.
