SB-10044146-4865

Title Oil consumption, low or uneven idle, "Low oil Level" or "Oil level low" in DIM **Status** Released
Ref No US24643.1.5 en-US **Status Date** 2012-04-10
Issuer - **Issue Date** 2012-04-10
Partner 3 US 7510 Volvo Cars North America **Reference** TJ 24382, SMB 21-005, CPI 11-2011

Volvo Car Customer Service	
	TJ Instruction
	TJ No 24643
	Date April-12 Issue 04
Title	Excessive oil consumption, low or uneven idle, Low oil Level message in DIM

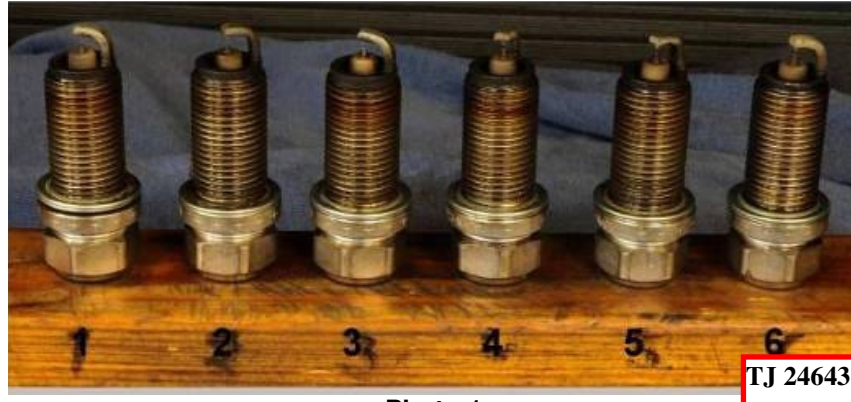
This step is only valid for engine 94, which was introduced in model year 2011. The customer may experience unexpected engine oil usage for the distance covered, e.g. 5,000 miles, the yellow warning symbol may be lit and the "Engine oil level low" message may be displayed in the DIM. The spark plugs may be equally dark (see Photo 1 below).

Print out DTCs using VIDA. Remove all spark plugs and compare the deposits / colors of each plug. If some plugs have a lot more soot than others, see Steps 3 and 4. If plugs match Photo 1, follow the steps below. Regardless of what the plugs look like, the latest ECM/TCM Upgrade should be performed (after the proper repair is carried out) before releasing the vehicle to the customer.

- Perform an ECM Upgrade according to VIDA. Note that after this download the customer may notice a slight difference in transmission shifting since the ECM and TCM Upgrades get downloaded together.
- Replace the engine oil dip stick with P/N 31251037
- Exchange the engine oil and refill to a volume 0.6 L (0.6 qts) higher, making the total oil fill volume 7.4 L (7.8 qts). Confirm that the oil level is up to the MAX mark on the new dip stick.
- Install a decal P/N 31349543 showing the new engine oil volume. Clean with isopropanol P/N 1161721 and apply the sticker according to the Photos 2 and 3.

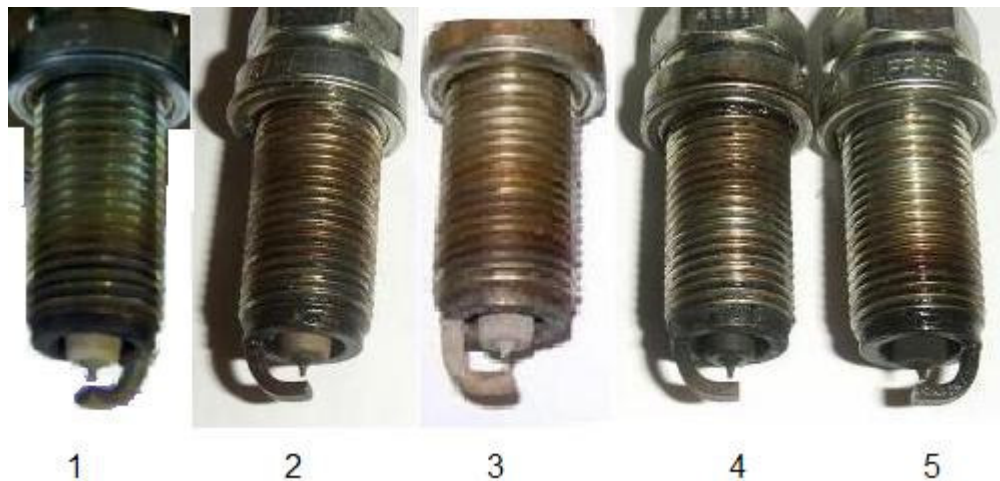
Photo 4. Photo examples for soot level reference

Spark plug soot level for Prior Approval: Level of soot on plugs (0 = no soot, 5 = excessive soot), see Photo 4 for reference. A rating of "0" would correspond to a brand new spark plug. You will be asked to provide this information and a picture of the spark plugs when submitting the online form to the Prior Approval Department.

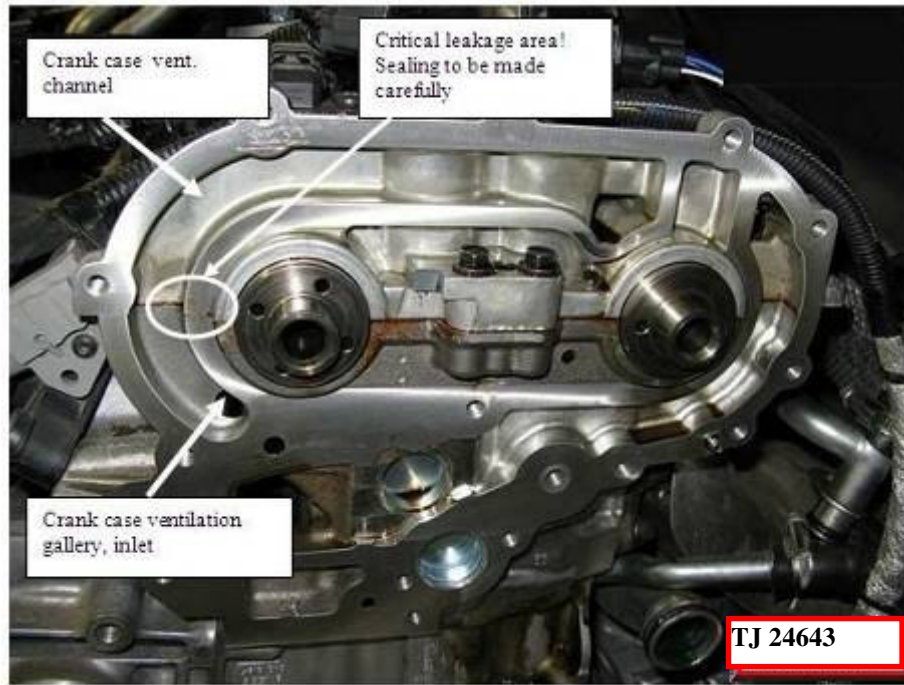
Photo 5. For reference only, not a valid check

If the sealing surface is discolored by oil as shown in the photos, it is most likely that there is a leak between the cam cover and the cylinder head in the area facing the PCV channel connecting the breather box and the PCV gallery. If this is the case, the valve guides should still be checked according to Step 4 before continuing. After checking according to Step 4 (as long as the same cam cover and cylinder head will be re-installed), the cam cover must be resealed according to VIDA. **To get claim approval, contact the Prior Approval Department.**

If the sealing surface is not discolored by oil as shown in the photos, continue diagnosis elsewhere in the engine. The cam cover should be resealed according to VIDA prior to re-installation, as long as the same cam cover and cylinder head will be re-installed.

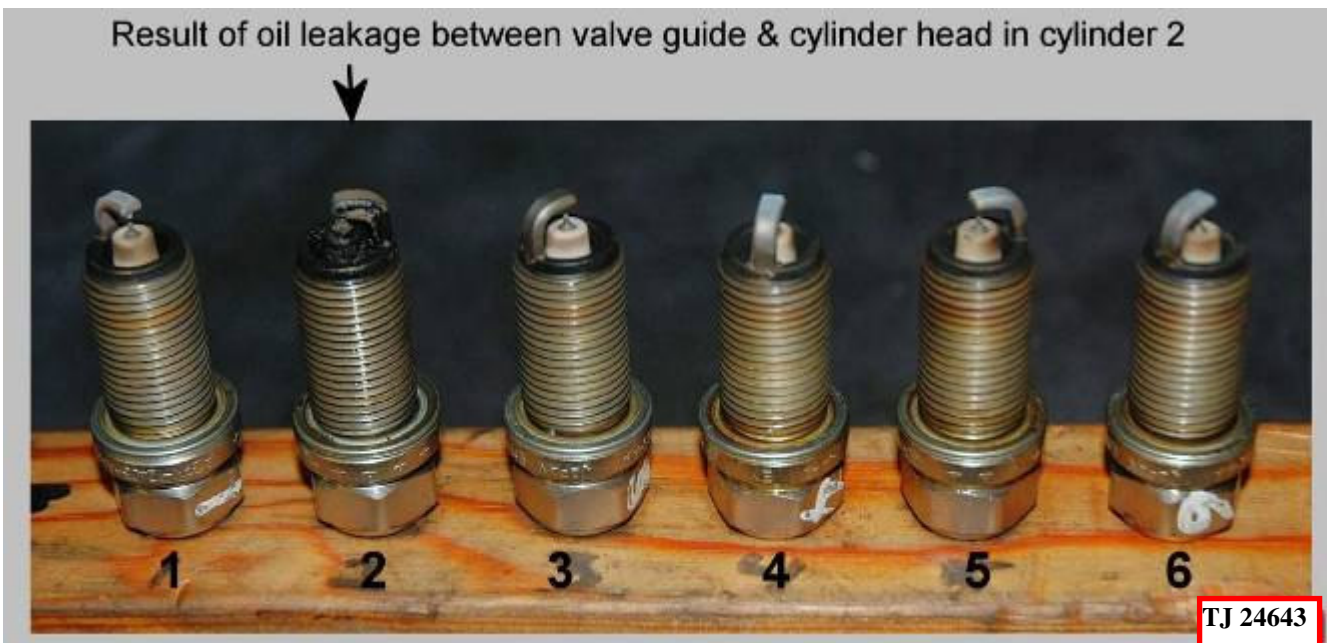
Look at the spark plugs in Photo 7 below. If the valve guide is leaking in a cylinder, the corresponding spark plug will have more soot than the others. In the example in Photo 7, cylinder 2 is consuming oil.

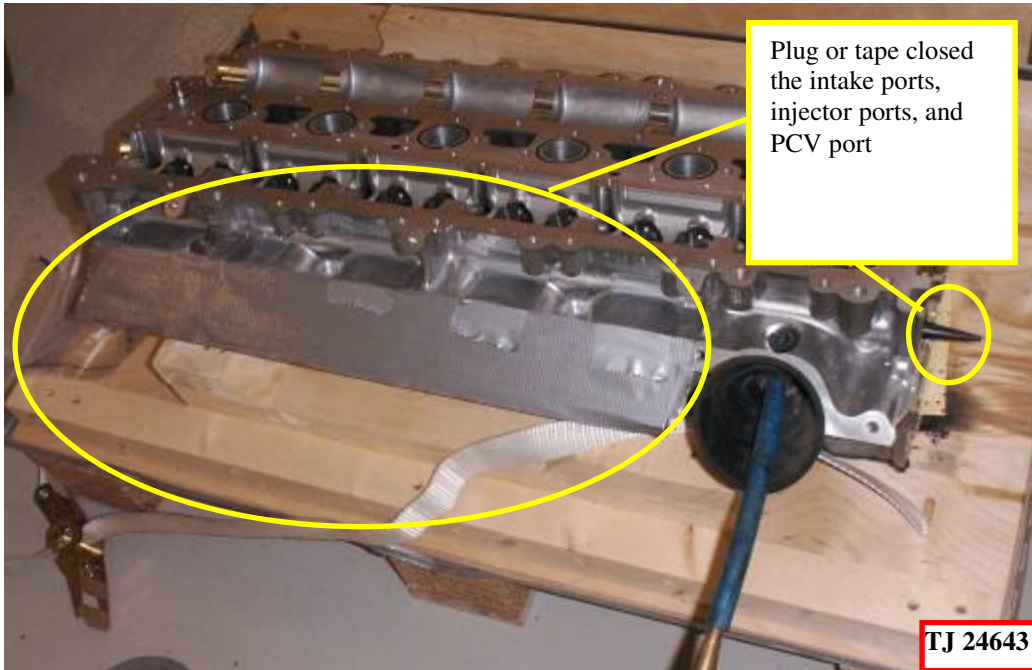
Photo 8. Note that the cylinder head is removed in this photo but this test should be performed on the vehicle.

Note! Use safety glasses! Remove the valve tappets. Plug all but one intake port, all injector ports, and the PCV inlet. Starting with the intake port that corresponds to the spark plug with the most soot, apply air pressure to one intake port at a time using a plug similar to those found on emissions testers. See Photos 8 and 9, left. Look at the base of the valve spring and check for ripples or bubbling in the ATF as you apply light

air pressure. If the ATF ripples or bubbles, then replace the cylinder head. **To get claim approval, contact the Prior Approval Department.**
