# Service Bulletin No. 361

MODEL <b>D Series Coaches</b>	TYPE <b>Field Change Program</b>	SECTION/GROUP <b>7 - Electrical</b>	DATE <b>Mar. 8, 2012</b>
SUBJECT <b>ELECTRONIC STABILITY CONTROL ( ESC ) TELL-TALE</b>			
CONDITIONS

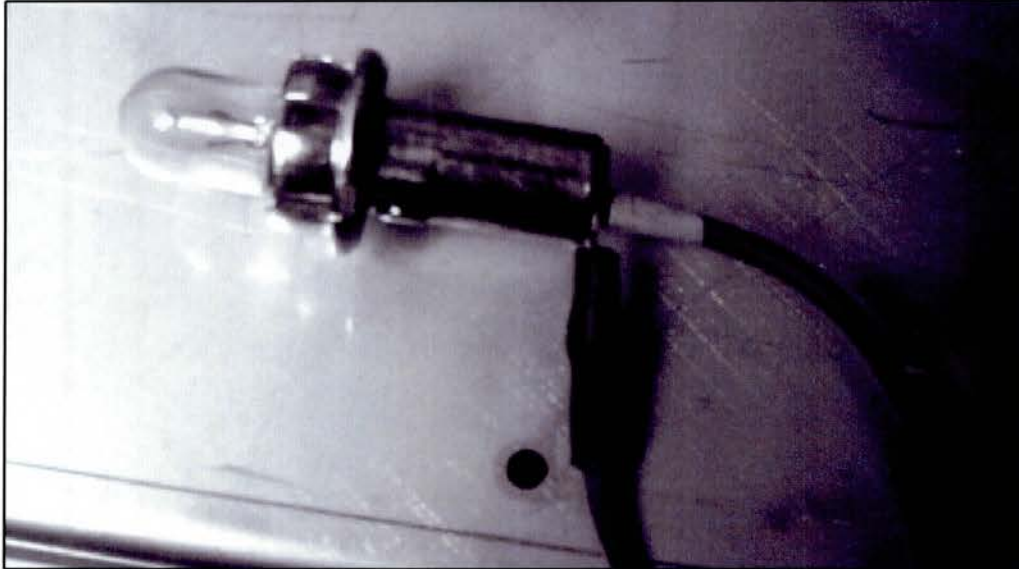
**Figure 1.**

3. Open the #3 baggage bay compartment curbside and roadside doors. Install the positive lock pin to secure the door in the open position.
4. Remove the cover from the curbside rear junction box.
5. Locate the ABS diagnostic light assembly. Carefully remove the bulb socket ( refer to Figure 1 ).

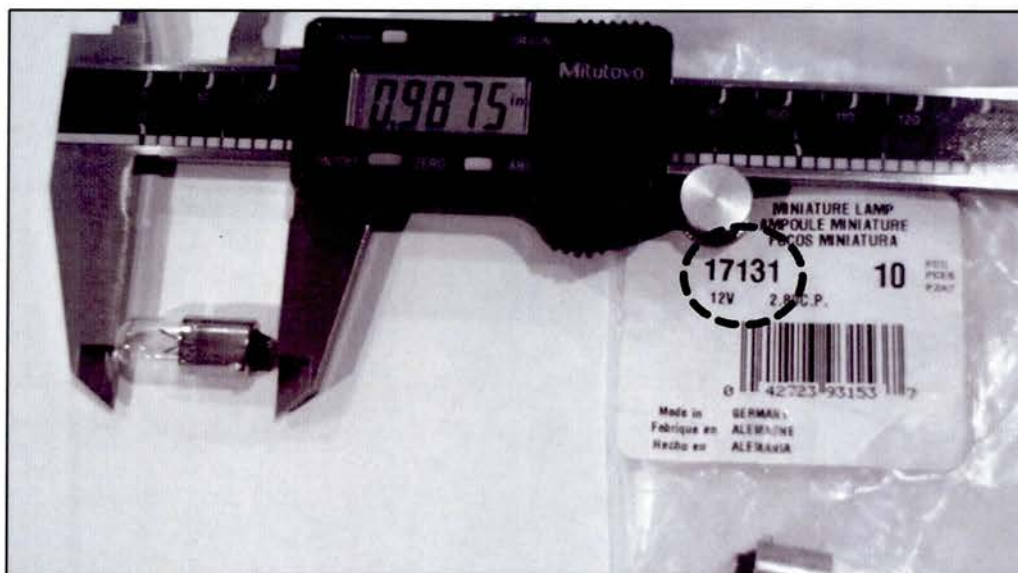
6. Measure the bulb length to ensure proper part installation ( refer to Figure 2 ).

**Figure 2. Correct bulb length ( just under one inch ).**

***If the bulb is the correct length of 1.0 inch, proceed to Step 7.***

***If the bulb is longer than the correct length discard the longer length bulb and replace with a new 1.0 inch bulb, Federal Mogul # 17131 ( refer to Figure 2 ).***

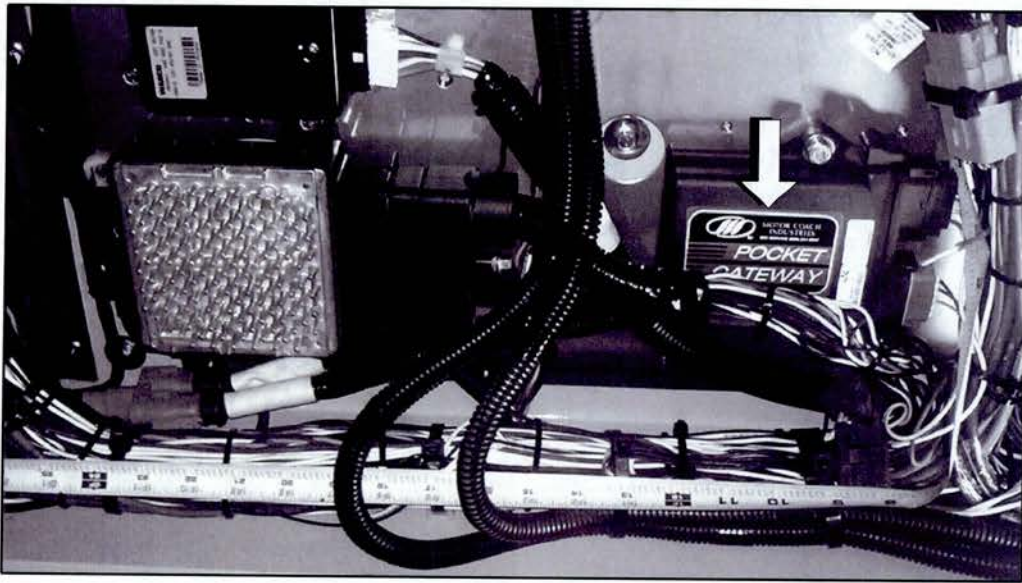
**Figure 3.**

8. Locate the Pocket Gateway module in the rear junction box ( refer to Figure 3 ).

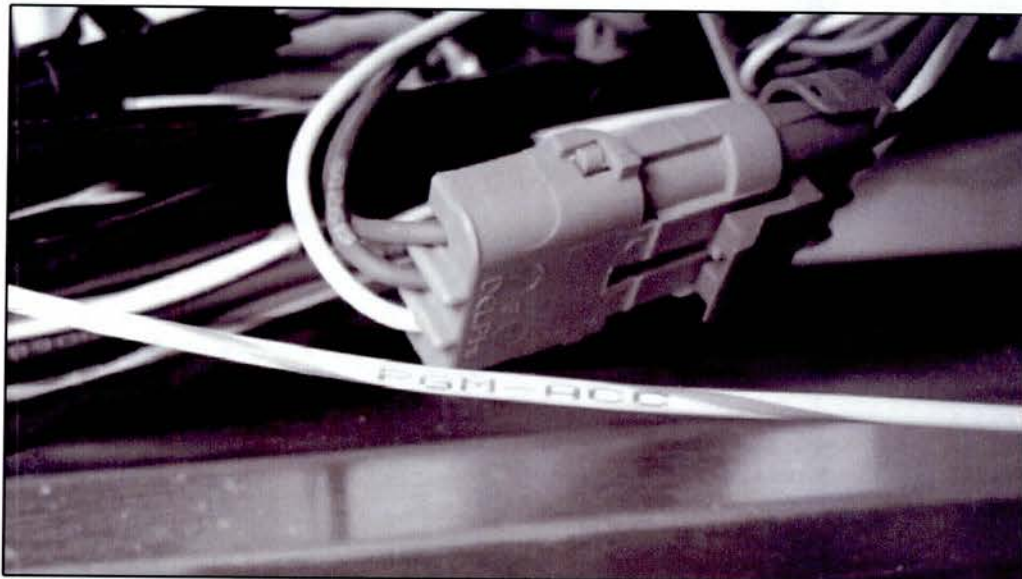
**Figure 4.**

9. Locate the white/green tracer wire labeled PGM-ACC exiting the top connector from Pin 12 ( refer to Figure 4 ).
10. Cut any existing tytraps to unsecure the PGM-ACC wire for a distance of twenty two ( 22 inches ) ( refer to Figure 3 ).

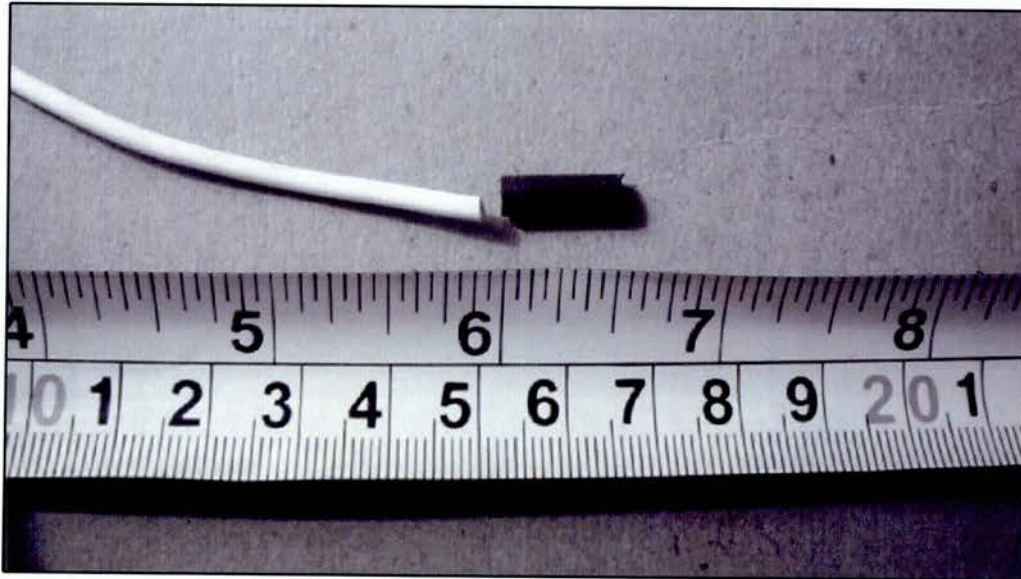
**Figure 5.**

11. Using wire cutters, cut the wire. Using shrink wrap, terminate the end of the wire routed to the curbside of the coach.
