Technical Service Bulletin

| GROUP | NUMBER | | | |
|---|---|--|--|--|
| AUTOMATIC TRANSMISSION | 12-AT-009-2 | | | |

ATM INPUT AND OUTPUT SPEED SENSOR DTC P0717, P0721 AND P0722

This TSB supersedes bulletin 12-AT-009-1 to correct the OP Times and OP Codes.

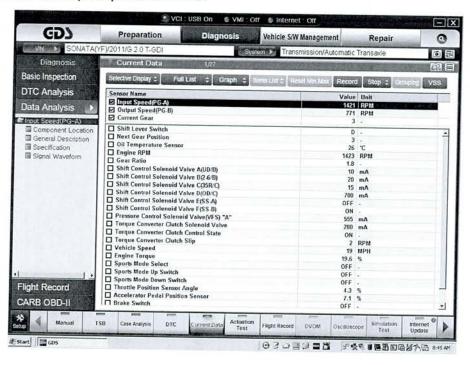
- Using a GDS, check for DTC in the "Automatic Transaxle" menu. Record the DTC and description. Delete the DTC.
- From the GDS, select the following parameters. Drive the vehicle and monitor the sensors.
 - Vehicle and A/T menu.
 - "Current Data"
 - Input speed and output speed sensors.
